*Paper Presented at*

*CUREe Open Symposium Sponsored by Kajima  
October 1999 Tokyo Japan*

**BUILDING PERFORMANCE IN THE 17 AUGUST 1999  
İZMIT (KOCAELİ), TURKEY EARTHQUAKE**

JOHN W. WALLACE, Ph.D., PE  
Pacific Earthquake Engineering Research Center  
Department of Civil and Environmental Engineering, 5731 Boelter Hall  
University of California, Los Angeles, CA 90095-1593

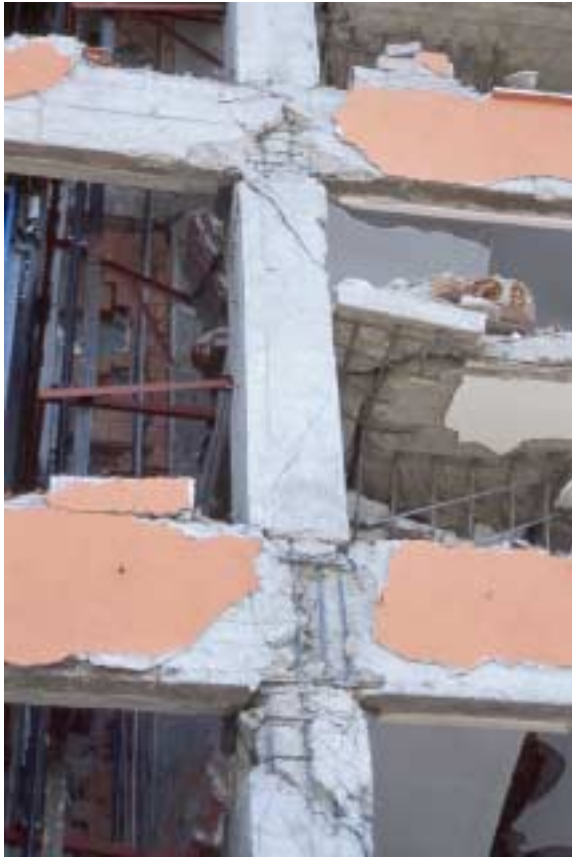
Fig. 9 Beam-column details and damage

Poor beam-column joint performance was observed in many buildings. Reinforcing details for a building under construction just west of Gölcük. In the lower joint shown in Fig. 9, no hoops are used within the joint and the beam longitudinal bars are spliced within the joint outside the column reinforcing cage. As joint deterioration occurs, anchorage of the beam bars is completely lost and vertical load carrying capacity is compromised. Joint ties were used in the upper story joint in Fig. 9; however, this was the only damaged joint where ties were observed. Although some diagonal cracking is observed in the column in Fig. 9, a relatively tight spacing of column hoops was used in this building compared with other buildings, which may have pushed the failure into the joint region (versus a column shear failure).

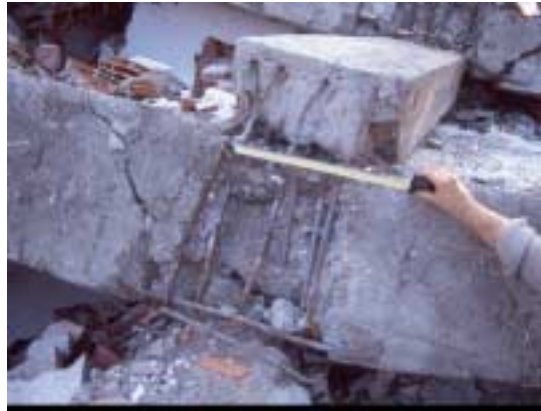
Fig. 10 Beam-column joint damage – bar slip

Poor anchorage of column bars through the joint may have initiated many upper story collapses (weak-column, strong-beam). It was common practice to hook the exterior column bars from above that were lapped just above the joint; however, hooks were not used on the bars along the interior face of the column (Fig. 10). The short lap of the smooth column bars appeared to pull through the joint effectively resulting in a “true hinge” above the floor levels leading to complete collapse of the building. This failure pattern was apparent in many collapsed or near collapsed buildings (Fig. 12).

The relatively wide spacing of transverse reinforcement (20 to 25 cm), the lack of crossties, and the use of 90-degree hooks on the hoops (versus 135-degree hooks anchored into the column core) were primary reasons for poor column performance (Fig. 10 and 11). For columns with nearly square cross-sections and adequate anchorage through the joint (strong-beams), insufficient transverse reinforcement was typically provided to resist the column shear developed when the columns reached their flexural capacity. As a result, relatively large diagonal cracks formed within the columns (e.g., see Fig. 13a), leading to “shear” failures and buckling of the vertical reinforcement. Relatively few column compression failures were observed. A compression failure for an interior column in a building west of Gölcük is shown in Fig. 11 (the same building as shown in Fig. 9).

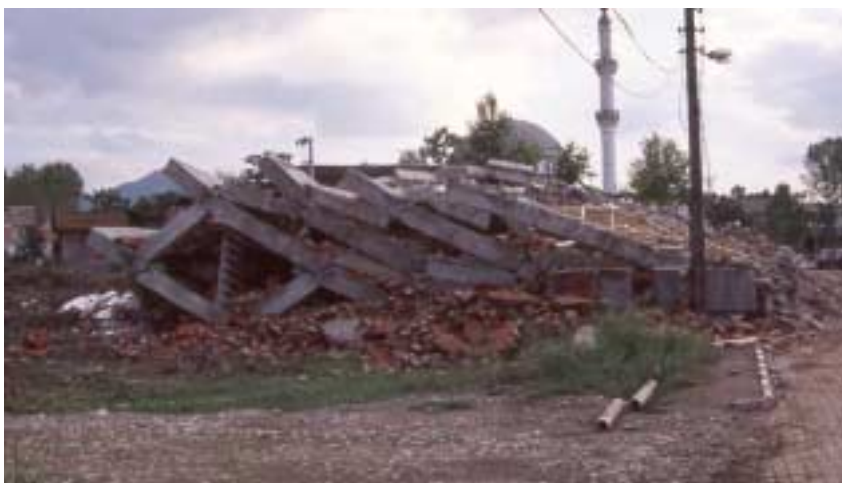
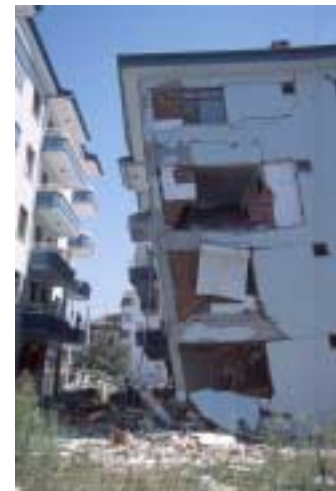
Fig. 12 Impact of column hinging on observed performance

A majority of the collapsed buildings were three to five story residential units. First story collapses due to poor structural configuration (soft-story) were common. The soft first-story level was typically created due to a taller first-story height and/or a lack of infill walls to provide for an open commercial area or for parking. Typical examples are given in Figure 7. As noted earlier, the hollow clay tile infill walls are commonly placed within the short column direction; therefore, column orientation and layout appeared to be arbitrary. In many of the buildings, majorities (often 75%) of columns were oriented with the long side parallel to the sides of the building (Fig. 8a). This created a relatively soft, weak building, resulting in column hinging about the weak axis at the top and bottom of the column (Fig. 8b). The use of column splices just above the floor levels exacerbated this problem, particularly at the base of the first story. It was apparent that column hinging was a major cause of first story and multiple story collapses.

(a) Complete collapse of building west of Gölcük

(b) Column Hinging

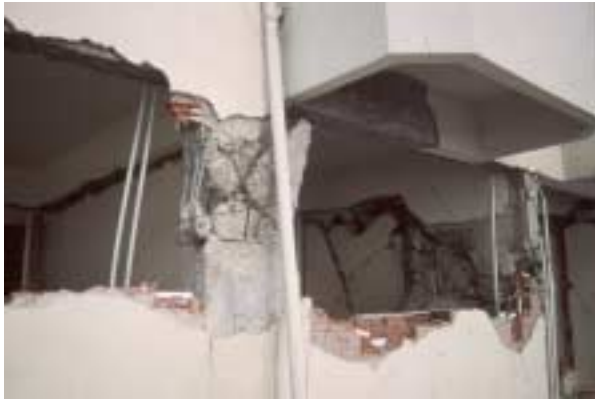
Many modern buildings were damaged in the city of Yalova (Fig. 13). Primary reasons for the poor performance includes previously mentioned deficiencies (column hinging, poor column details, column shear failures, soft-stories). The building in Fig. 13(a) was situated on the corner of two streets and the two faces of the building facing the streets were fairly open for retail space and parking, leading to a collapse of the first-story. A similar nearby building (Fig. 13b) did not exhibit a first-story collapse even though the axial load-carrying capacity of all the first-story columns along one side of the building had been compromised (e.g., Fig. 14a). Collapse of the building was apparently prevented by the use

(a) Column shear failure (wall in background)

Fig. 14 Damage to frame-wall building in Yalova

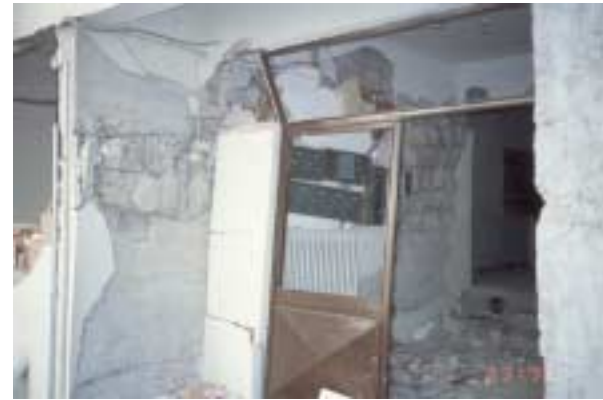
of relatively short, narrow coupled walls (Fig. 14a,b). A total of eight walls, with cross sections of approximately 200 mm by 1200 mm, were distributed around the perimeter of the building. Although the walls were damaged, the axial load-carrying capacity was maintained and collapse was avoided (as well as in several similar buildings that did not appear as damaged). Relatively deep beams and with short spans (approximately 4.5 m) to the interior columns may also have provided an alternate load path, with the walls providing vertical stability. Consistent with observations from other damaging earthquakes, a few, well-placed structural walls provide substantial life-safety.

(b) Shear failure in coupled wall

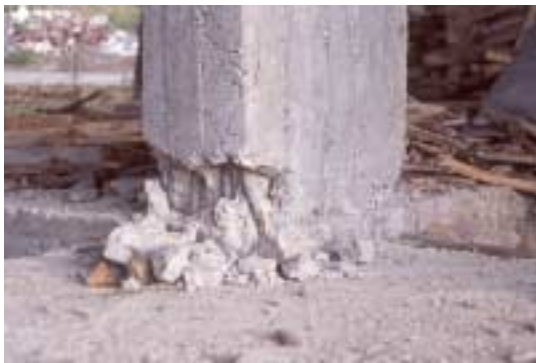
Poor construction practices, as well as poor consolidation of concrete were observed in numerous buildings. In Fig. 15, poor alignment was achieved at the splice between the column vertical bars and the vertical foundation bars, and the vertical bars in the foundation were bent over to match

Fig. 15 Bent column bar at foundation

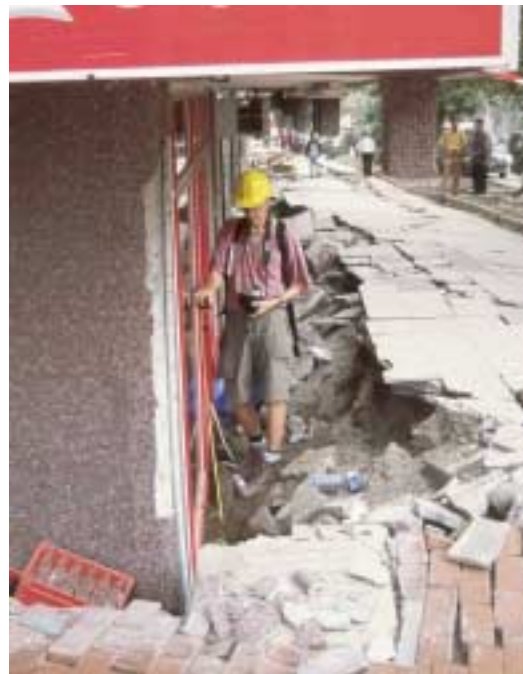
Poor foundation performance was observed throughout the city of Adapazarı which is founded on a former lakebed. The soils for the top 10 m consist of sands and silty sands with low blow counts (uncorrected SPT blow counts of 5 to 10). According to some boring logs available over the Internet, the ground water table is only 2 m below the ground surface. Local residents indicated that the ground bubbled for several minutes and sand boils were observed throughout the city. Liquefaction-induced bearing failures lead to substantial building settlement (Fig. 17), and in some cases, lead to overturning of tall, narrow buildings (Fig. 18).

Fig. 17 Bearing/settlement failure in Adapazari

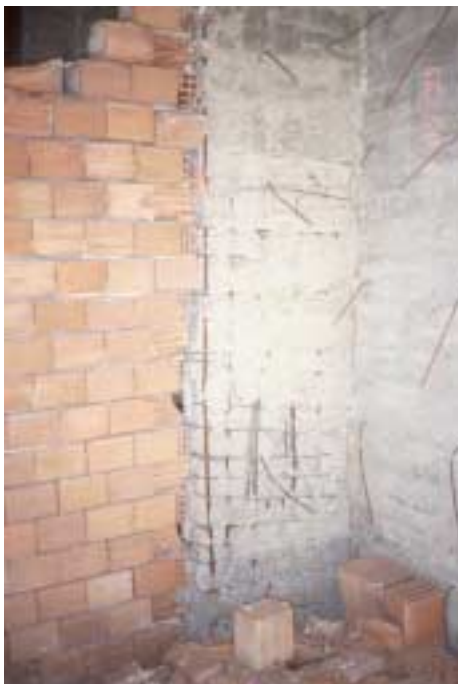
the column vertical bars. Significant misalignment of columns between floor levels (1.4 cm/100 cm) was also observed. Poor concrete consolidation, lack of concrete cover, and rusted reinforcement are depicted in Fig. 16 for a seven-story building under construction in Yalova.

Fig. 16 Poor concrete placement  
In shear wall (Yalova)

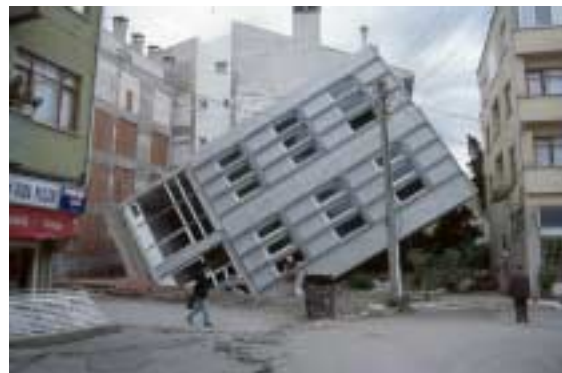
Fig. 18 Liquefaction induced bearing failure  
in Adapazari
