SANTA MONICA BAY AREA MUNICIPAL STORM WATER/ URBAN RUNOFF PILOT PROJECT — EVALUATION OF POTENTIAL CATCHBASIN RETROFITS

Prepared for
Santa Monica Cities Consortium
c/o City of Santa Monica
Engineering Department
1685 Main Street
Santa Monica, CA 90407-2200

Woodward-Clyde Project No. 9653001F-6000

September 24, 1998
Prepared by:

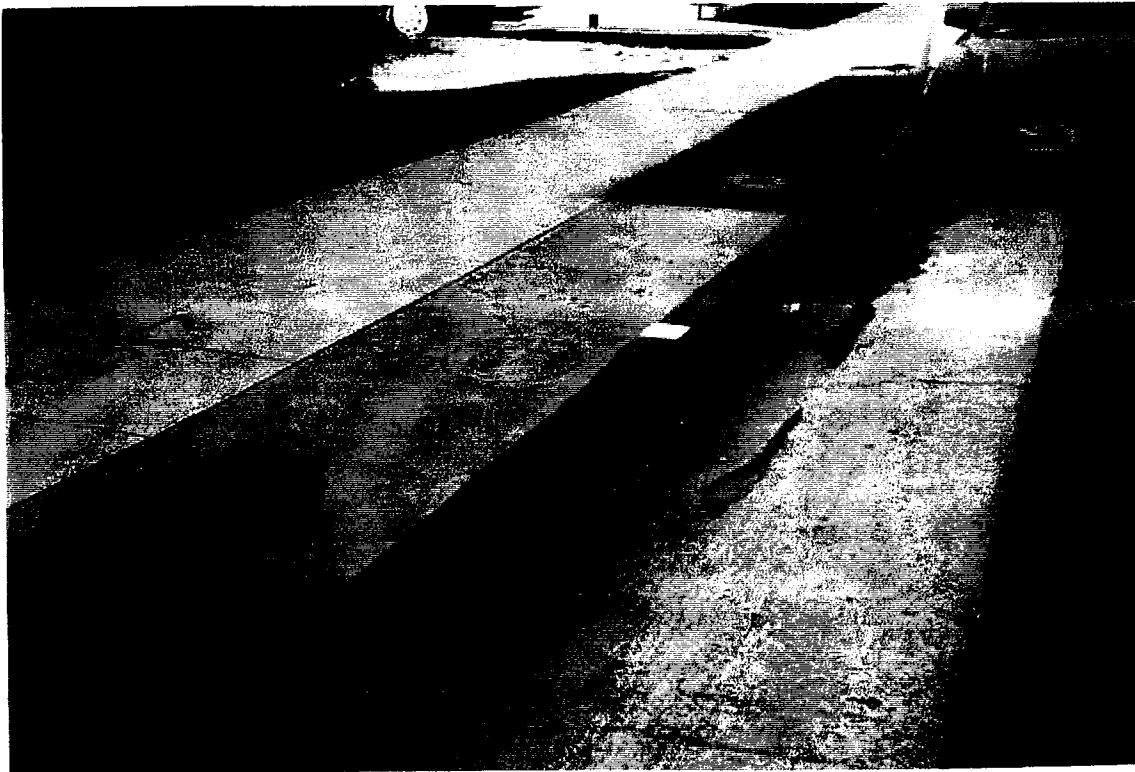
Material had accumulated in front of the boardover, as shown in Figure 4-3. The boardover, which had been constructed of interior-grade plywood was slightly warped. The inside of the catchbasin chamber was relatively clean, as shown in Figure 4-4, except for light organic material that had apparently been carried in by nuisance water (under the edge of the boardover).

FIGURE 4-3.
BOARDOVER AT CATCHBASIN IN RESIDENTIAL AREA (SUNSET PARK AREA, SITE 1).

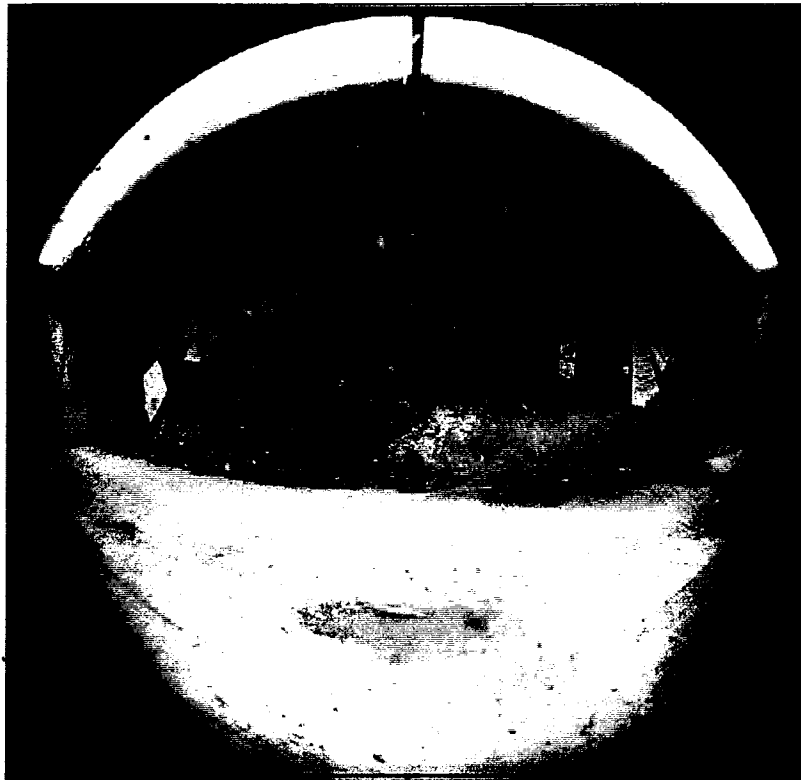
The material was removed on November 5, 1997, with the assistance of personnel from the City of Santa Monica. Approximately 3 ft³ of leaves and light material (fluff) were collected. The smaller material was screened and weighed at UCLA. Table 4-1 shows the results. Only 3.2% of the material was found to be small enough to pass through a 325 mesh sieve.

FIGURE 4-8.
ACCUMULATED MATERIAL INSIDE CATCHBASIN AT SUNSET
PARK AREA, SITE 3 (CONTROL).

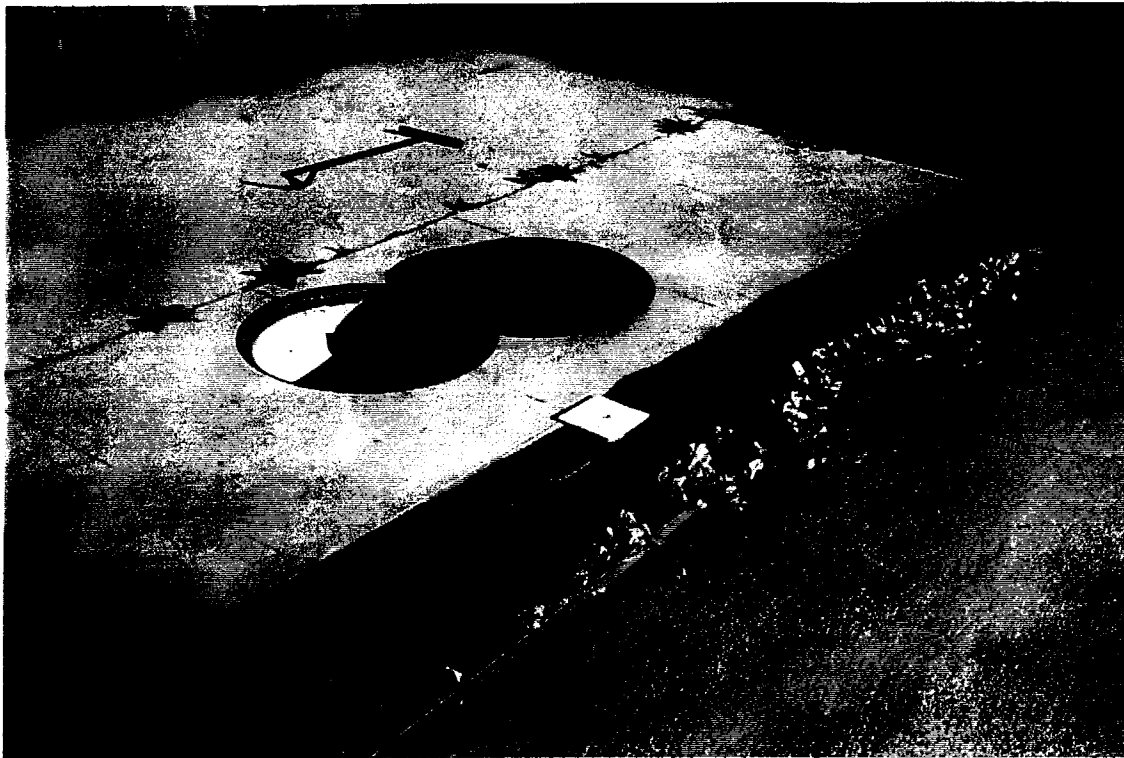
The inside of the catchbasin chamber equipped with the prototype retrofit provided by AbTech was found to be essentially clean, similar to the catchbasins that had been equipped with inlet screen panels and boardovers. A few items of debris were caught in the basket that hangs inside the chamber; leaves were also beginning to accumulate. Figure 4-9 shows the front of the catchbasin. The screen had prevented leaves from entering the catchbasin chamber. Figure 4-10 shows the inside of the catchbasin, photographed from the manhole. In this picture the front screen had been removed, and the internal baskets are clearly visible.

FIGURE 4-9.
VIEW OF FRONT OF AB TECH SCREENED CATCHBASIN (SUNSET PARK AREA).
