CIWMB CATCH BASIN INSERT STUDY FINAL REPORT

USED OIL RESEARCH, TESTING, AND DEMONSTRATION GRANT

Grant Number URD3-02-0005

May 24, 2005

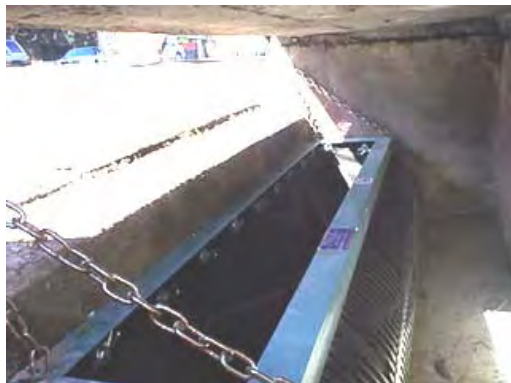
Figure 3-1. DrainPac™ catch basin insert.

The DrainPac™ is a flexible storm drain catchment and filtration liner designed to filter pollutants, debris, and solids prior to discharge into storm drain systems. The DrainPac™ is available in four (4) styles: grate top, curb, and round configurations, as well as new styles designed for outfall, or "end of pipe" applications and drop-in drain applications. Each insert is equipped with a choice of two (2) overflow systems, the hydraulic bypass and the new uninhibited bypass, both of which accommodate heavy rains and potential flooding. A picture of the curb inlet DrainPac™ system is shown in Figure 3-1.

According to the manufacturer, the DrainPac™ can handle flow rates of up to 150 gpm/sq. ft and hold up to 7100 pounds of material. Tests performed at UCLA (not in this study) show removal efficiencies for the DrainPac™ System at 99% for TSS, and 51% to 88% for PAHs. Typical cost for the DrainPac™ System range from about \$1000 for a 21-foot wide curb inlet to about \$500 for a 4- to 7-foot wide curb inlet. The manufacturer recommends that maintenance be performed at least twice per year (once before the wet season and once after the wet season). Quarterly inspections during dry periods and monthly inspections during wet periods are also recommended. The cost of a yearly maintenance service agreement with the manufacturer is \$225 per unit.

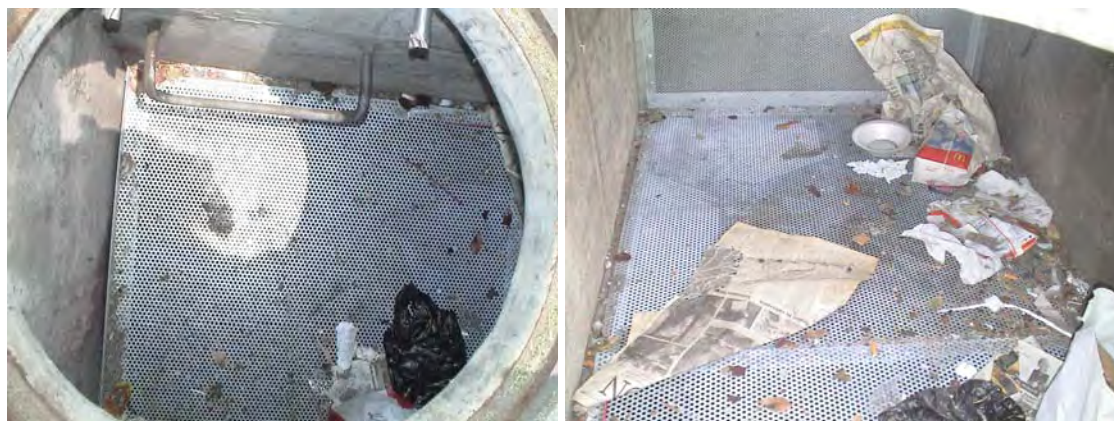
Figure 3-5. Alternative catch basin insert system installed by the City of Los Angeles.

During the course of these two phases of the study, one insert at a CPC site and three inserts at FL sites were replaced by the City of Los Angeles with an alternative insert system without the knowledge of the research team. This alternative system is shown in Figure 3-5 and consists of a screen that covers the entire bottom of the catch basin. Notice that this design provides no oil absorption, but has ample capacity for capturing bulk solids. The loss of the inserts was unfortunate and reduced the number of inserts available for the study.

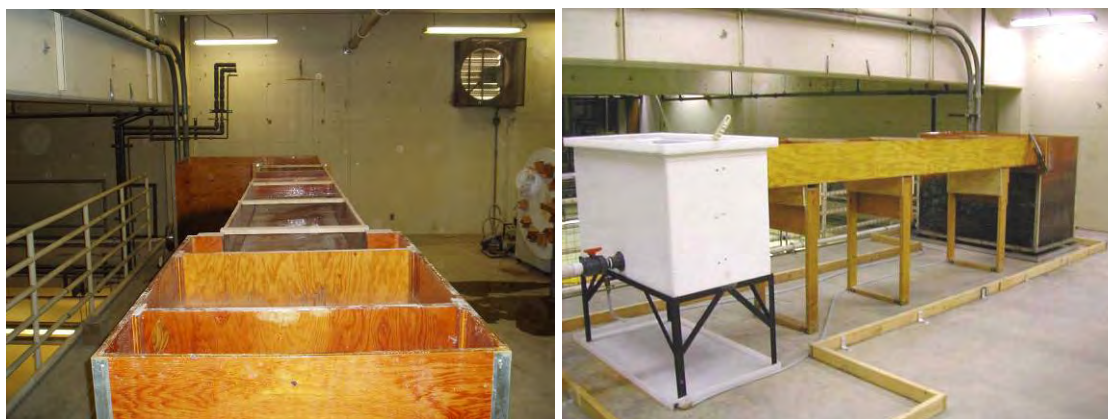
Figure 3-8. Testing apparatus prior to upgrade (left) and after upgrade (right).

Pictures of the testing apparatus in its new location are shown in below. Figure 3-8 shows a full view of the apparatus prior to and after being upgraded. Figure 3-9 shows the inlet configuration, the new stilling basin, and the catch basin outlet.

As mentioned above, the UCLA testing apparatus was moved from its previous location and needed to be repaired due to leaks and needed to be modified to accommodate the inserts tested in this study. A new stilling basin tank was also installed.

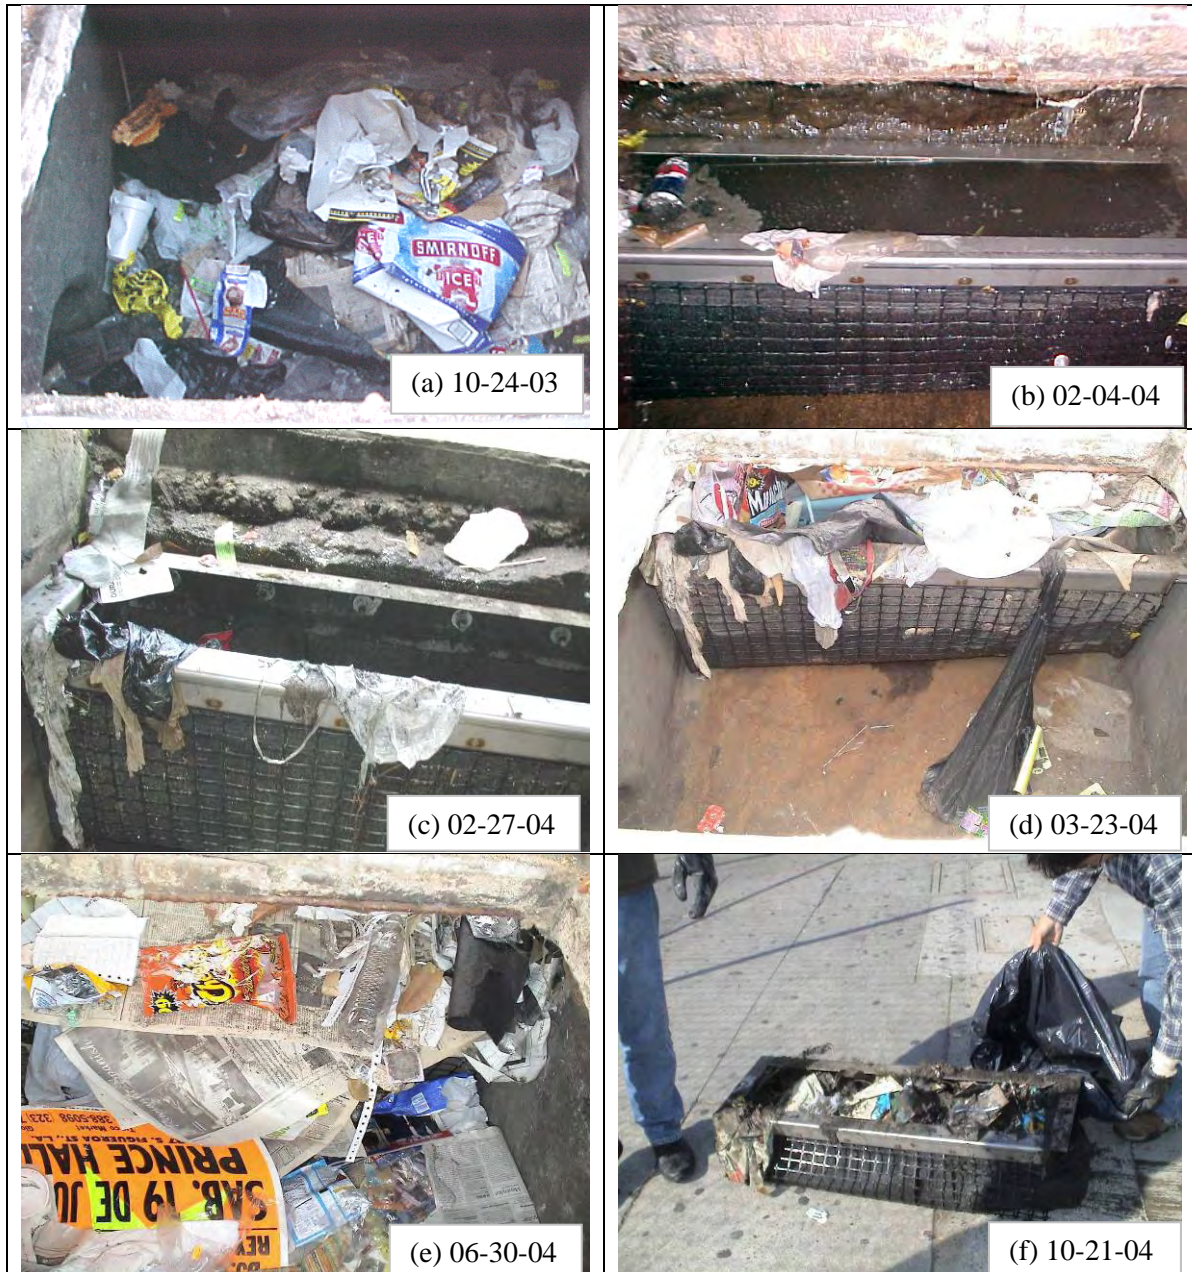
Figure 4-4. Field inspection photos of DrainPac catch basin insert at the intersection of Washington Blvd. and Vermont Ave.

The initial site visit (10-24-03) before the installation of the DrainPac indicated that the site was located at a busy intersection with very high trash loading (Figure 4-4a). The first inspection after the installation of the insert was made on 02-04-04 during a small storm event ($\sim 0.75"$; see Figure 3-10). Although the insert appeared to be operating at full hydraulic capacity, the inflow was still being processed by the insert (Figure 4-4b). The next visit (02-27-04) occurred in less

than a month after a relatively large storm event ($>2''$). The site examination indicated that some flow bypass had occurred with trash and debris settling at the edge of the insert (Figure 4-4c). Also, standing water indicated the insert was beginning to clog. The site was completely overwhelmed with trash during the fourth visit (03-23-04; Figure 4-4d) and since only one storm ($>1''$) occurred since the previous visit, most of the trash was likely due to wind rather than runoff. The next inspection on 06-30-04 the insert appeared to be completely buried with wind-blown trash (Figure 4-4e). During the last inspection of the site (10-21-04) the insert was retired and captured debris were collected for laboratory tests (Figure 4-4f).

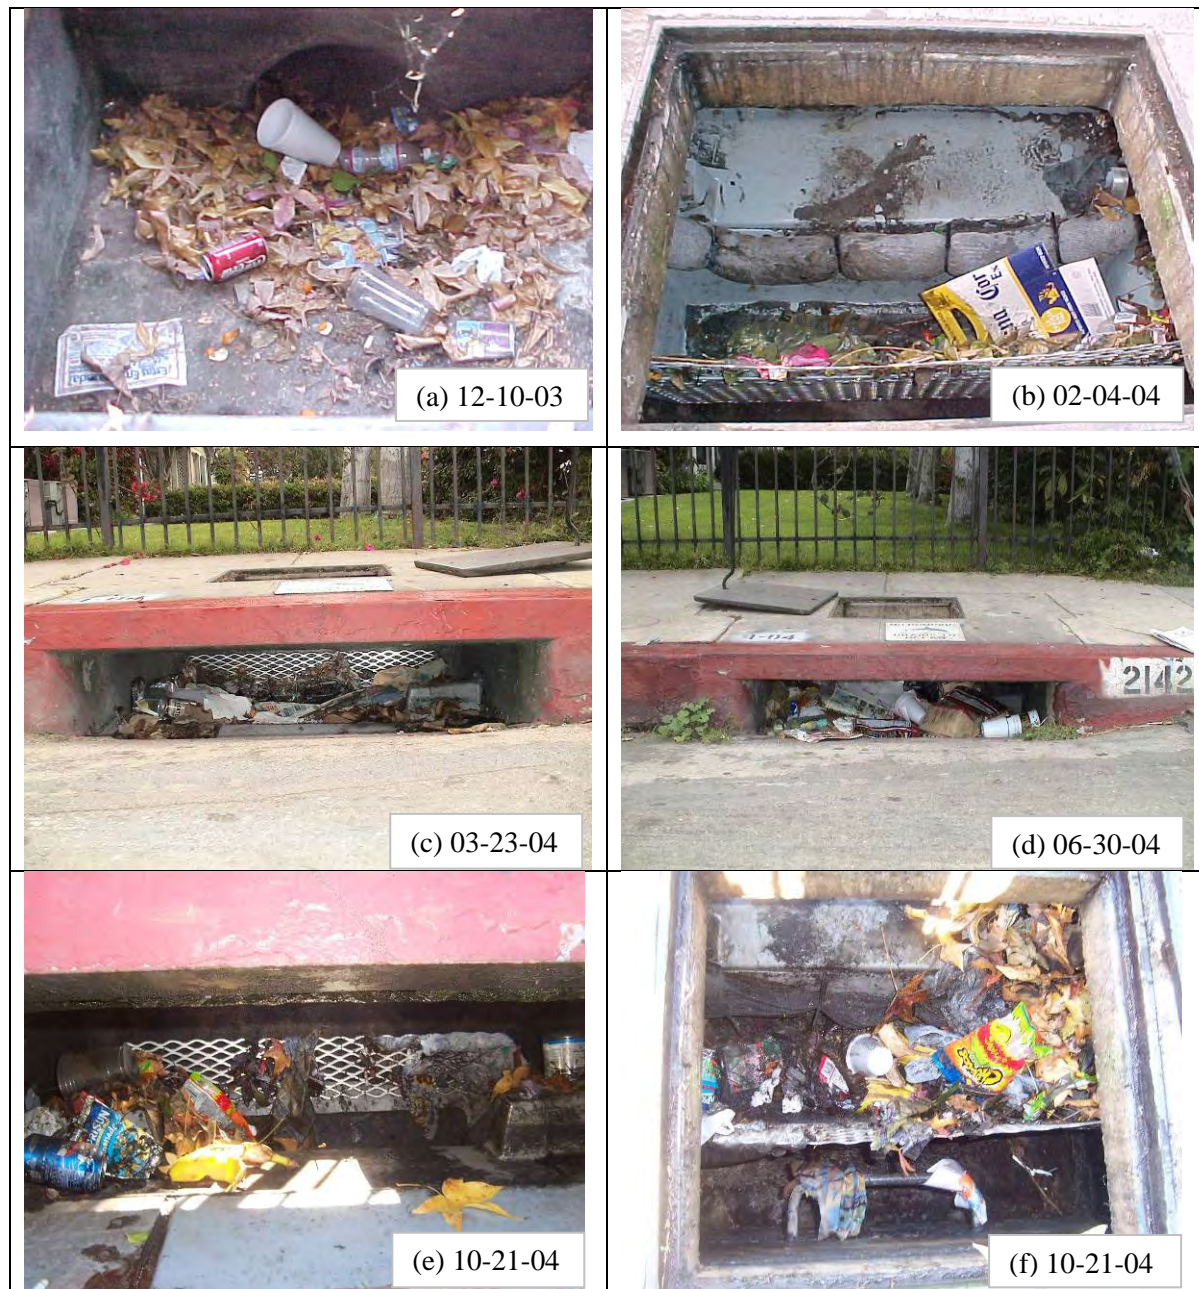
Figure 4-8. Field inspection photos showing the condition of Curb-Inlet Basket at the intersection of 23rd St. and Portland (east side).

The initial site survey was completed on 12-10-03 before the installation of the insert. Excessive leafy debris from nearby deciduous trees appears to comprise a significant proportion of the material delivered to this catch basin (Figure 4-8a). The first visit (02-04-04) after insert installation was performed just after one storm event (~0.75"). Some trash and debris along with a notable accumulation of coarse sediment were collected by the insert (Figure 4-8b). However, the insert still had plenty of capacity at this time. During the next visit in less than two months after installation (03-23-04) the insert had accumulated a significant amount of trash, but was still functioning with limited signs of bypass (Figure 4-8c). The site survey conducted on 6-30-04 showed that the insert had reached its full capacity and was overflowing with wind-blown trash and debris (Figure 4-8d). The final site inspection was performed on 10-21-04 after a few inches of rainfall (see Figure 3-10). There was less trash in the insert than the previous visit and the media boom at the lip of the insert was missing its adsorptive material indicating that the insert was cleaned by Los Angeles County maintenance staff prior to the wet season. Since the absorptive media was missing, this insert was retired during this final visit (Figure 4-8e and Figure 4-8f).

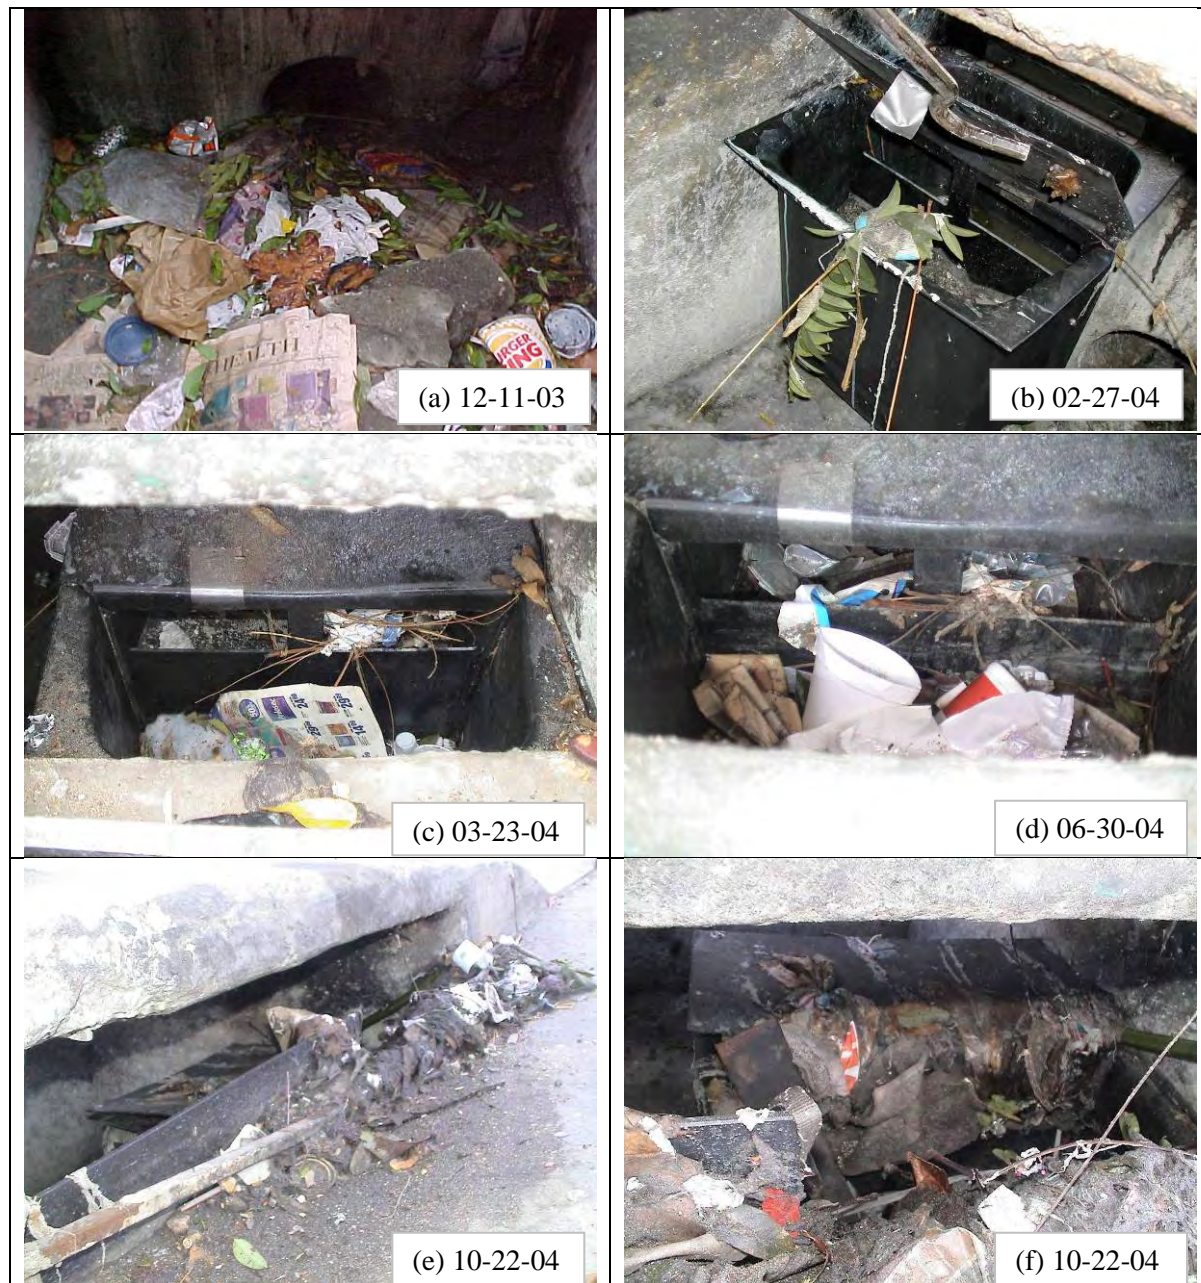
Figure 4-16. Field inspection photos showing the condition of Hydro-Kleen at the intersection of Washington and Walton.

The initial site survey before the installation of the Hydro-Kleen insert occurred on 12/11/03. Examination of the site showed evidence of high trash loadings and a missing catch basin lid (Figure 4-16a). The first inspection after installation of the insert occurred on 02-27-04. Although there was evidence of bypass (Figure 4-16b), the insert appeared to be in good working condition even after a few storms, including an event greater than 2 inches. The missing concrete cover had been replaced prior to the installation of the insert. During the second inspection, it was noticed that the insert was capturing significant amounts of trash (Figure 4-16c). The third inspection was completed after another few months (06-30-04) and although the insert has captured more trash than the last visit it still appeared to be in good working condition (Figure 4-16d). The final inspection was conducted approximately three months later (10-22-04) and the insert had reached its volumetric capacity. There was a significant amount of oily sediment and debris on the curb indicating blockage of the insert. The insert was retired and the captured contents were collected for laboratory analysis (Figure 4-16e and Figure 4-16f).

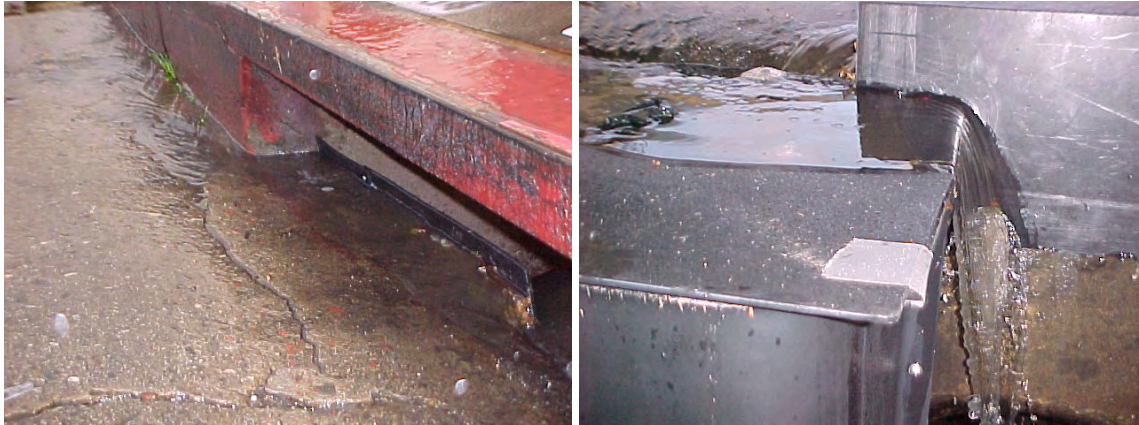
Figure 4-17. Relatively low-intensity storm showing bypass (FL-006-H, 2/4/04).

(presumably due to clogging), as well as improper installation. For example, Figure 4-17 shows a HydroKleen insert bypassing a significant proportion of the inflow during this April 4th, 2004 site visit after only one month in the field. Figure 4-18 shows an improperly installed FloGard that created a lip near the inlet that caused the flow to bypass the insert. In contrast, Figure 4-19 shows two properly installed inserts near capacity, but processing the flow.

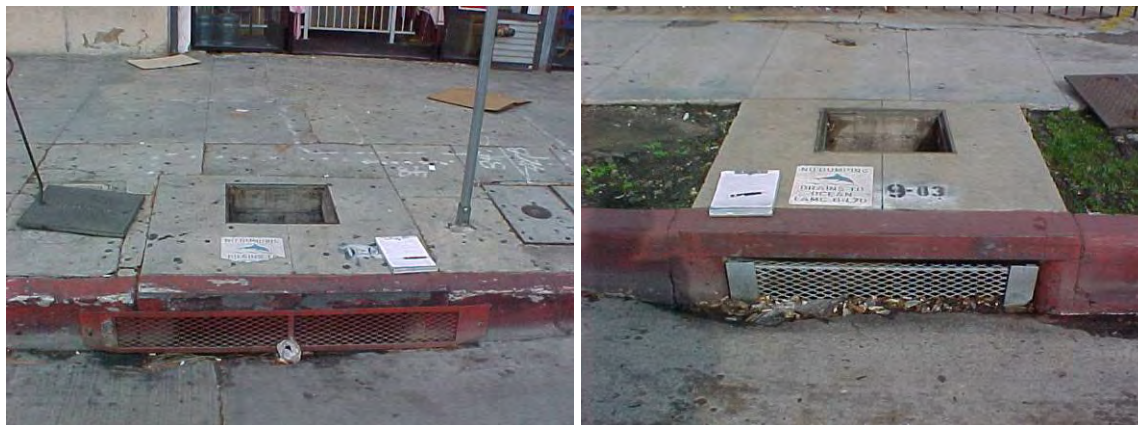
Figure 4-20. Curb inlet screens installed at two sites: FL003-F (left) and CC004-H (right).

Two of the sites had screens installed at the curb inlet (FL003-F and CC004-H) as shown in Figure 4-20. These curb inlet screens blocked much of the trash and debris from entering the curb inlet. Consequently, the inserts installed at these locations appeared to show significantly less trash and debris accumulation. While no data yet to support, it is presumed that these simple inlet screens can improve long-term oil retention of any catch basin insert type by reducing the tendency for blinding the absorbent media.

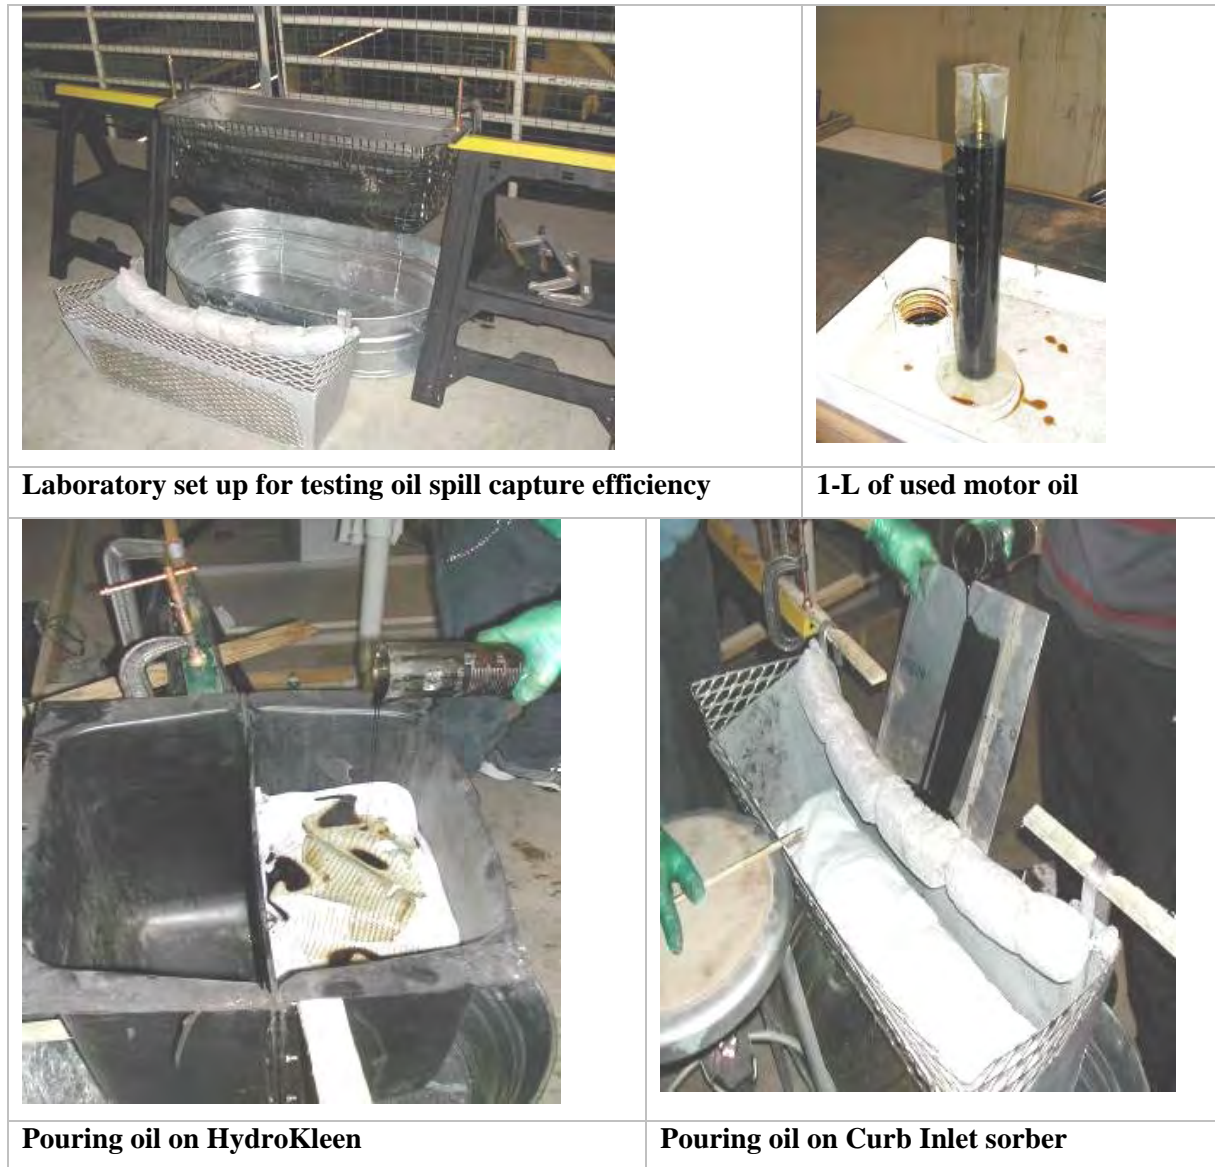
Figure 4-21: Laboratory set up for the evaluation of spill control by catch basin inserts.

The inserts were equipped with new media for these tests. Each insert was suspended on two saw horses above an oval shaped, galvanized tub. One liter of used motor oil was poured into the front of the insert and allowed to drip down the front of and then into the insert. The tests were performed at room temperature (18 to 21 °C) and the pouring was timed and completed over 2 minutes. Figure 4-21 illustrates the laboratory testing procedure for the spill tests.

The ability of each device to retain oil will depend upon the way the oil enters the front. Only the HydroKleen and DrainPac devices ensure that all the oil will be contacted by the oil absorber. However, the DrainPac has sorption surfaces on the bottom but there is too little

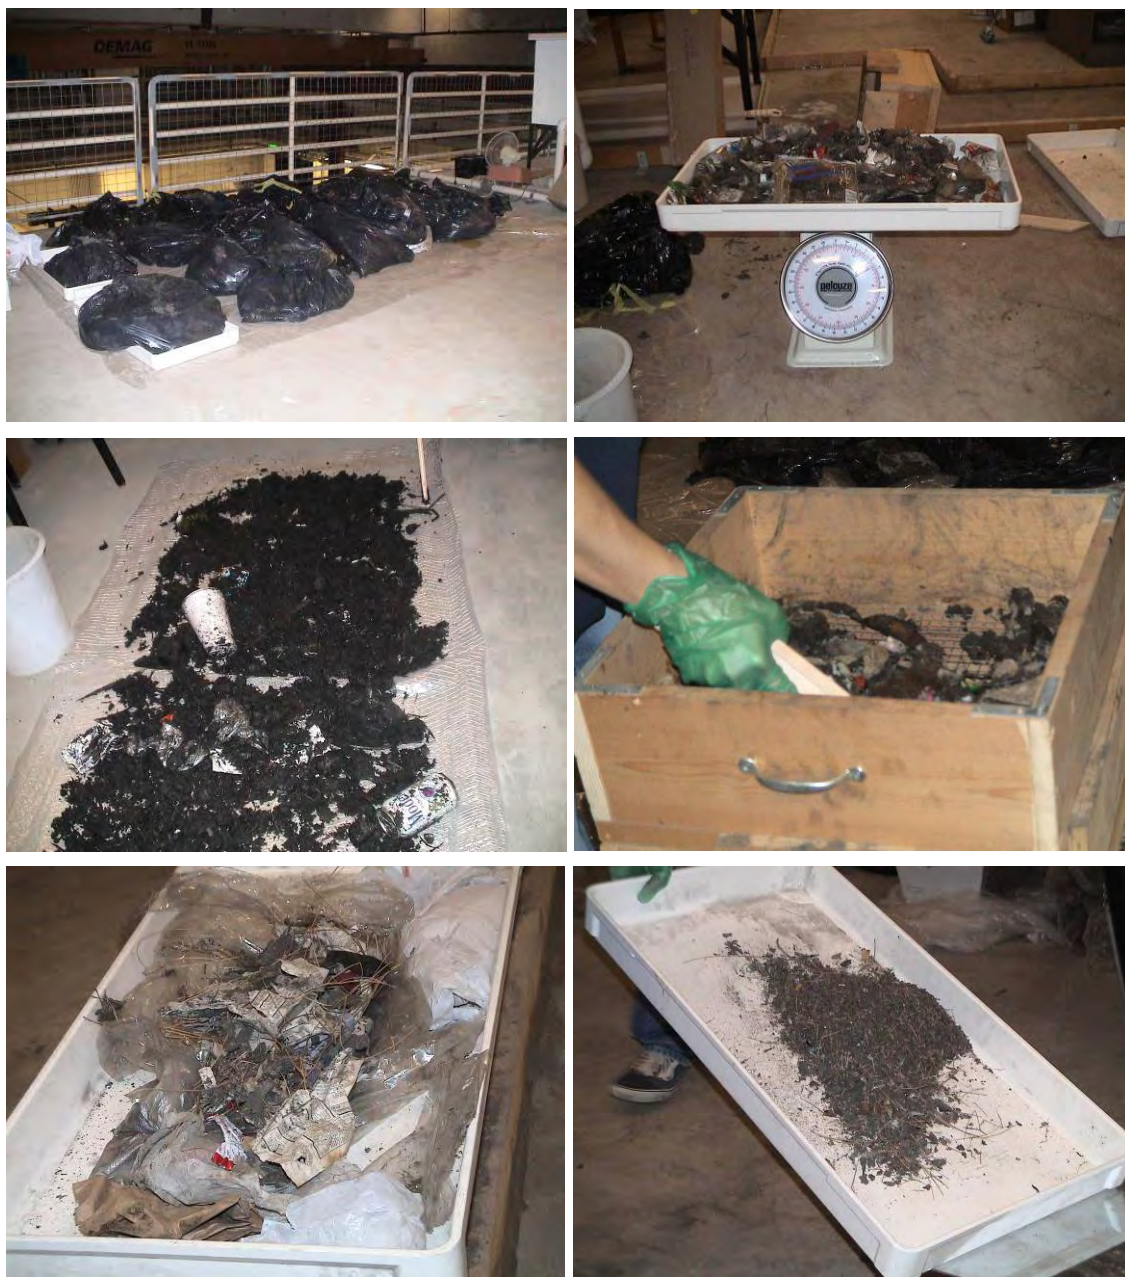
Figure 4-26. Photos of bulk solids screening process.

After the cumulative pollutant capture period of the study, material recovered from the inserts was characterized. The materials captured by all four types of inserts (Catch Basin Inlet, DrainPac, FloGard, and HydroKleen) at various sites were returned to the UCLA campus for analysis. Consisting of primarily coarse sediment, leaves, debris, and litter, the material captured by each insert was weighed wet and then a representative volume of the material was sampled, air dried, sieved into two size fractions using a 1-inch screen, and then weighed. Figure 4-26 includes photographs illustrating this solids analysis procedure.

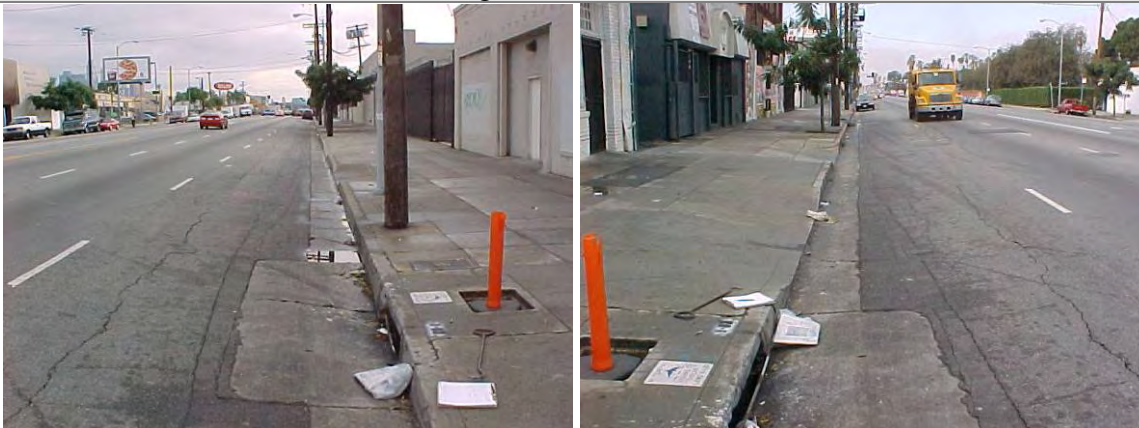
Date inspected:
12/11/03

Comments:
Initial site visit.
Notice the missing cover and damaged inlet.

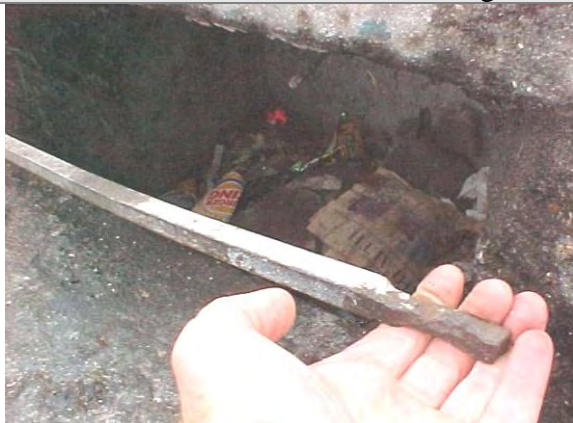
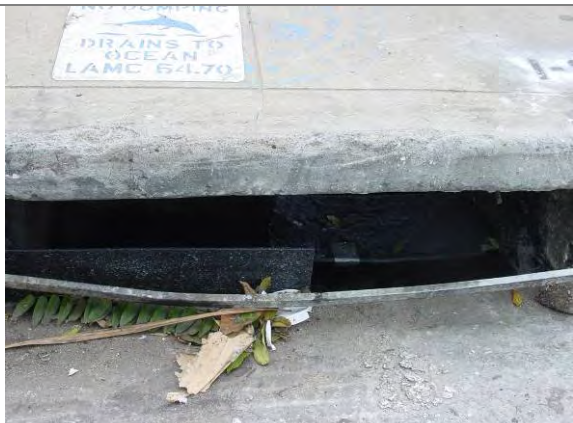
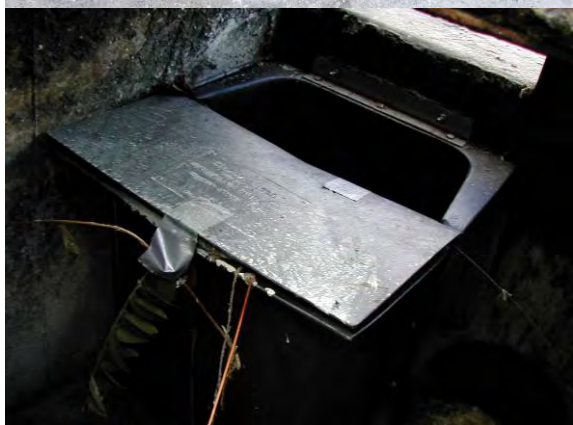
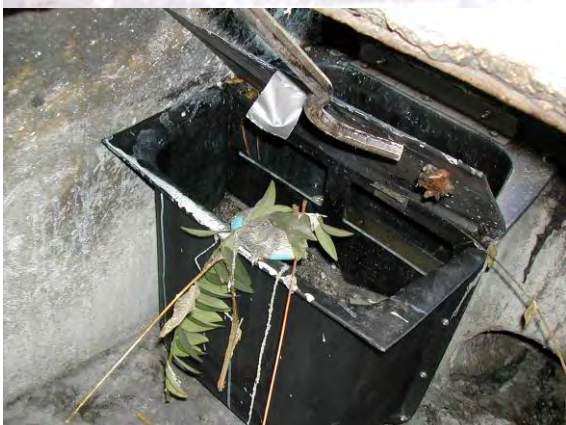
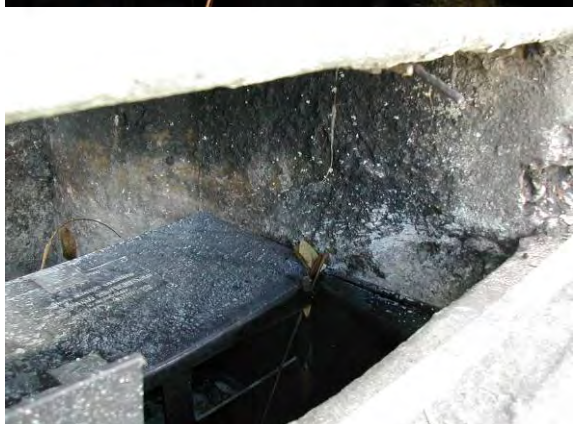
Date inspected:
2/27/04

Comments: After a few storm events this device appears to be in good working order. Notice the missing concrete cover has been replaced.

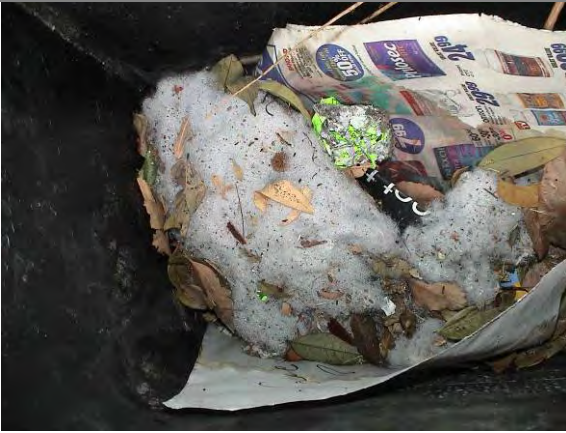
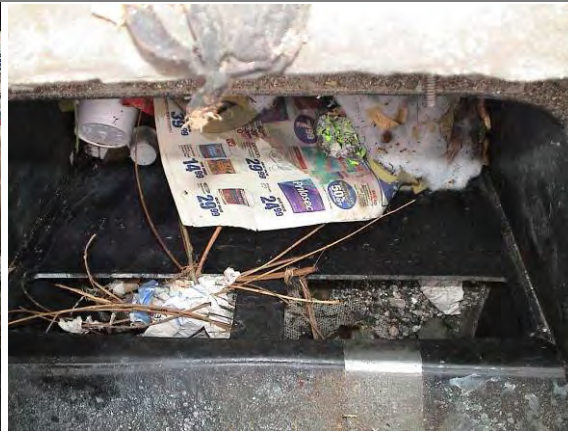
Date inspected:
3/23/04

Comments: This site had a significant amount of trash inside the catch basin prior to installation. Now the insert is capturing nearly all of the trash. This was previously a field-to-laboratory site that was switched due to installation timing conflicts.

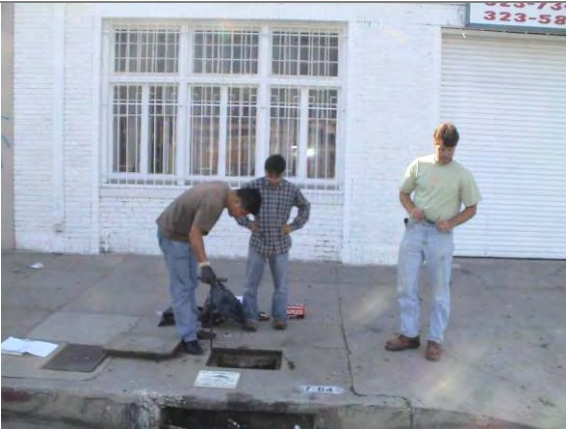
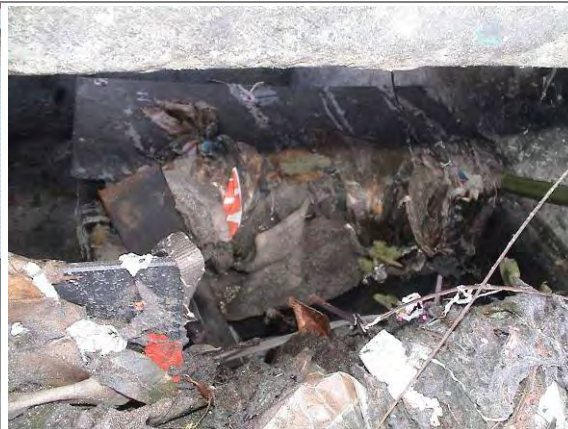
Date inspected:
10/22/04

Comments: Significant oily sediment and debris present at the curb; evidence of blockage.

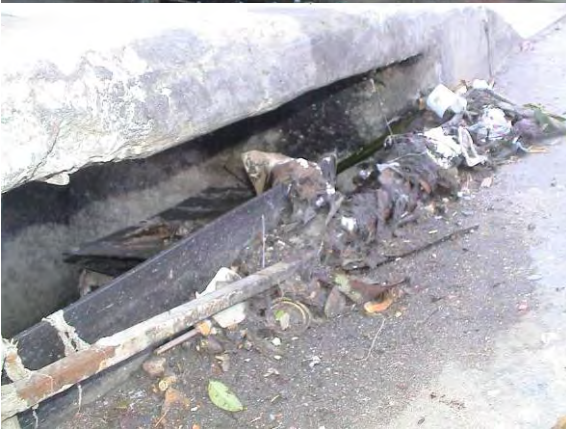
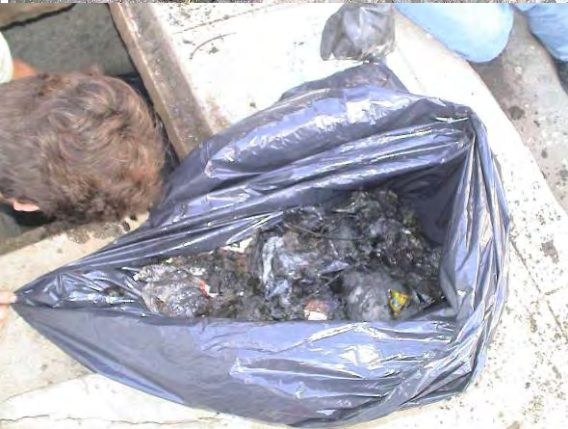
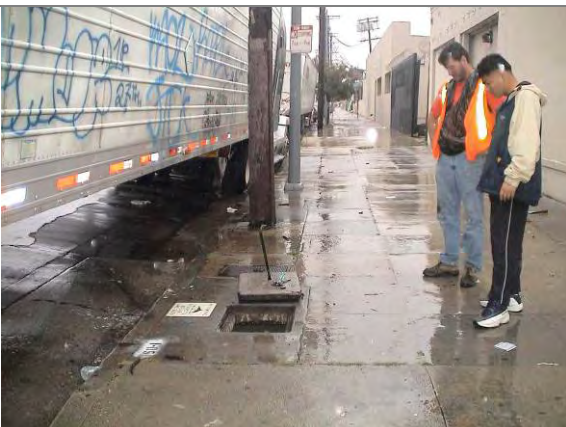
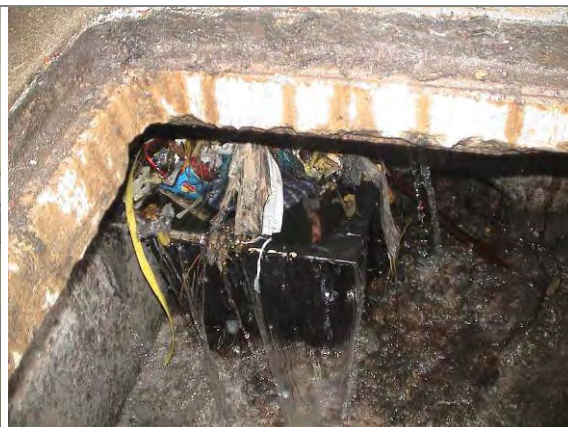
Date inspected:
03/22/05

Comments: It was raining during this visit to retrieve this insert. After this visit, this insert was taken to the laboratory for its final tests.

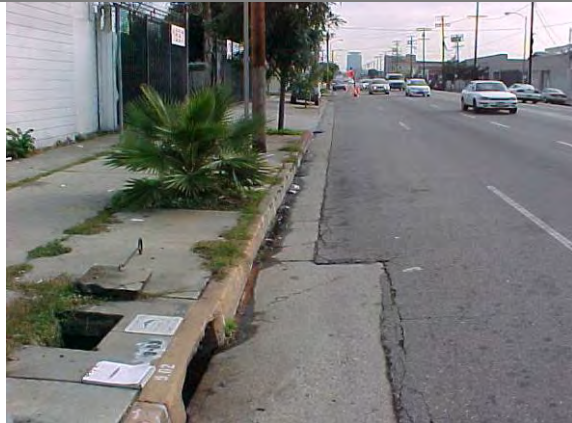
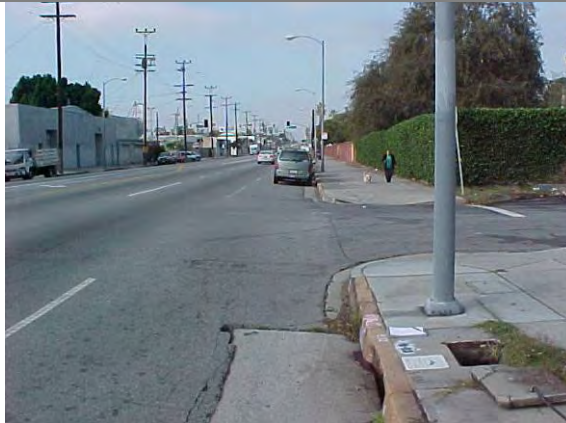
Date inspected:
12/11/03

Comments: Initial site visit. Top left photo is looking upstream; top right is downstream. The catch basin was relatively clean with minor dry weather flows. Note that this catch basin is inline with the storm drain system.

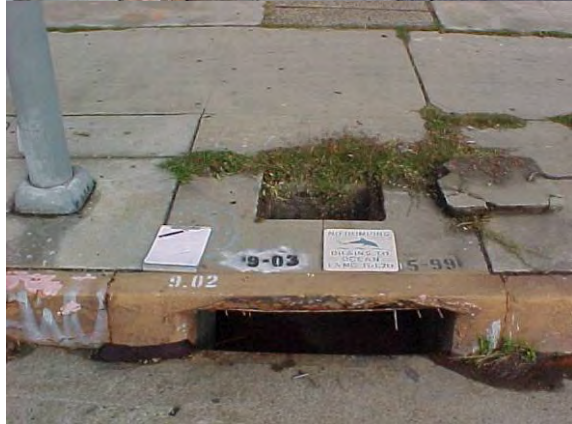
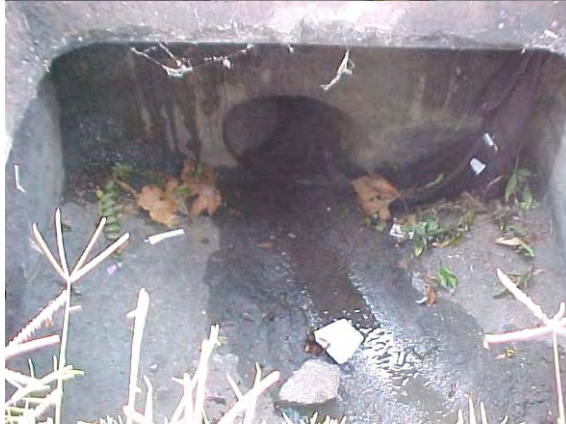
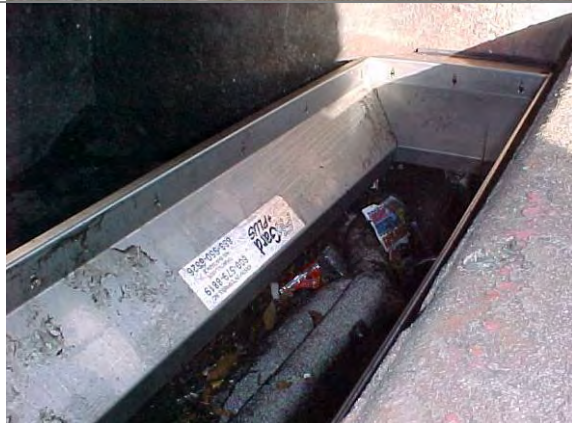
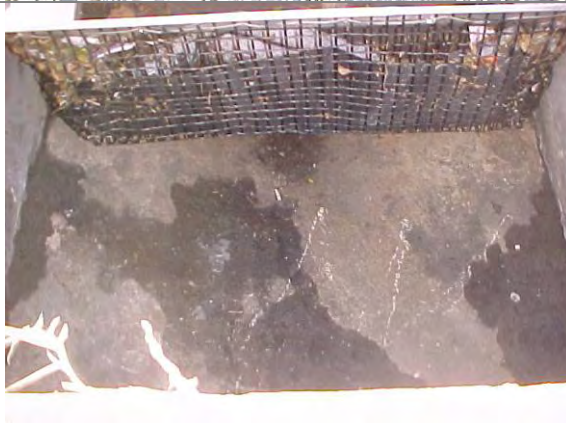
Date inspected:
2/4/04

Comments: This was the first site visit after one storm event. This insert was removed from the site and subsequently transported to the UCLA laboratory for testing.

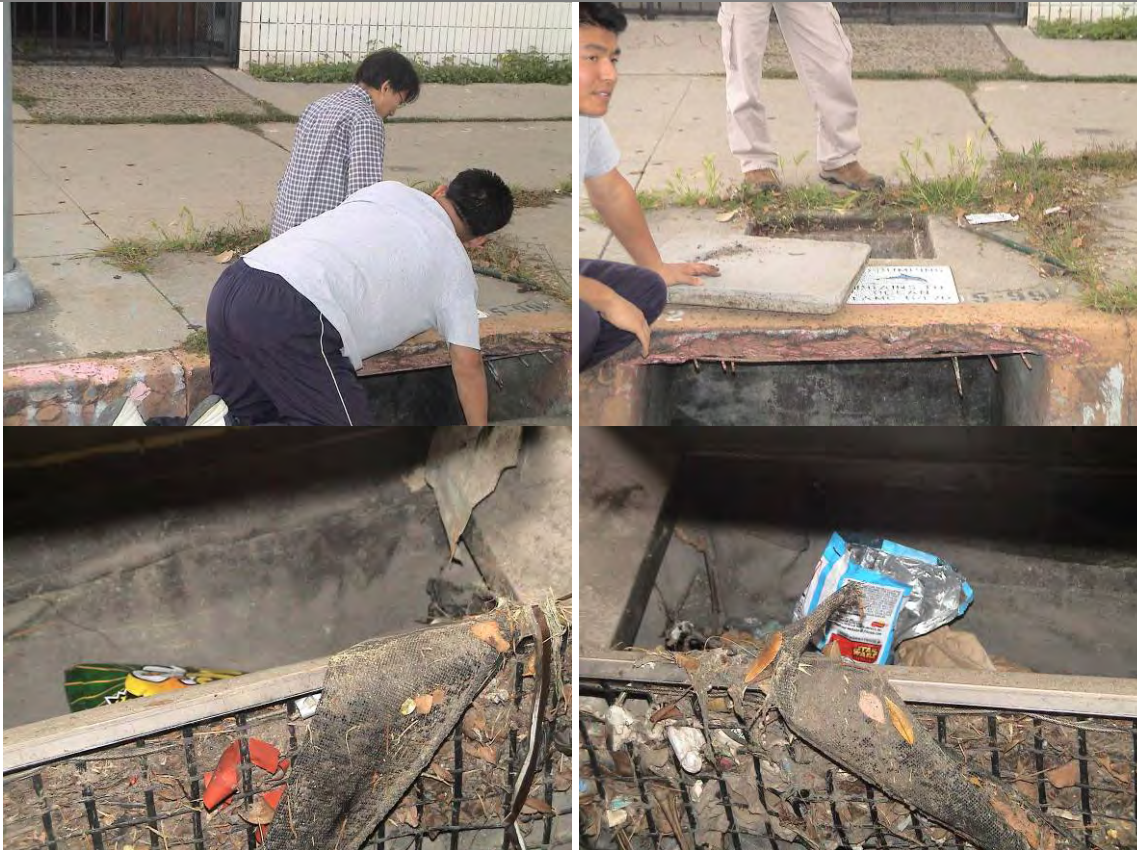
Site : FL-001-F Location: Washington and Walton (Area 1 - Site A)

Comments: This insert showed significant signs of sediment caking. The absorbent was hanging outside the insert. After this visit, this insert was taken to the laboratory for its final tests.

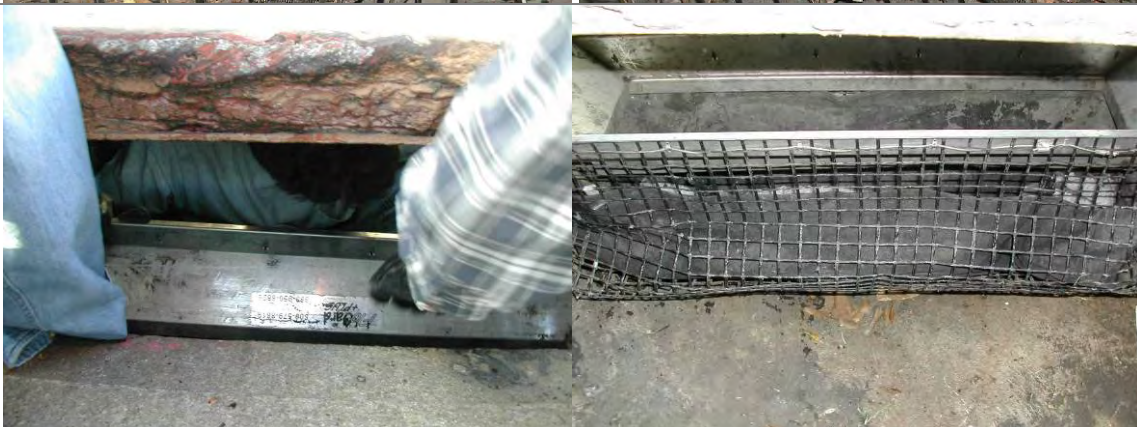
Date inspected:
10/21/04

Comments: During this visit the insert was cleaned and the media was replaced.

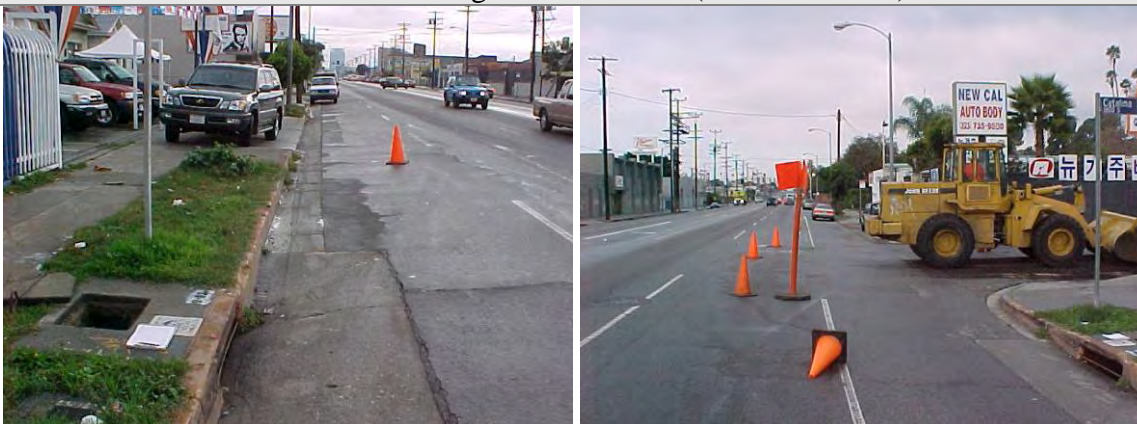
Date inspected:
12/11/03

Comments: Initial site visit. Top left photo is looking upstream; top right is downstream. The bottom right photo shows resurfacing activities on Catalina Ave. Note that this catch basin is inline with the storm drain system.

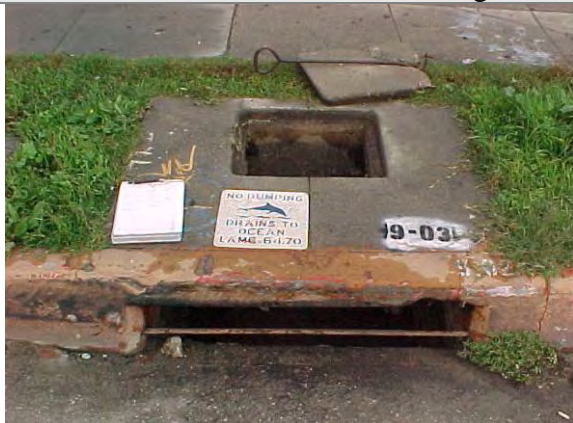
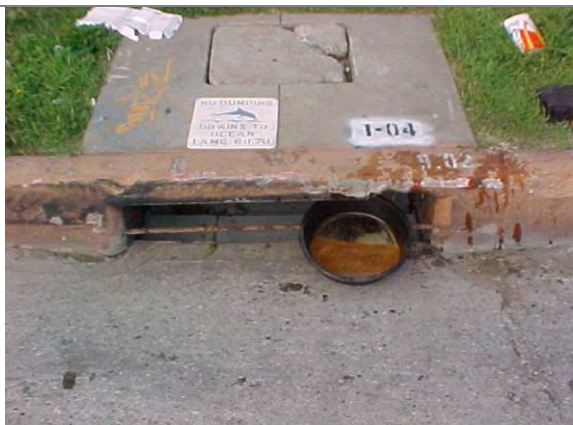
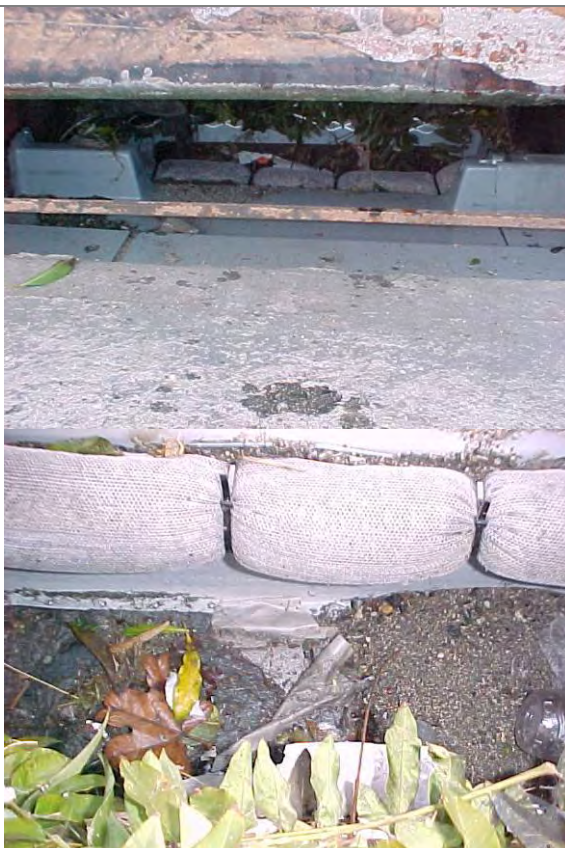
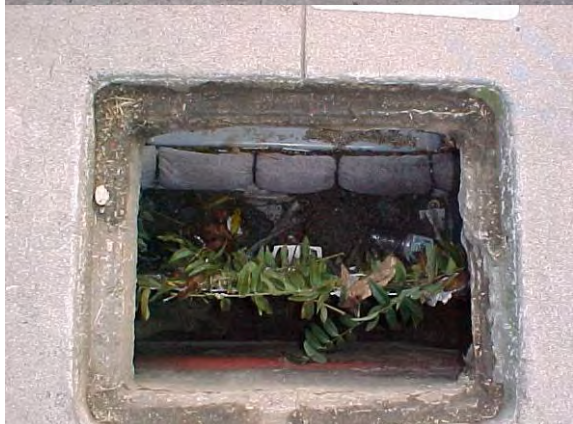
Date inspected:
2/4/04

Comments: This is the first visit after installation and one storm event. An oil pan with automotive fluid was found at the inlet of this catch basin during this visit. No signs of oil inside the insert, but plenty of coarse sediment and some vegetative debris. The insert was removed from the catch basin and subsequently transported to the UCLA laboratory for testing during this site visit.

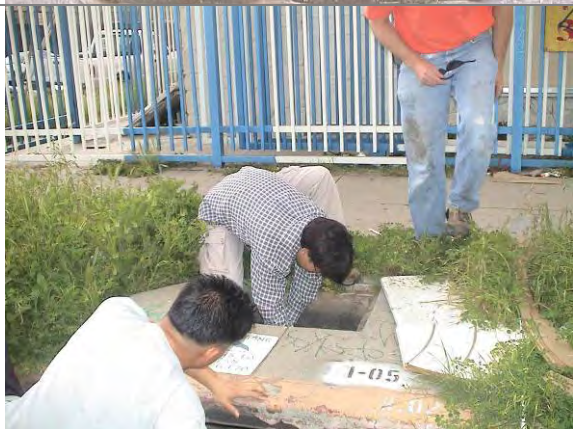
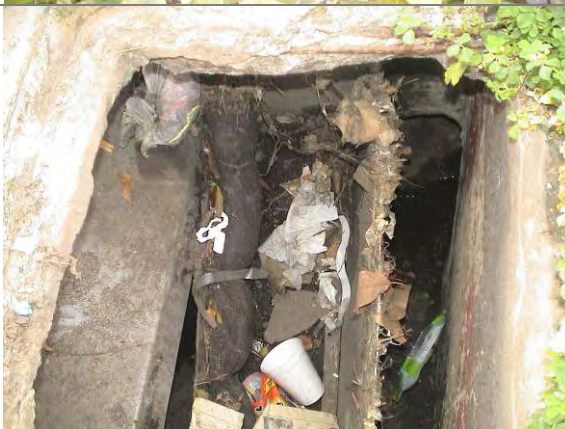
Date inspected:
03/22/05

Comments: During this visit, the insert showed significant signs of sediment accumulation and oily sediment. It also appeared to have recently bypassed. After this visit, this insert was taken to the laboratory for its final tests.

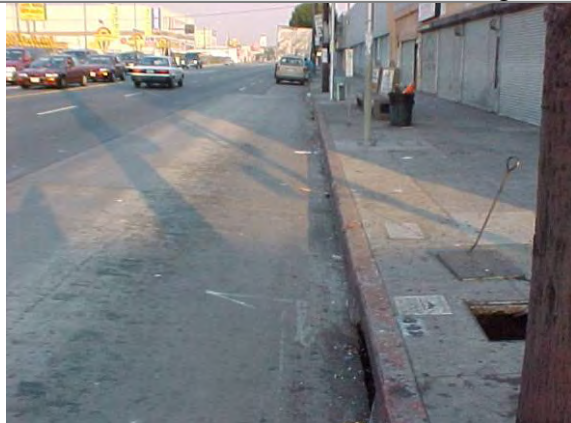
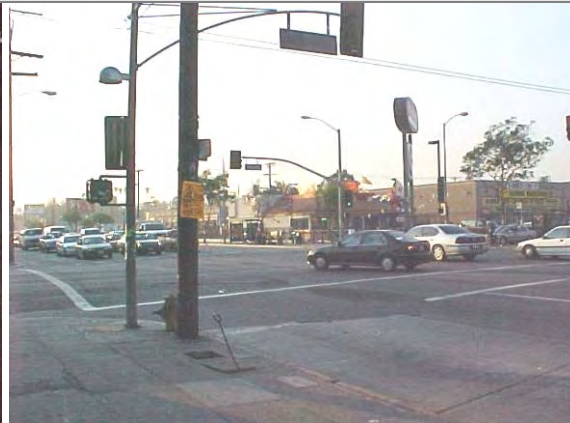
Date inspected:
10/24/03

Comments: Initial site visit. Top left photo is looking upstream; top right is looking downstream into the intersection. As shown in the figures, obviously this site is located in a very busy intersection with high trash loading.

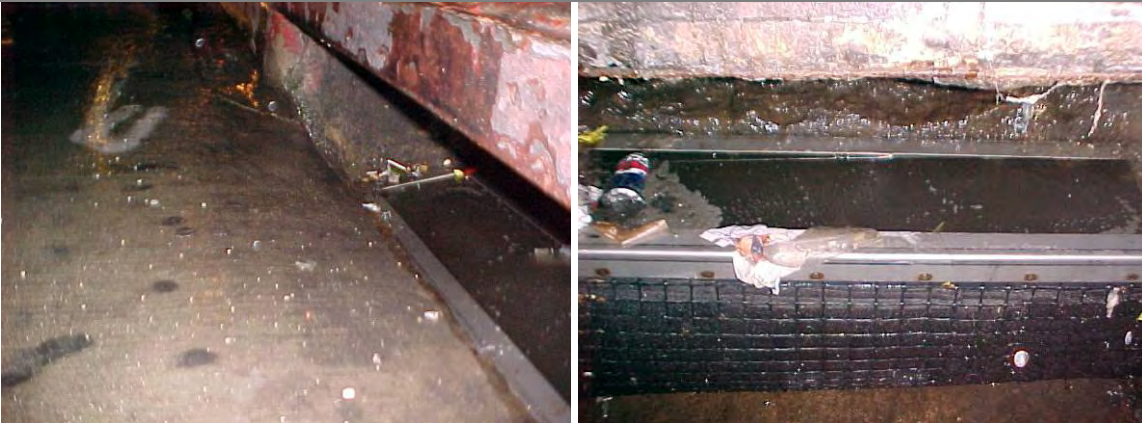
<p>Date inspected: 2/4/04</p> <p>Comments: This was the first site visit after installation. It was raining and appeared to be at full hydraulic capacity but still processing the flow.</p>
