CIWMB CATCH BASIN INSERT STUDY FINAL REPORT

USED OIL RESEARCH, TESTING, AND DEMONSTRATION GRANT

Grant Number URD3-02-0005

May 24, 2005

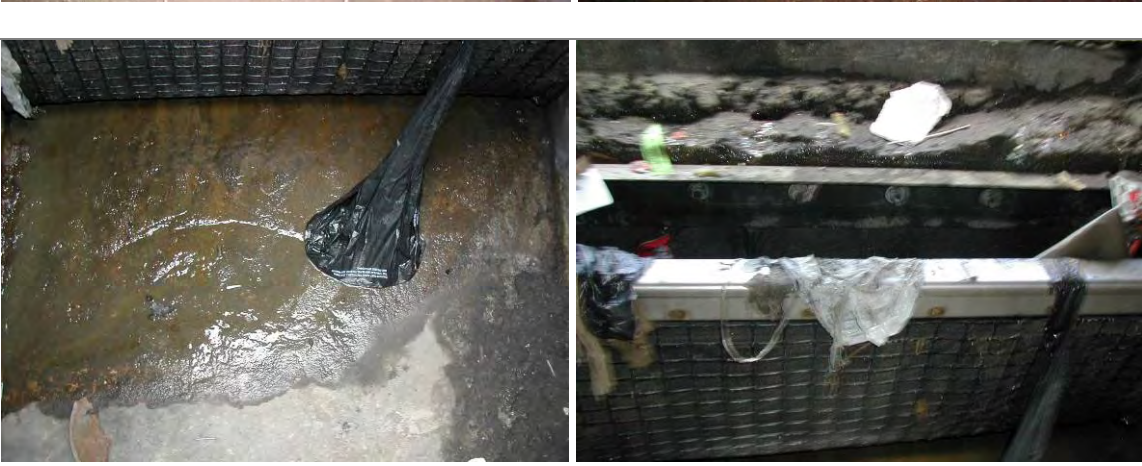
<p>Date inspected: 2/27/04</p> <p>Comments: Trash at lip of insert indicates bypass may have previously occurred. Standing water in insert slowly draining indicates the filter media is beginning to clog.</p>

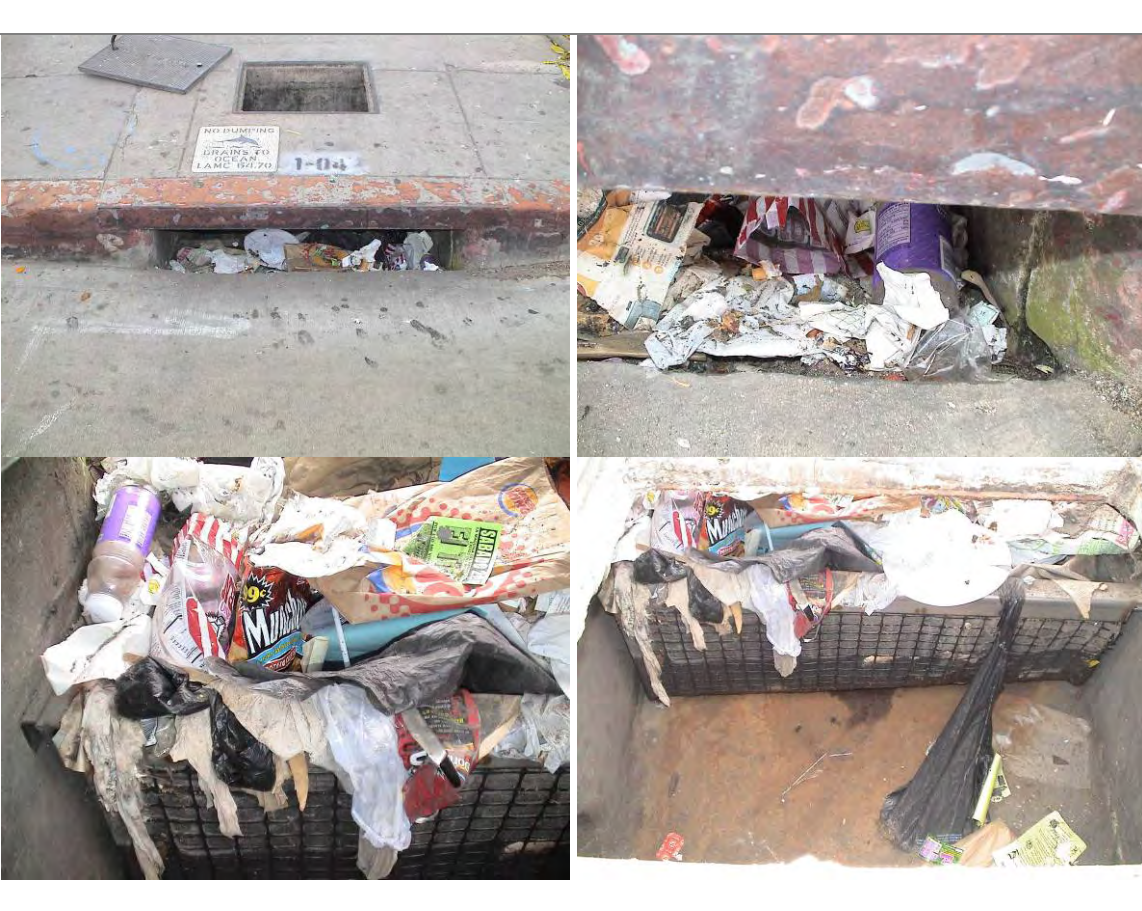
<p>Date inspected: 3/23/04</p> <p>Comments: This site was completely overwhelmed with trash during this visit. Subsequent events are likely to dislodge larger objects and floatables.</p>

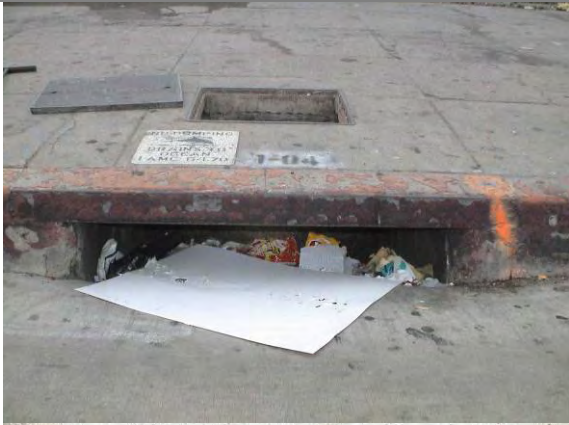
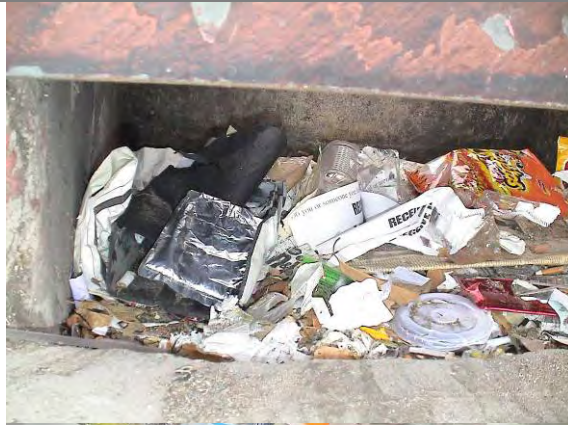
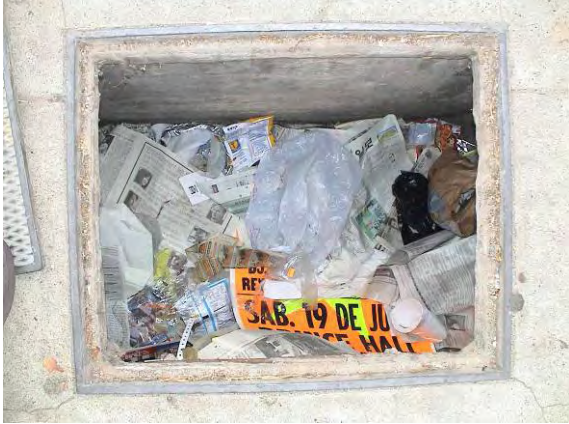
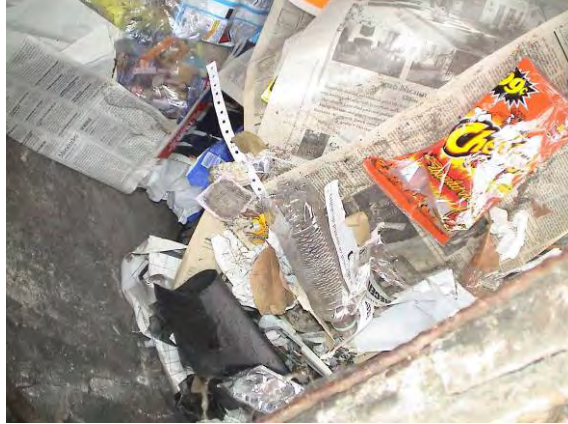
Date inspected:
6/30/04

Comments: The insert is now completely buried by trash. This device will be retired during the next site visit.

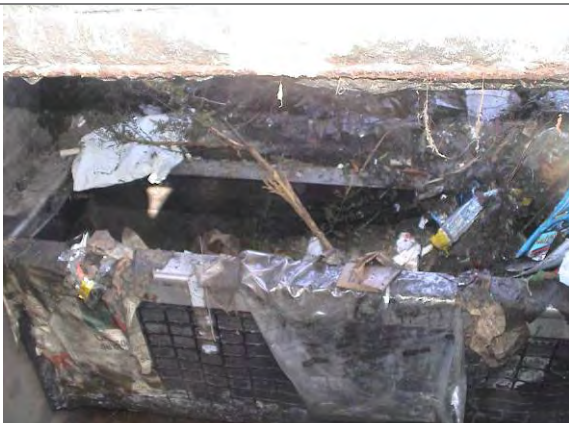
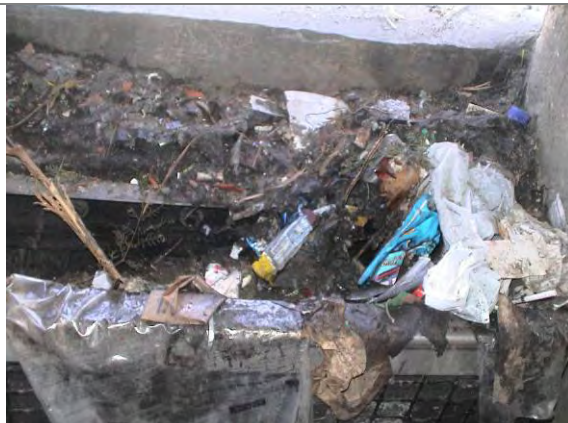
Date inspected:
10/21/04

Comments: Some of the trash that was in the insert has been removed and some bypass, but still lots of trash and debris. The insert was retired during this visit.

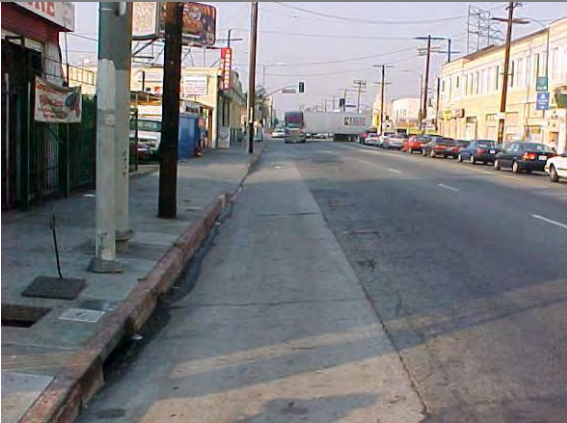
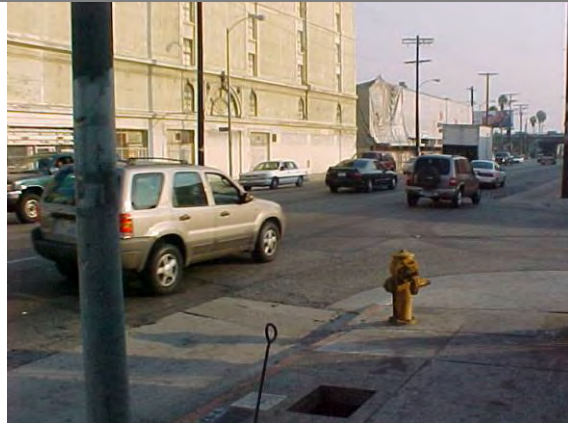
Date inspected:
10/24/03

Comments: Initial site visit. Top left photo is looking upstream; top right is looking downstream. This deep catch basin had a significant amount of trash.

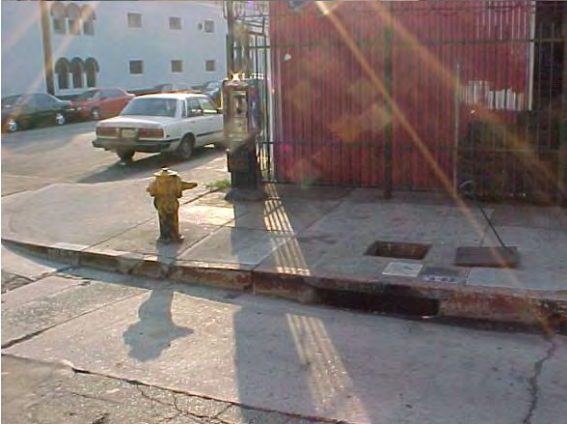
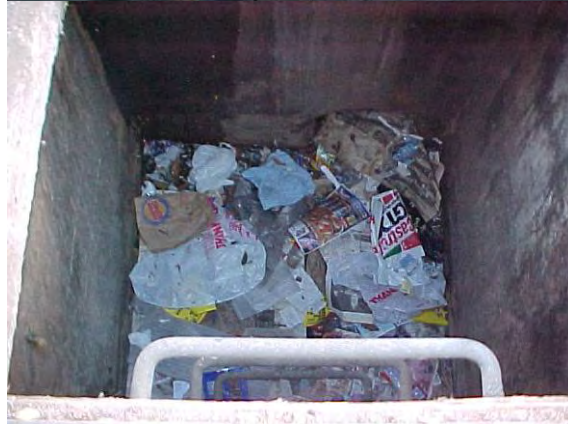
Date inspected:
2/27/04

Comments: This insert was installed in the second week of February. After about a week and a half, there is already significant trash and debris with signs of bypass.

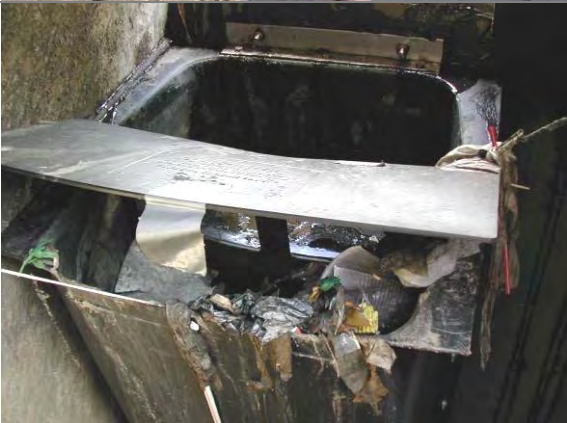
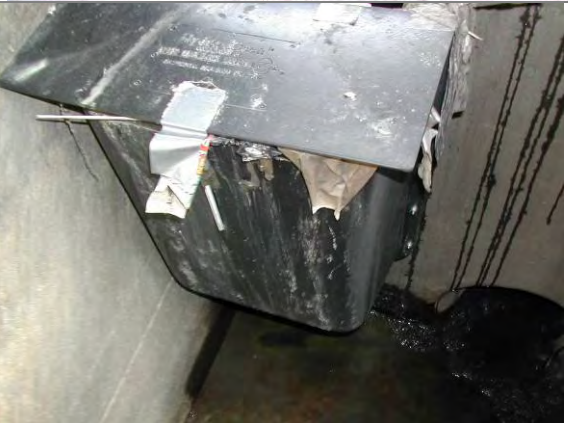
Date inspected:
3/23/04

Comments: After another month in the field this insert has nearly reached its trash loading capacity.

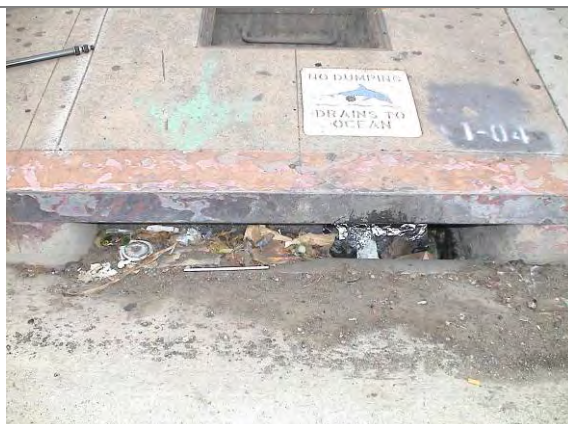
Site : CC-012-H Location: Vermont, N of Cordova, West side (Area 1 - Site B)		Hydro Kleen

<p>Date inspected: 6/30/04</p> <p>Comments: The insert is now overflowing with trash and should be retired during the next site visit.</p>

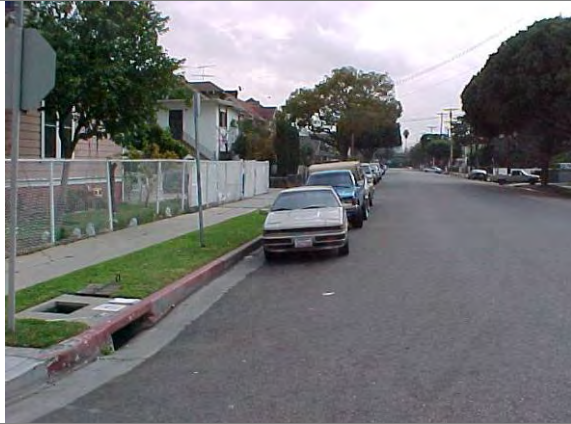
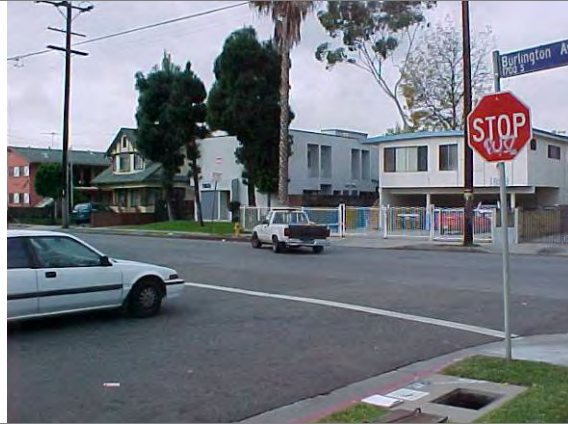
Date inspected:
12/11/03

Comments: Initial site visit. Top left photo is looking upstream; top right is looking downstream to the intersection. All residential area. Little trash and debris in catch basin.

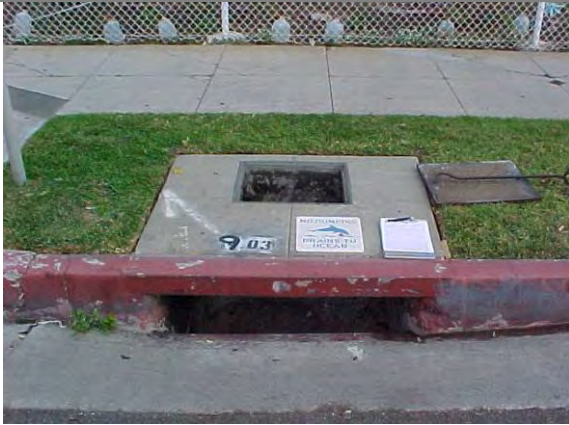
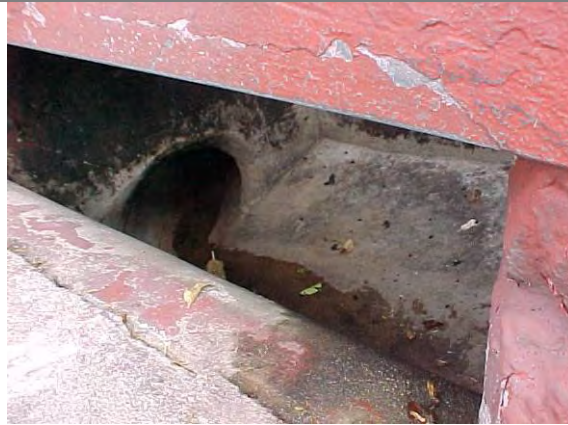
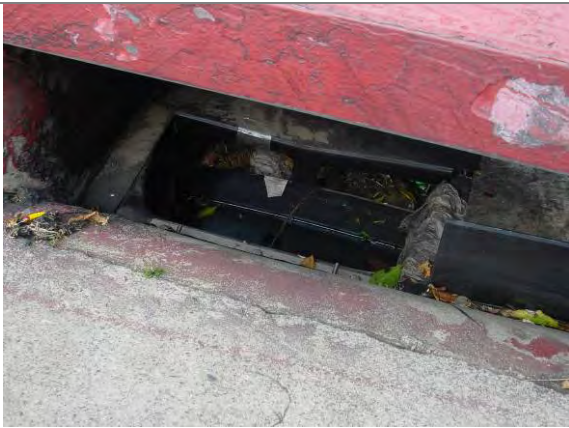
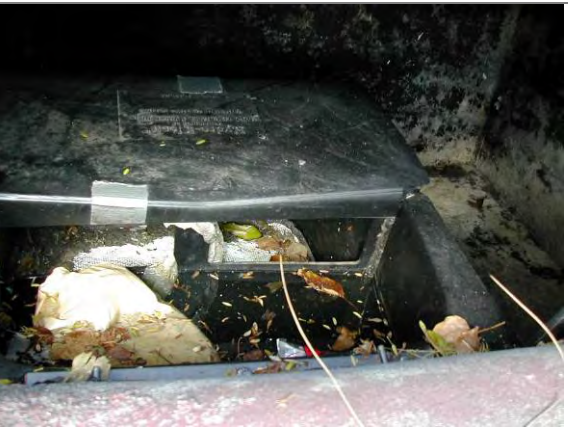
Date inspected:
2/27/04

Comments: As intended by the design, notice the standing water in the sedimentation chamber and the captured trash and debris in the filtration chamber.

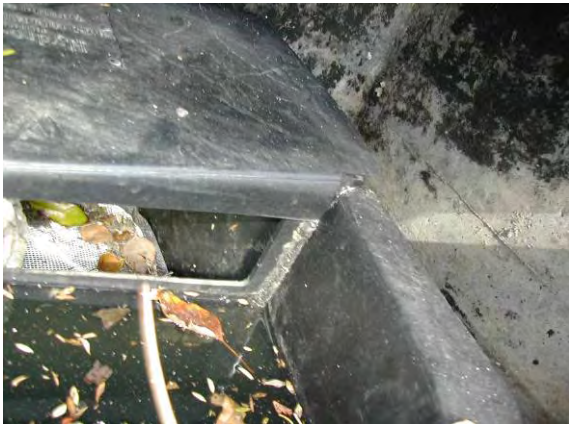
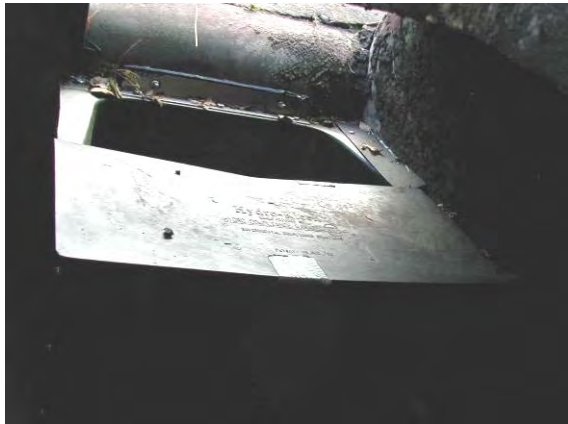
Date inspected:
3/23/04

Comments: There was less water during this visit, but there is evidence of recent high flow bypass with the sediment residue on the lid and lip of the insert. The media appears to be beginning to clog.

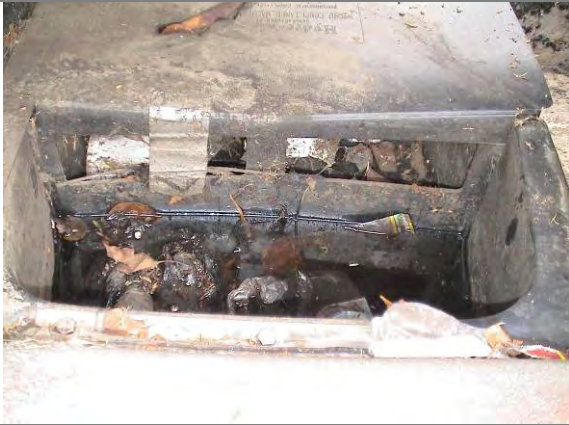
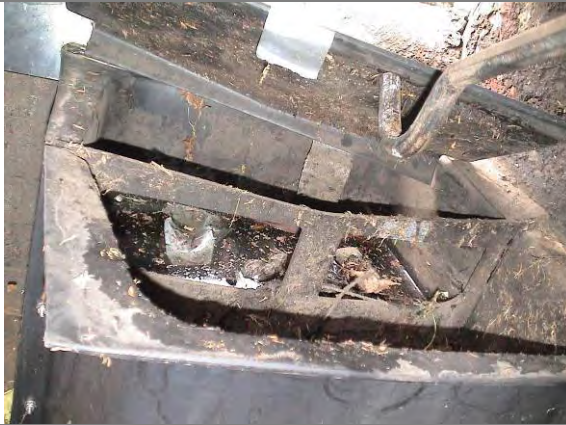
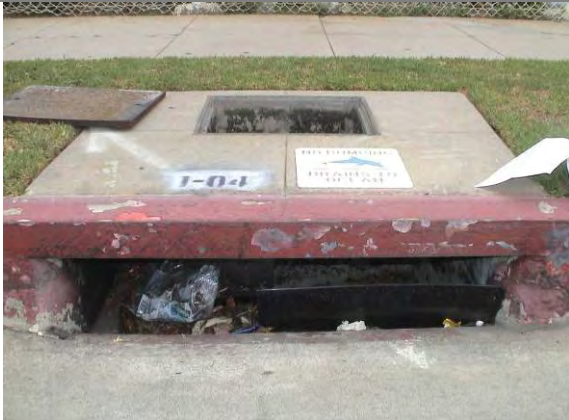
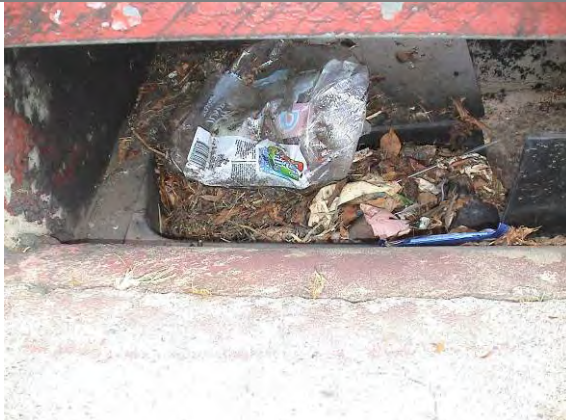
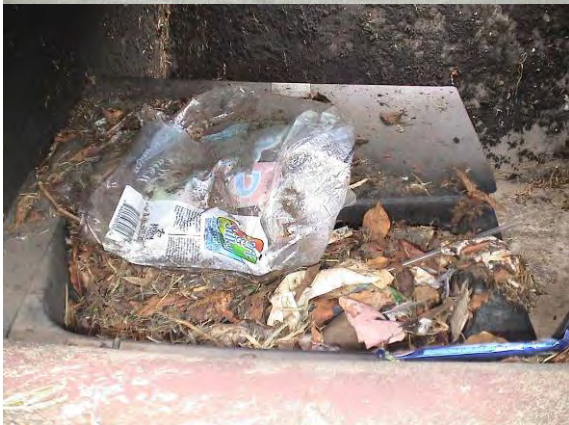
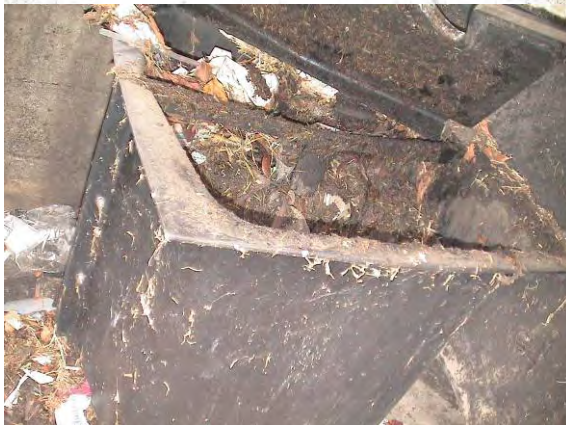
Date inspected:
6/30/04

Comments: The insert is completely full and the media is likely clogged. The insert will be retired during the next site visit.

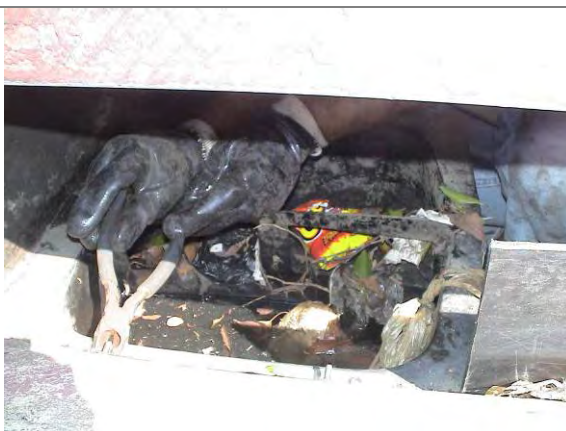
Date inspected:
10/21/04

Comments: As before, this insert was filled with material during this visit. The trash was removed for laboratory analysis. This site was converted to an FL site for the next wet season.

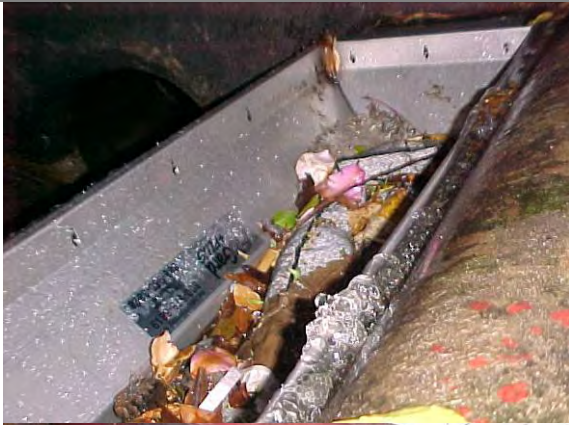
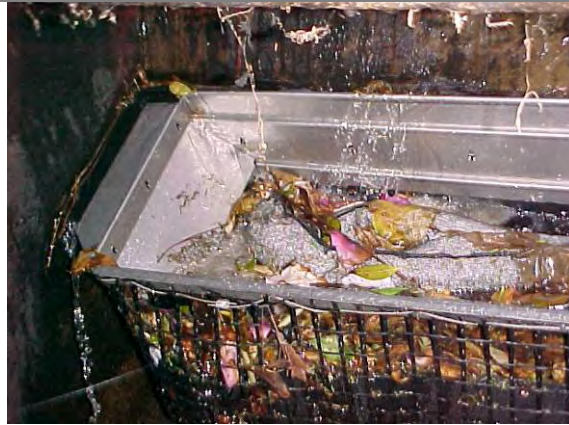
Site : CC-003-F Location: 18th and Burlington Ave, N corner (Area 1 - Site C)	Flo-Gard Plus
 	<p>Date inspected: 12/11/03</p> <p>Comments: This was the initial site inspection prior to insert installation. Notice the relatively small amount of trash and debris inside the catch basin.</p>

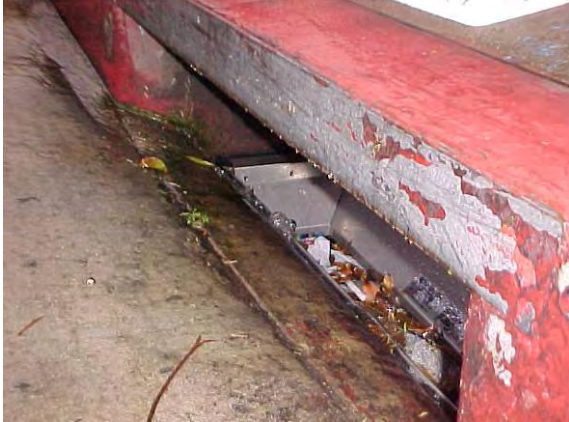
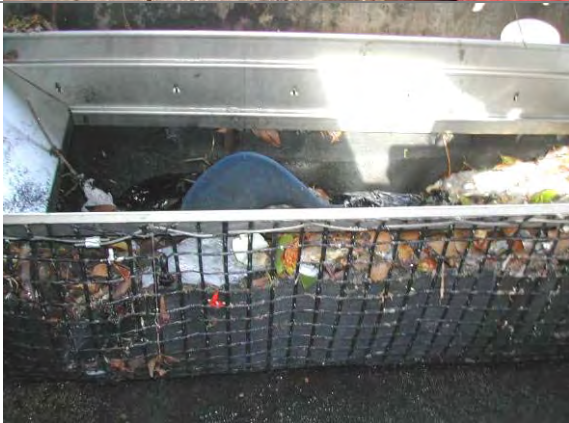
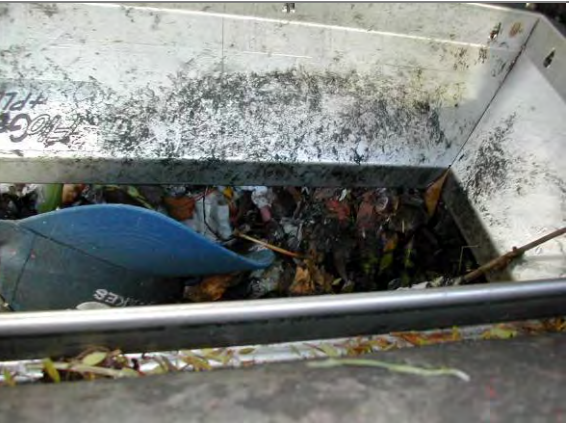
Date inspected:
2/4/04

Figure 4-18. Improper installation of insert that caused bypass (CC-003-F, 2/4/04).

Comments: These pictures were taken during an actual storm event. Notice bypass flows along the lip and down the side of the insert. Also notice the absorbent boom floating at the surface of the insert; which is the intention of the design.

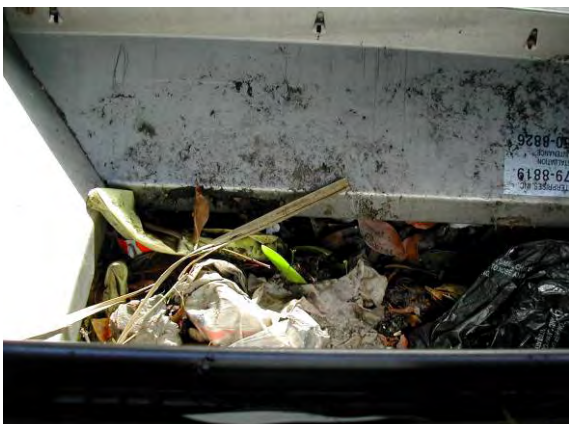
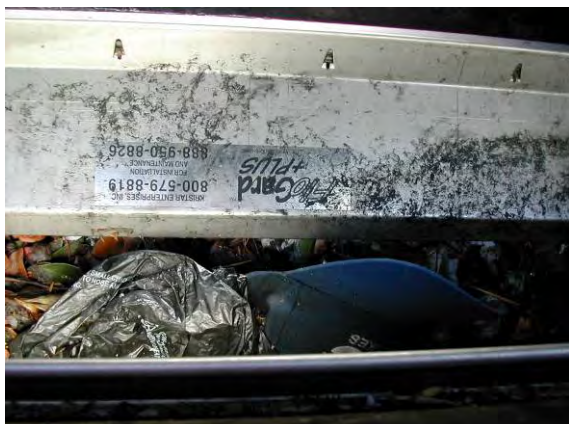
Date inspected:
2/27/04

Comments: Notice the significantly greater amount of trash and debris since the last inspection.

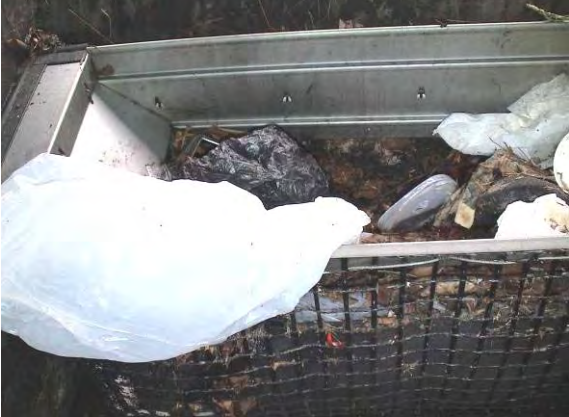
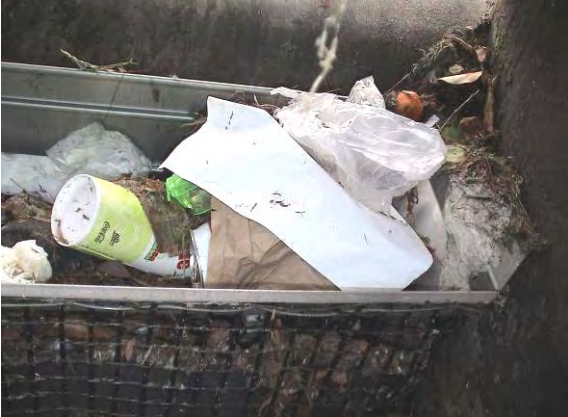
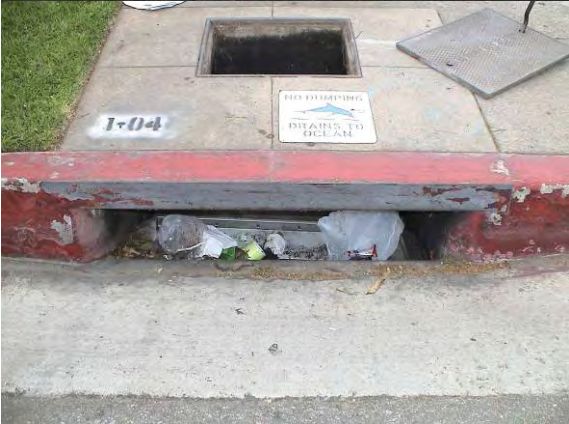
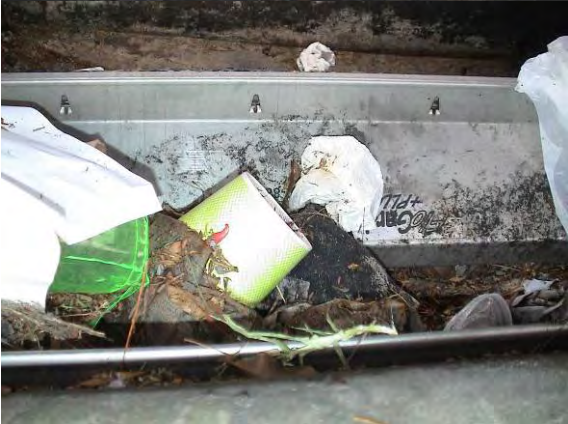
<p>Date inspected: 3/23/04</p> <p>Comments: The insert is now shown nearly at full capacity.</p>

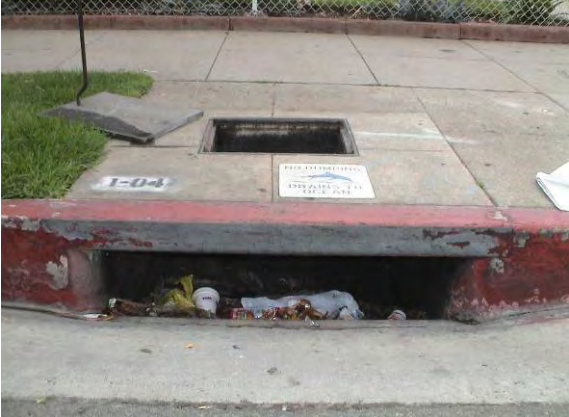
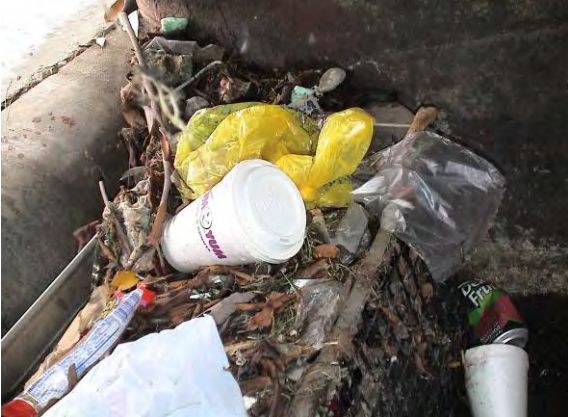
<p>Date inspected: 6/30/04</p> <p>Comments: The insert cannot hold anymore trash. Any further loadings will bypass.</p>

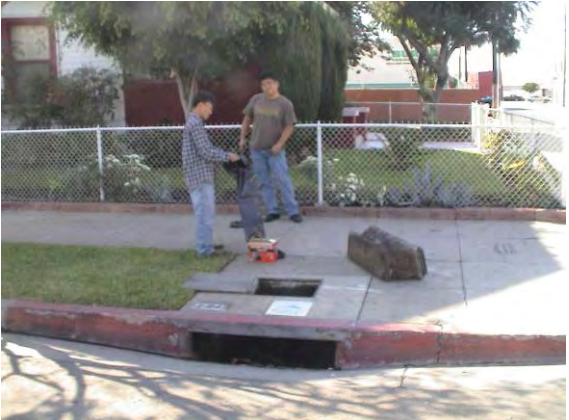
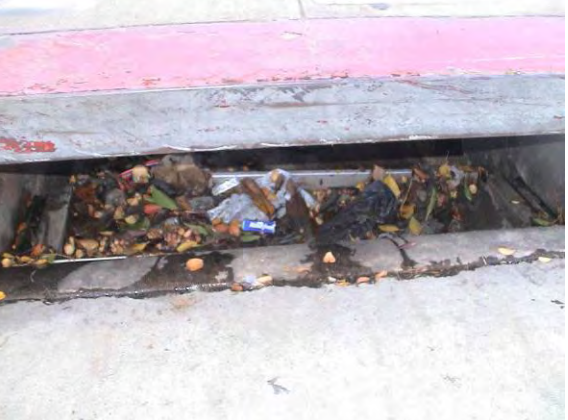
<p>Date inspected: 10/22/04</p> <p>Comments: The material in this insert was removed during this visit. New media was inserted and it was converted to an FL site.</p>

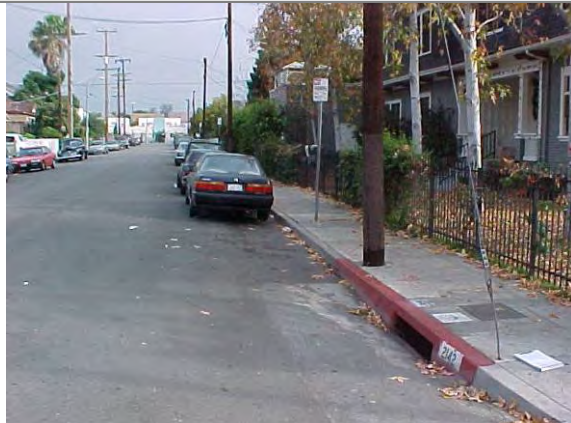
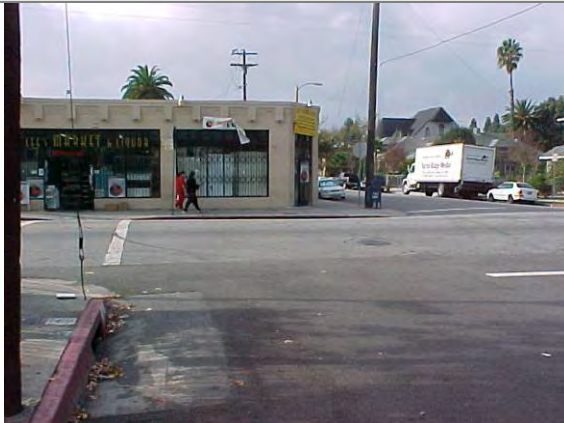
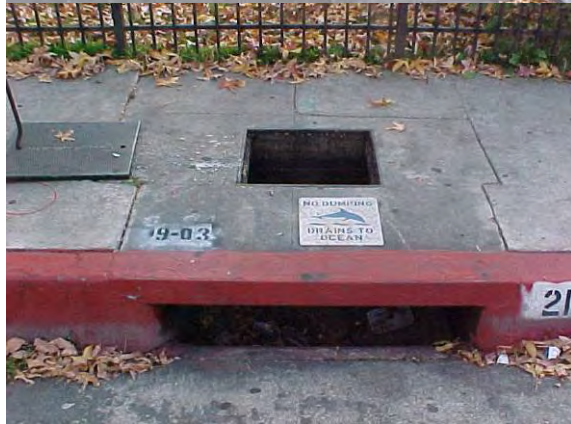
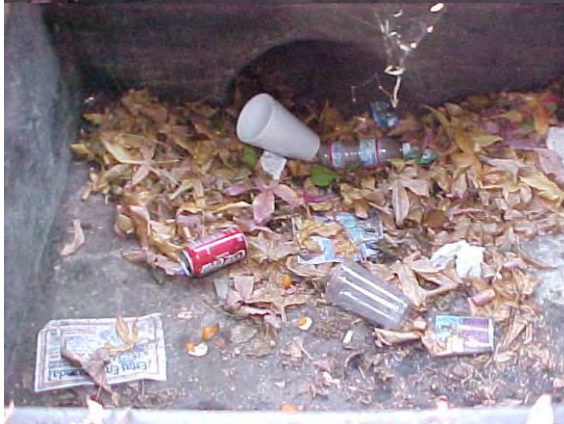
Date inspected:
12/10/03

Comments: Initial site visit. Top left photo is looking upstream; top right is looking downstream. Nearby deciduous trees appear to deliver excessive leafy debris to this catch basin.

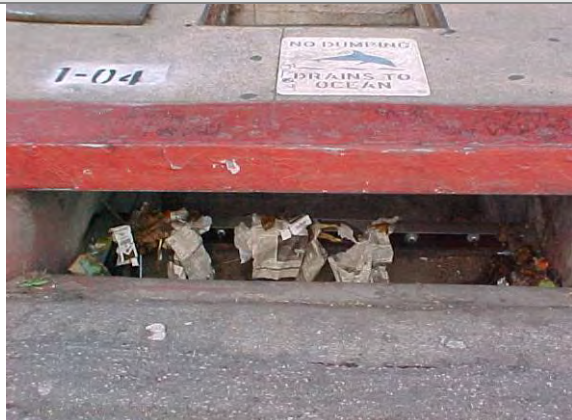
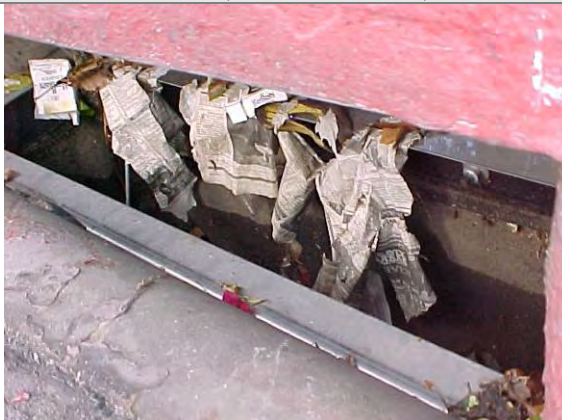
<p>Date inspected: 12/10/03</p> <p>Comments: Initial site visit. Top left photo is looking upstream; top right is looking downstream.</p>

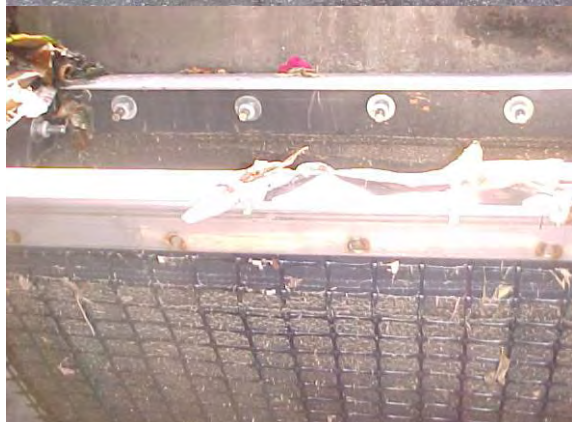
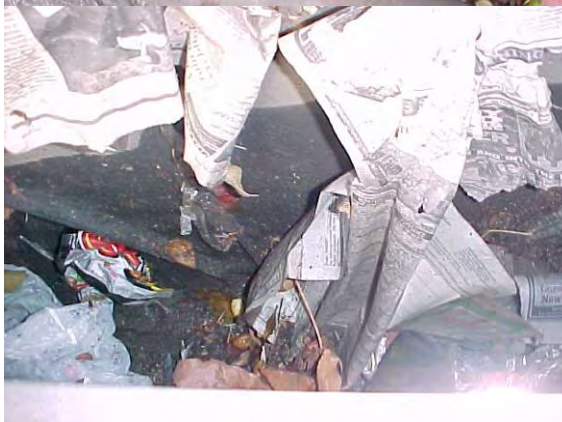
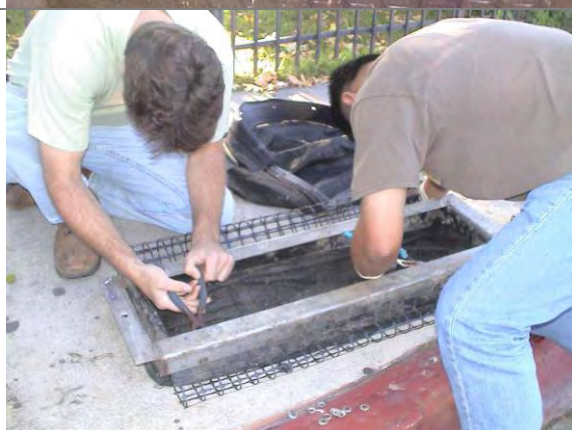
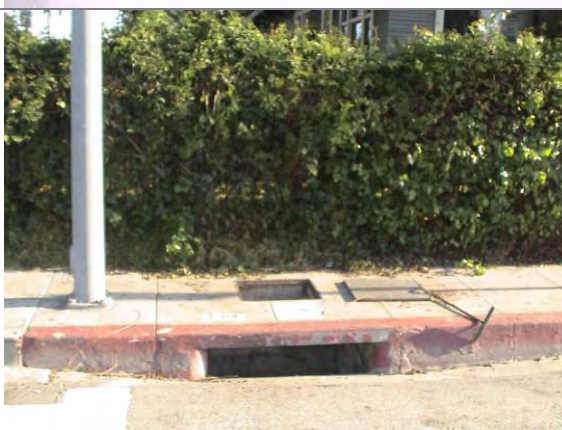
Date inspected:
2/4/04

Comments: This was the first inspection of this site. Notice the device has accumulated significant trash for only one storm event. This was originally a CC site, but was changed to an FL site due to installation timing conflicts.

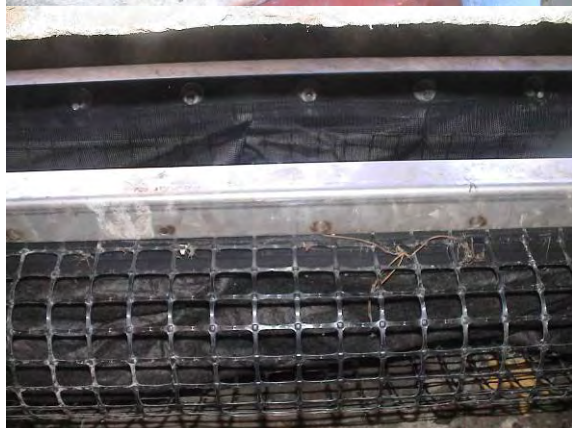
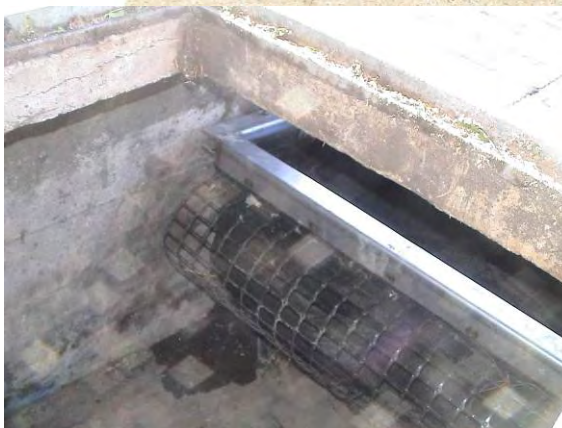
Date inspected:
10/22/04

Comments: This FL insert was installed during this visit in preparation for the wet season.

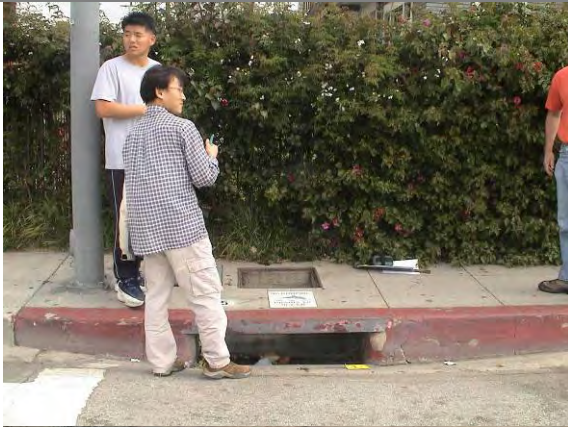
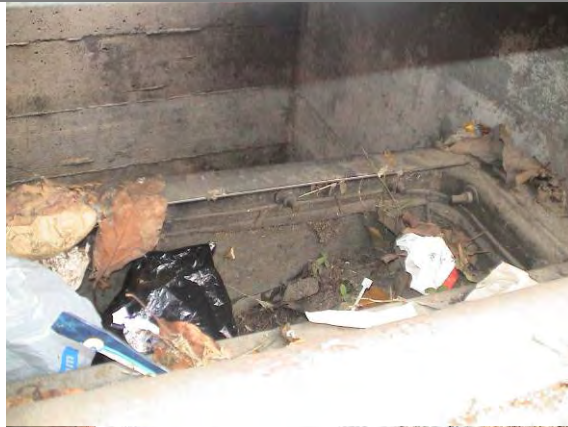
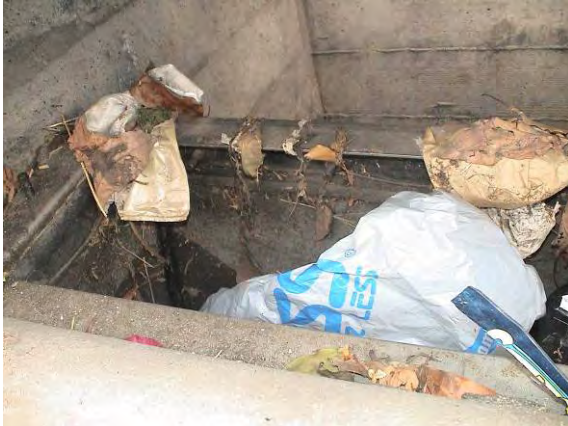
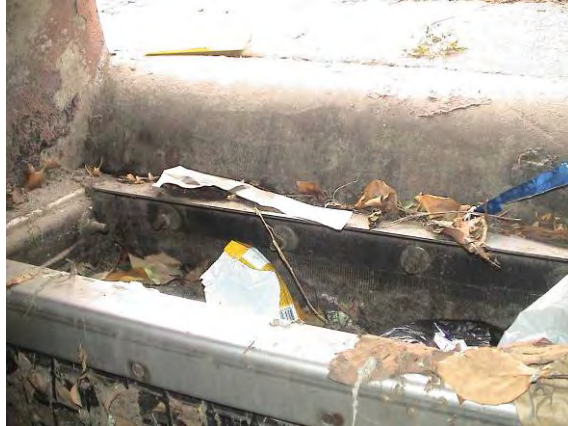
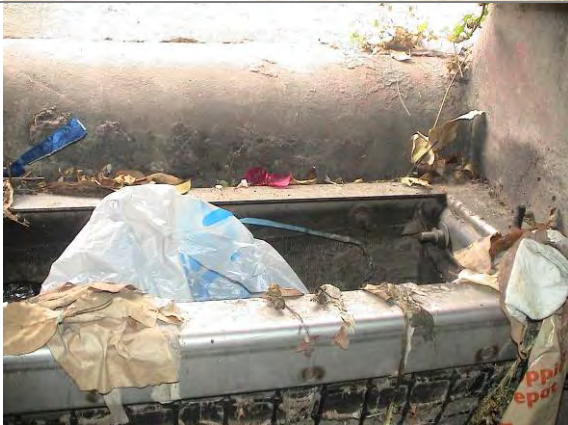
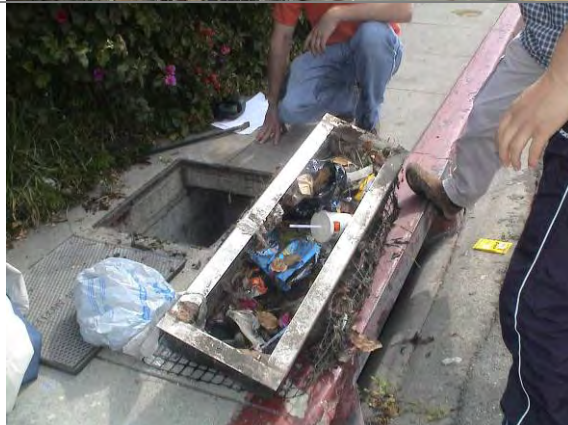
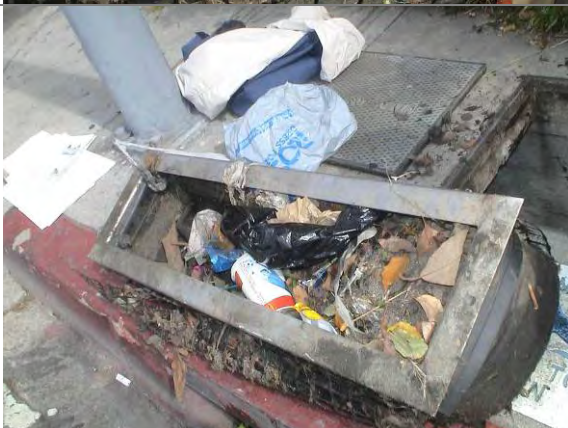
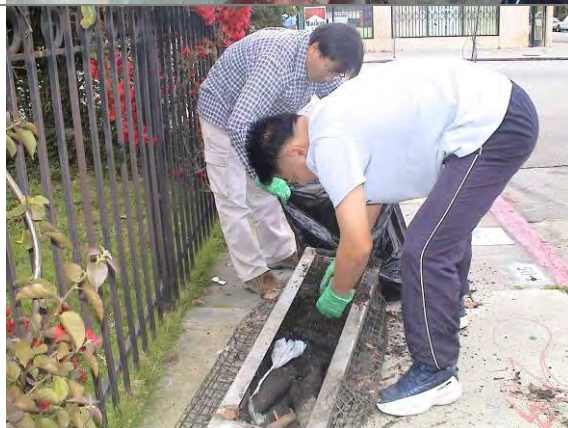
Date inspected:
03/22/05

Comments: After this visit, this insert was taken to the laboratory for its final tests.

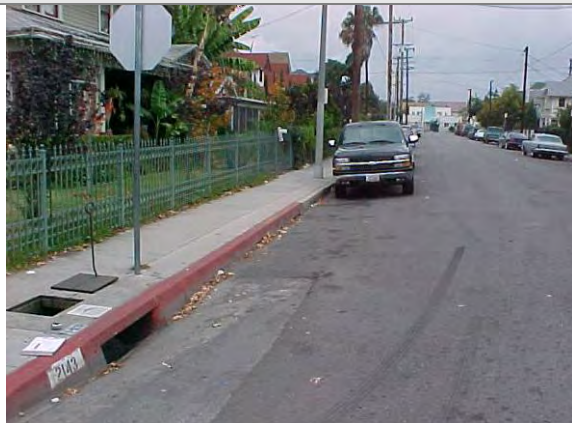
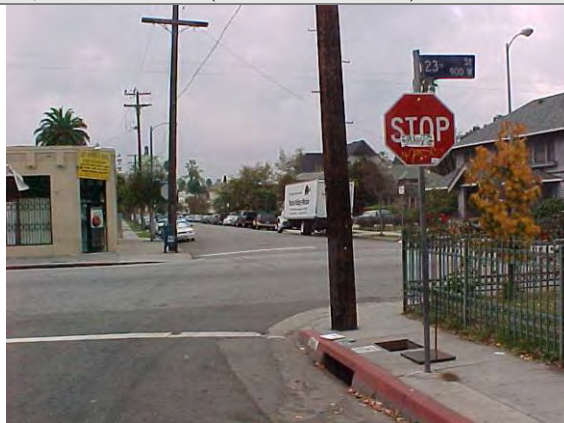
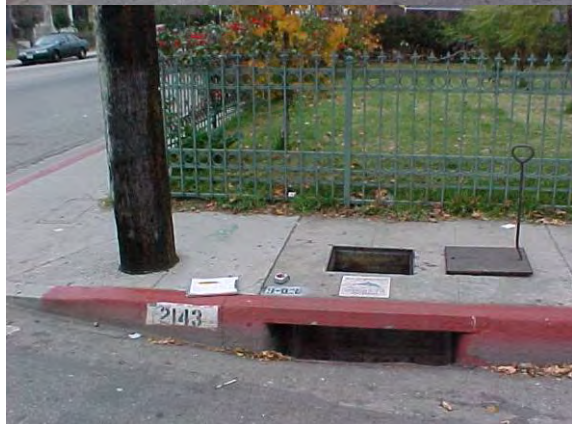
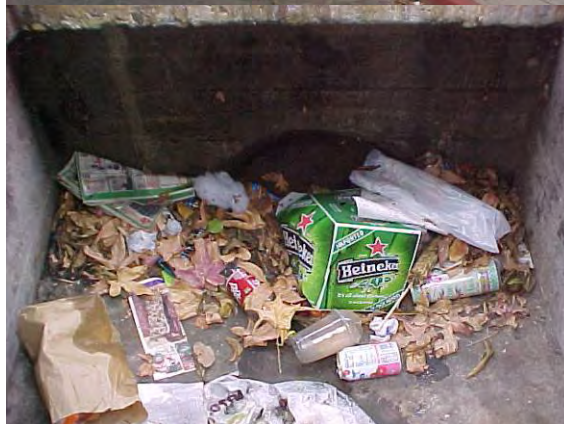
Date inspected:
12/10/03

Comments: Initial site visit. Top left photo is looking upstream; top right is looking downstream. There is evidence of significant trash loading to this catch basin as shown in the photo.

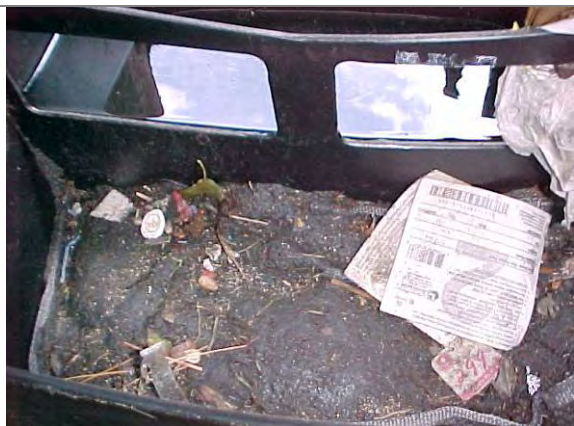
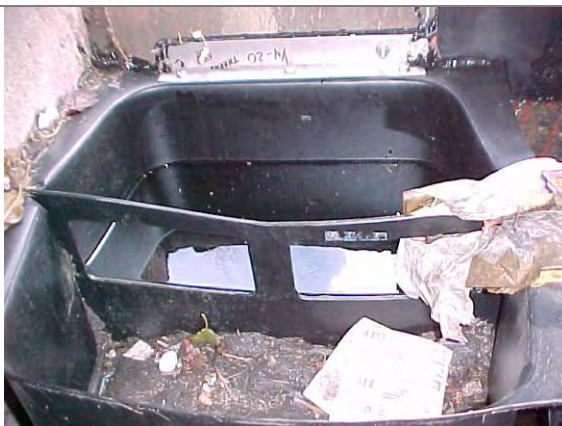
Date inspected:
2/4/04

Comments: Notice the standing water. This device is actually designed to have standing water in the first chamber to allow for settling. This was originally a CC site, but was changed to an FL site due to installation timing conflicts. It was removed and subsequently transported to the UCLA laboratory during this visit.

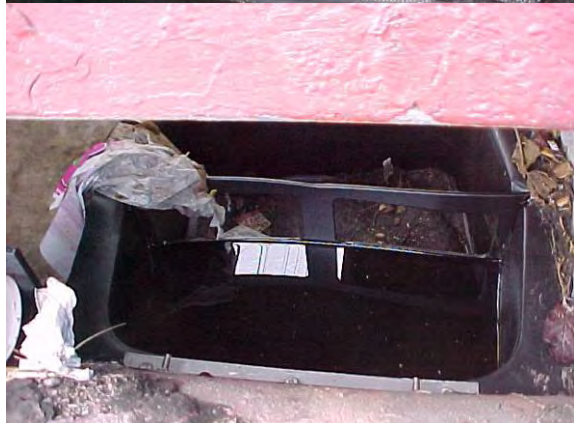
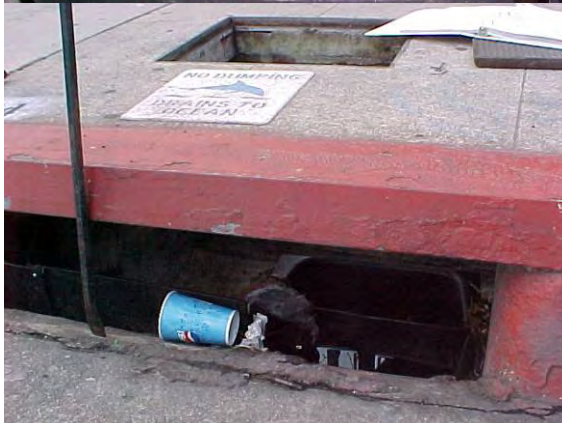
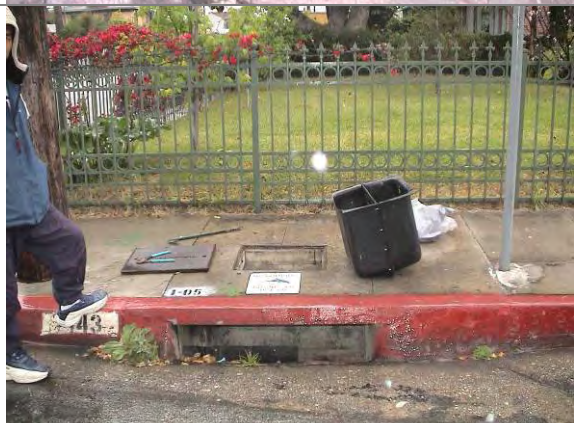
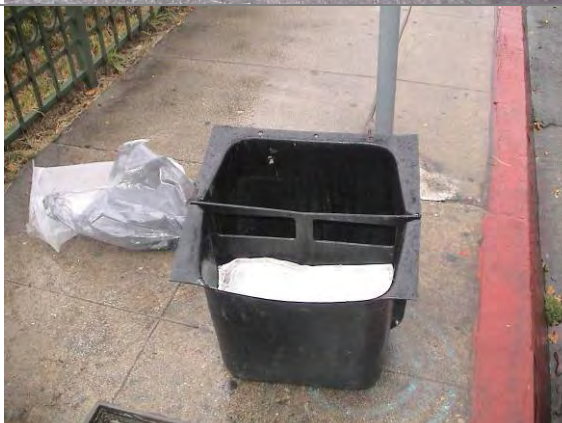
Date inspected:
03/22/05

Comments: After a few months in the field this insert did not show significant accumulation. After this visit, this insert was taken to the laboratory for its final tests.

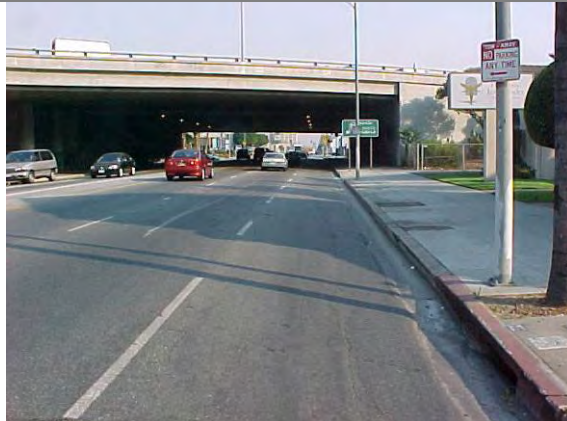
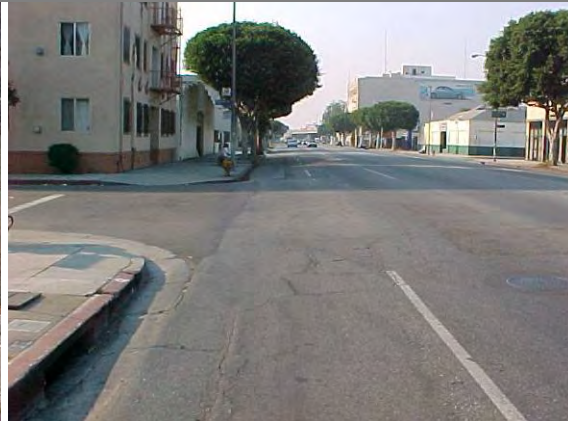
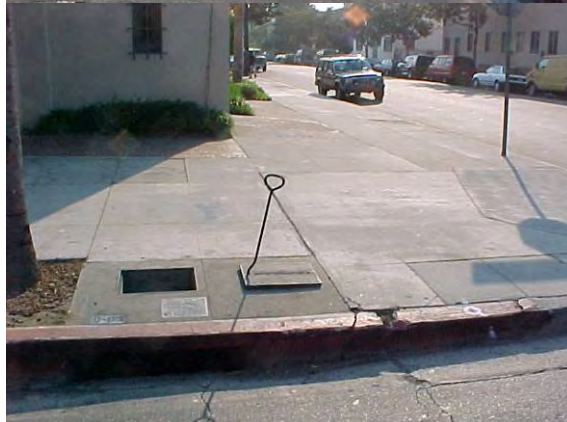
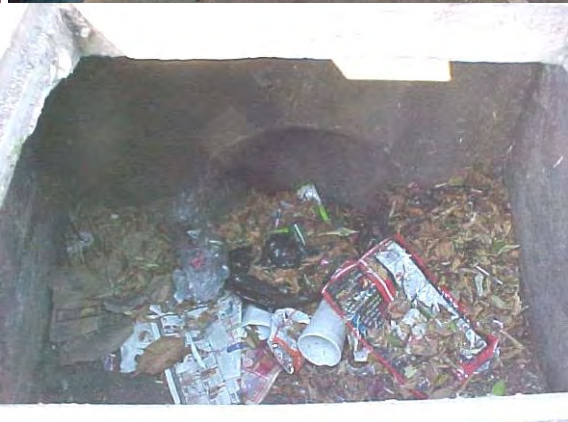
Date inspected:
10/24/03

Comments: Initial site visit. Top left photo is looking upstream; top right is looking downstream. Bottom left picture is looking down Bonsallo Ave. Notice the large amount of trash and debris within the catch basin.

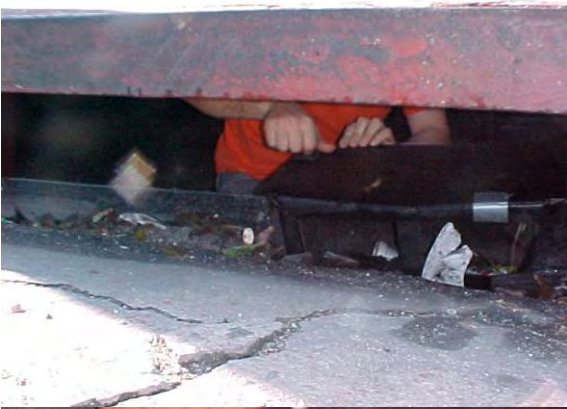
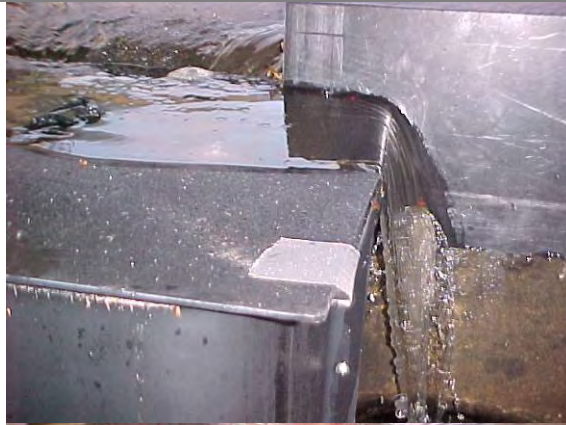
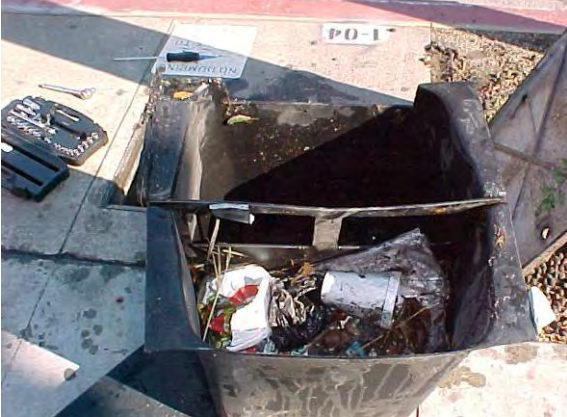
Date inspected:
2/4/04

Comments: This installation utilizes a weir to route flows into the insert because the inlet width is wider than the insert width. Majority of the flows at this site were found to bypass the insert during this storm event. The insert was removed and transported to the laboratory for testing. Note that the lip of the insert had to be trimmed and notched to fit in this catch basin. It was sealed using black caulking. Thus, upon reinstallation the insert should again be caulked to minimize the chance for bypass.
