CIWMB CATCH BASIN INSERT STUDY FINAL REPORT

USED OIL RESEARCH, TESTING, AND DEMONSTRATION GRANT

Grant Number URD3-02-0005

May 24, 2005

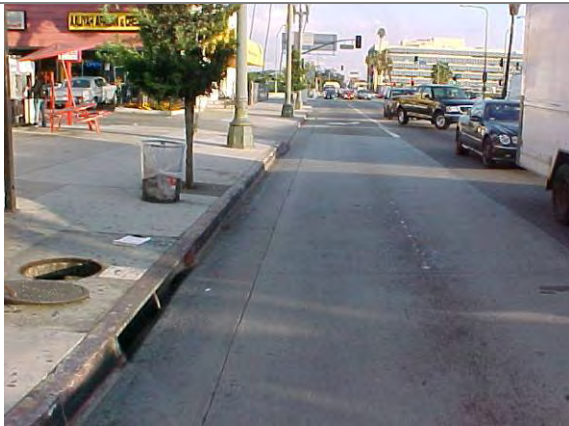
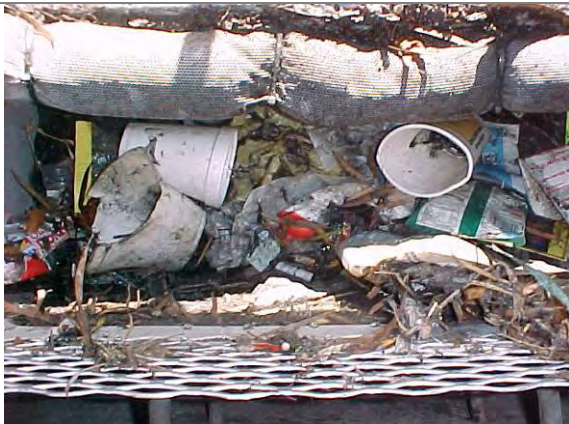
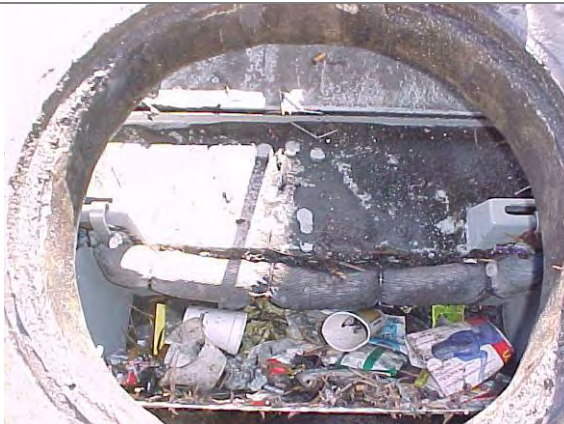
**Date
inspected:**
2/4/04

Comments: First
site visit since
installation
indicates
significant trash
loadings at this
site.

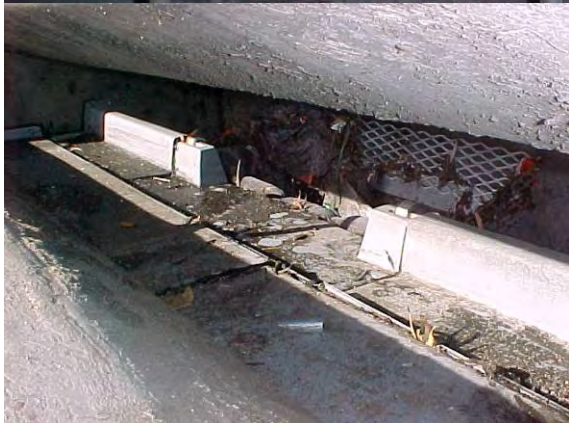
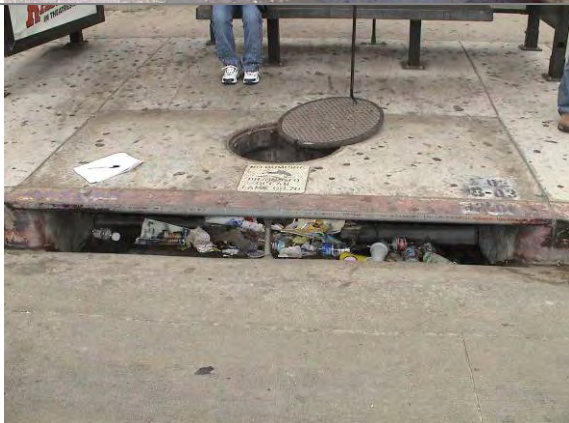
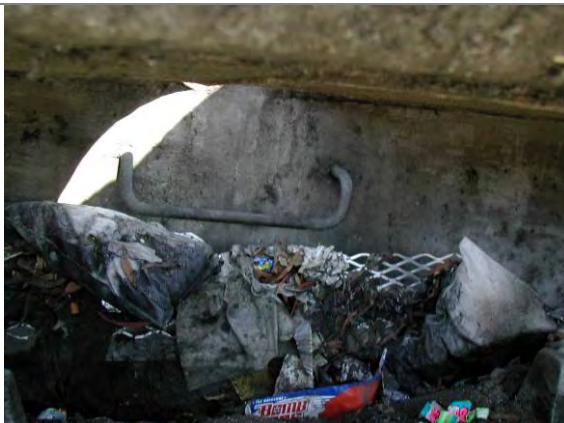
**Date
inspected:**
2/27/04

Comments:
Notice this site
exhibits very high
sediment loadings
and evidence of
oil and grease.

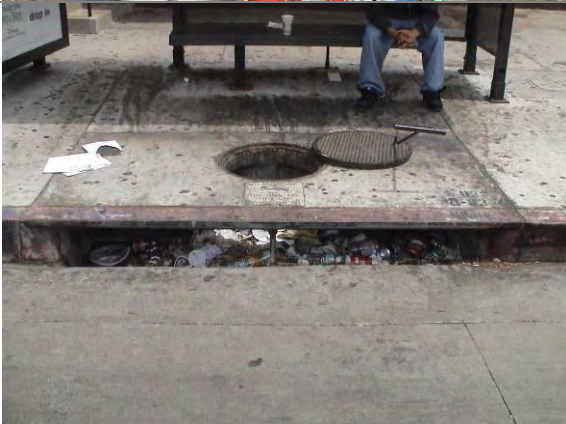
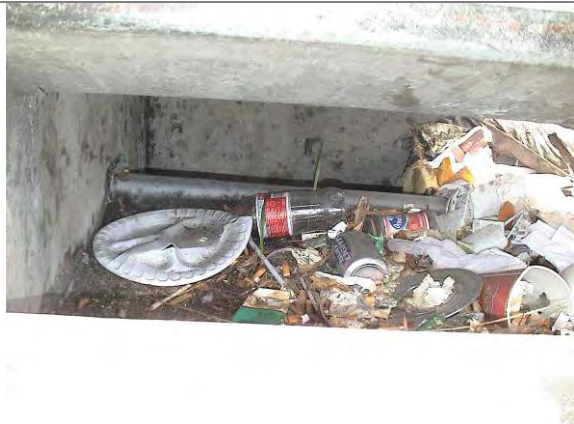
**Date
inspected:**
3/23/04

Comments: After just two months, this insert is completely filled with mostly anthropogenic refuse and sediment.

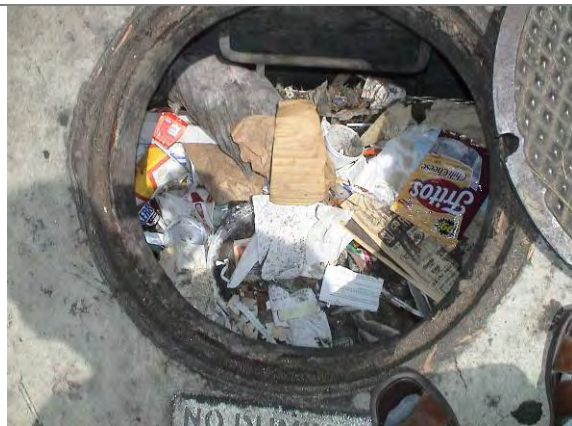
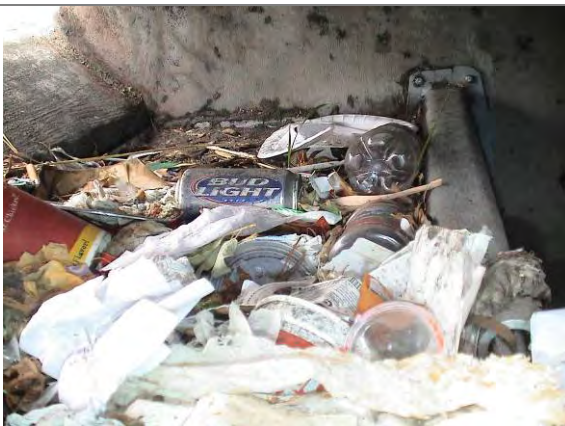
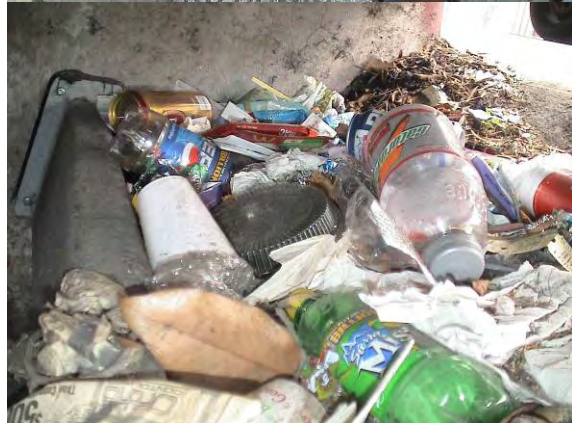
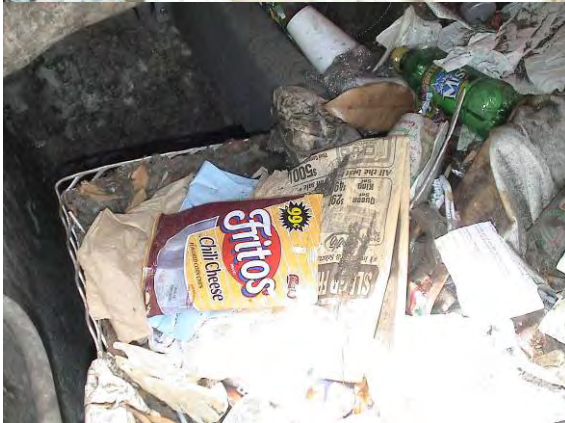
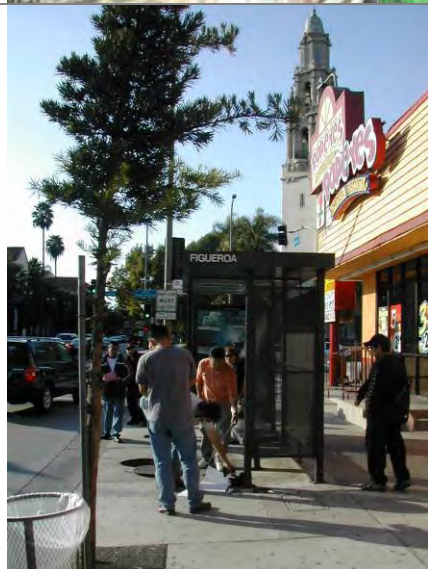
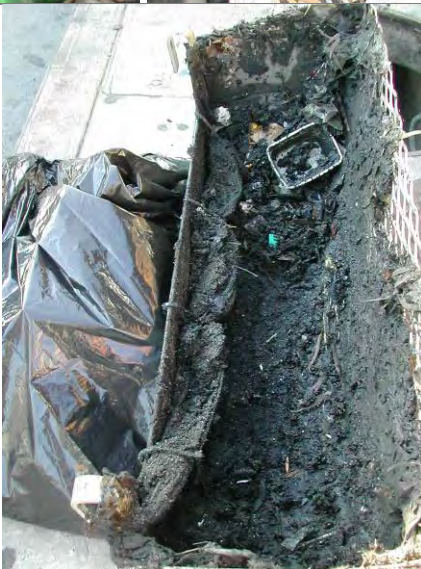
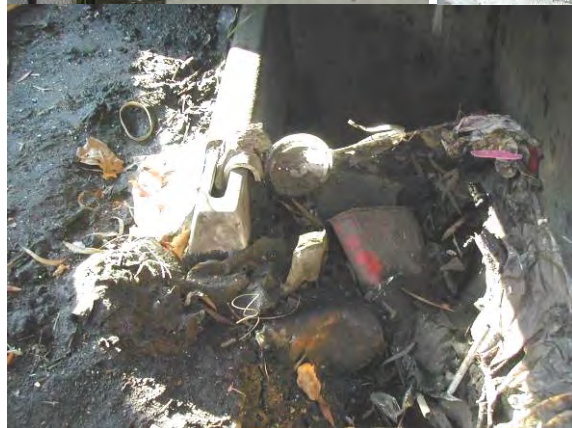
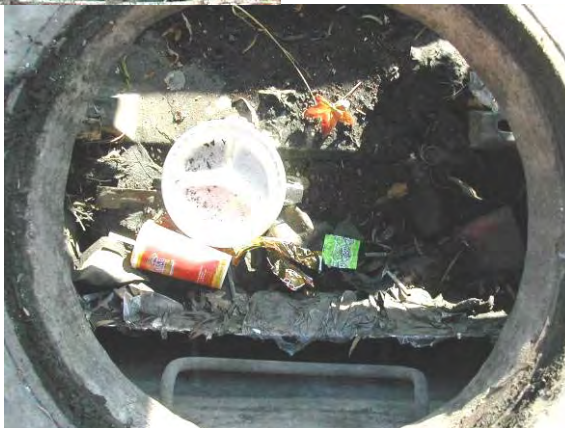
**Date
inspected:**
6/30/04

Comments: Additional trash has accumulated in the insert and on the sedimentation shelf. This insert should be retired during the next site visit.

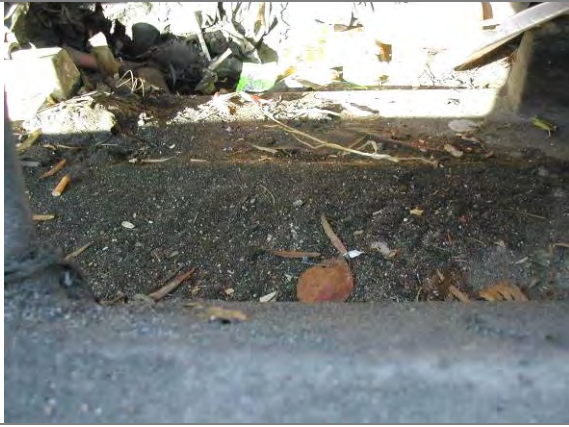
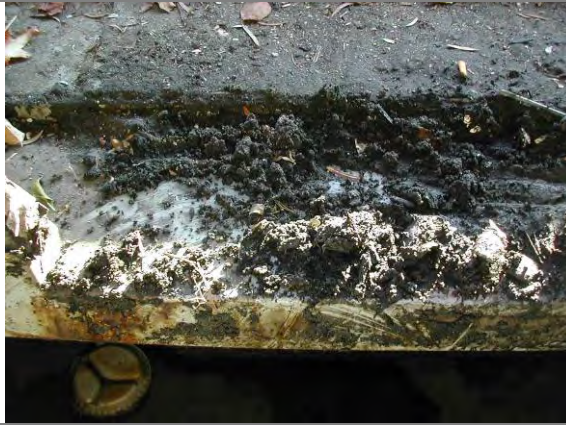
Site : CC-014-C **Location:** Adams and Figueroa St (Area 1 - Site F)

Comments: The insert at this busy intersection has received lots of trash and sediment. The media shown in the lip of the insert appears deflated indicating the absorbent material has been lost during operation. Significant sediment build-up on weir indicates coarse sediment removal is occurring.

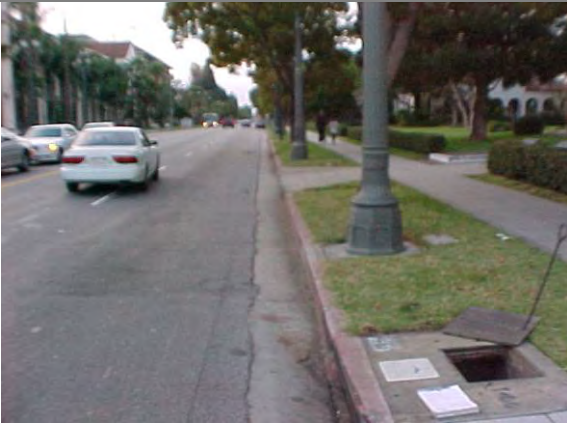
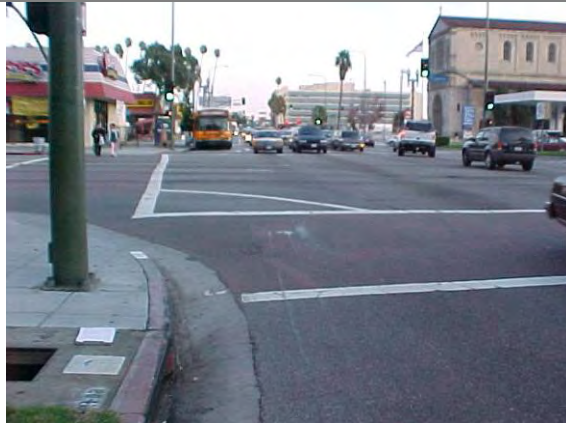
Site : CC-014-C2 **Location:** Adams and Figueroa St (Area 1 - Site F)

Comments: Initial site visit. Top left photo is looking upstream; top right photo is looking downstream toward the intersection. Significant trash and debris loads present at site. Notice the catch basin outlet appears to be nearly clogged.

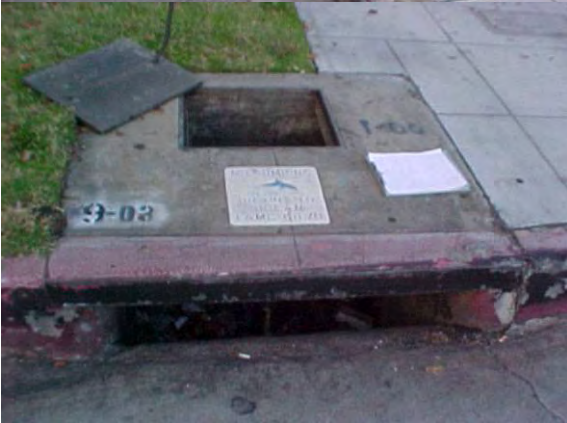
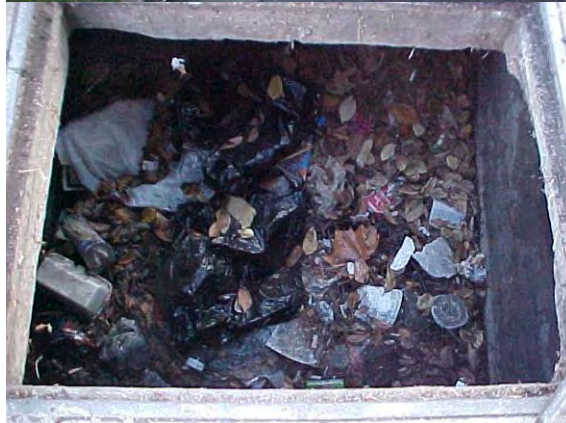
Site : CC-014-C2 Location: Adams and Figueroa St (Area 1 - Site F)	Curb Inlet Basket

<p>Date inspected: 2/4/04</p> <p>Comments: First site visit since installation. As compared to CC-014-C across the street, this site contains more leaf litter and sediment than human-generated trash.</p>
   	<p>Date inspected: 2/27/04</p> <p>Comments: More trash and debris has accumulated since last visit and some has bypassed insert, but still appears to be slightly below capacity.</p>

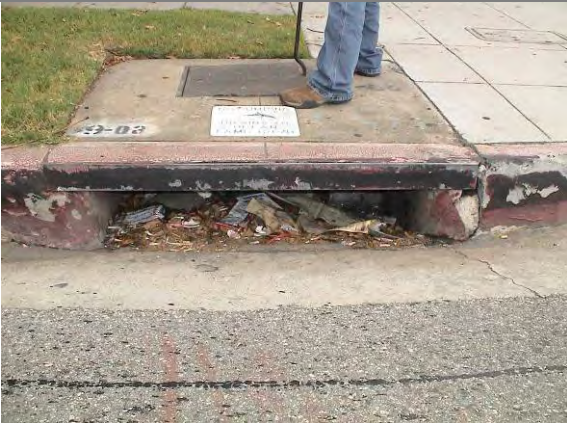
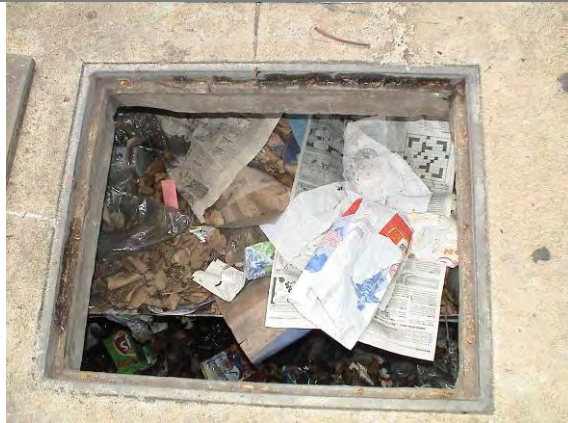
Date inspected:
3/23/04

Comments: The insert is now at capacity and should be cleaned prior to the next wet season.

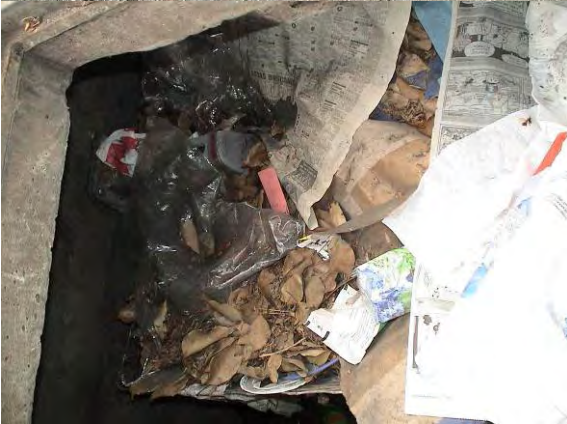
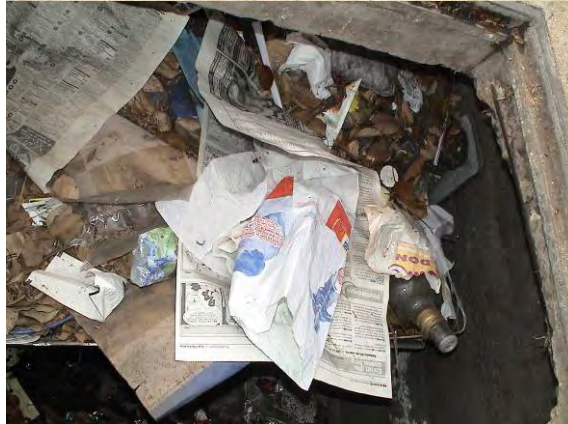
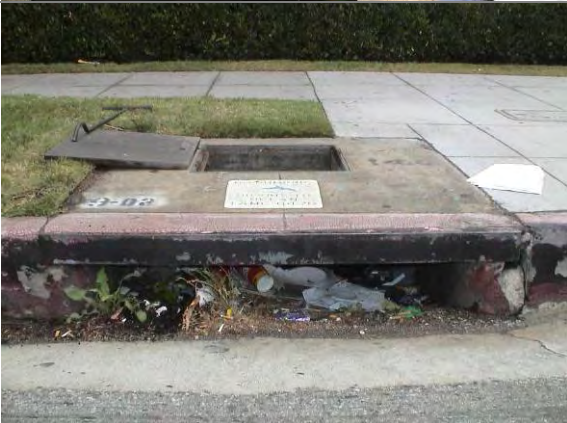
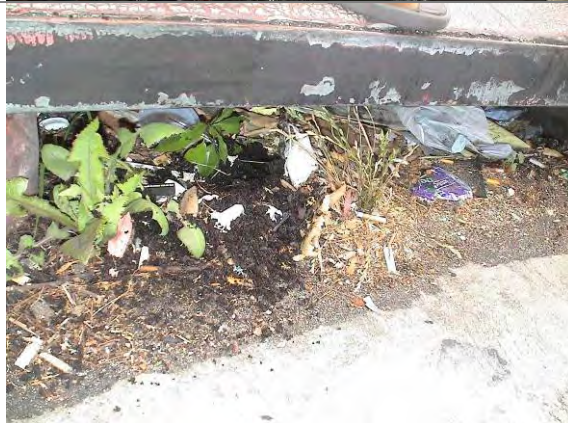
Date inspected:
6/30/04

Comments: As before, this insert is full and needs to be cleaned. The last cleaning of this catch basin appears to have been Sept. 2003. Notice the build-up of sediment and growth of weeds at the inlet of this catch basin.

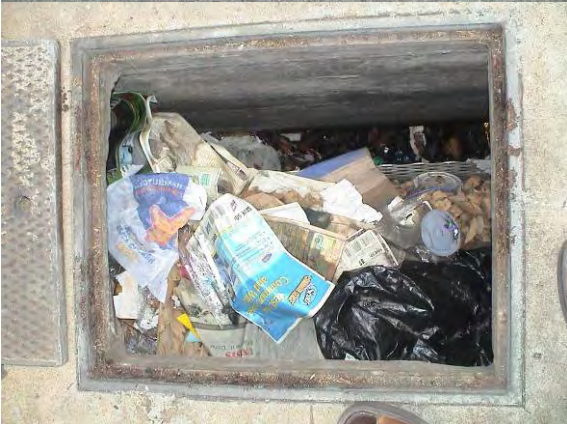
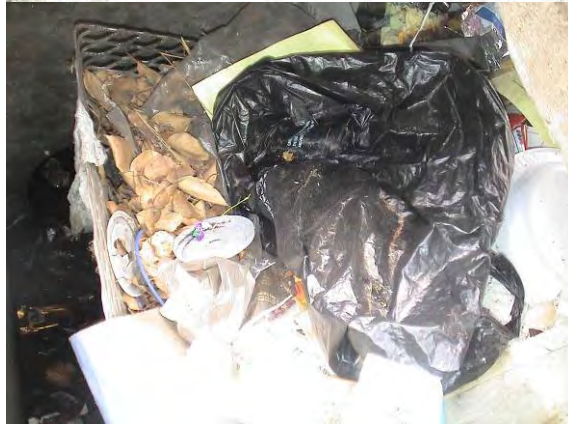
Site : CC-014-C2 Location: Adams and Figueroa St (Area 1 - Site F)	Curb Inlet Basket
 	<p>Date inspected: 10/22/04</p> <p>Comments: This insert receives mostly sediment, leaves, and pine needles. The media appears to be "deflated" indicating the absorbent material was lost during operation. It was retired after this inspection.</p>

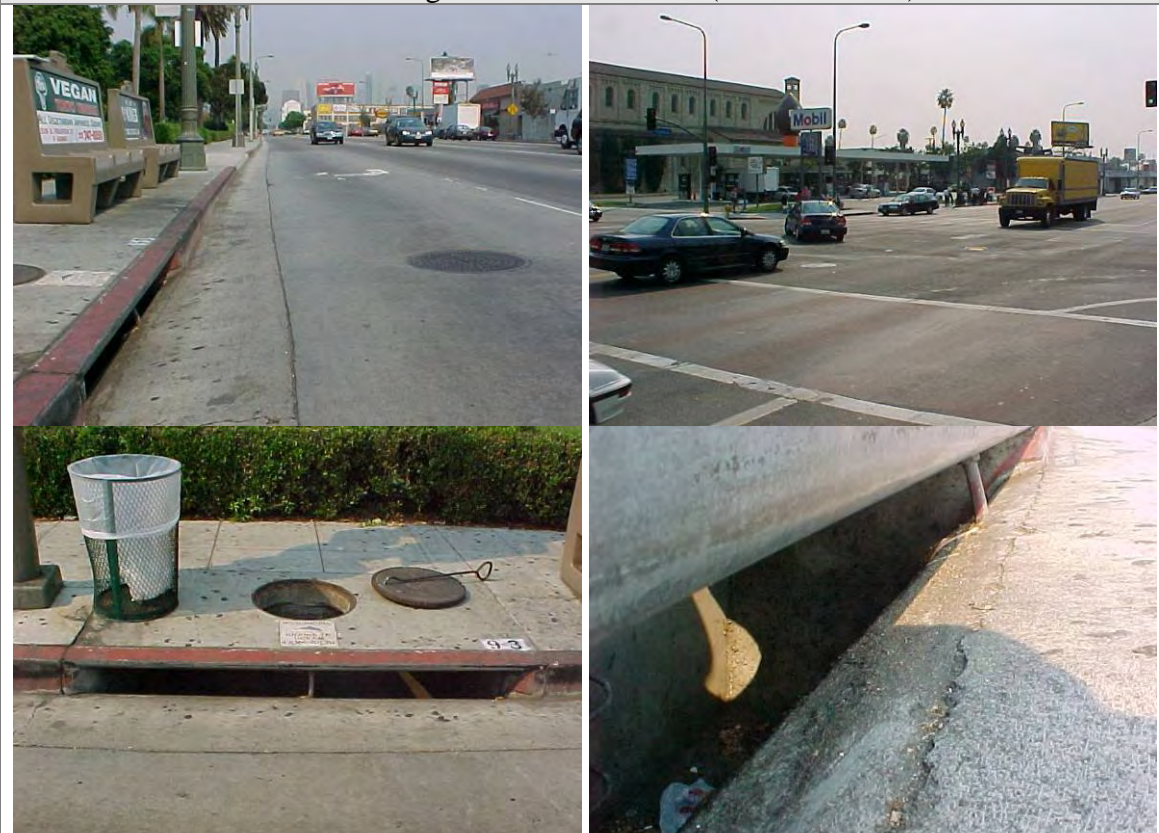
Site : CC-014-D Location: Figueroa St and Adams (Area 1 - Site F)	DrainPac

<p>Date inspected: 12/10/03</p> <p>Comments: Initial site visit. Top left photo is looking upstream; top right photo is looking downstream toward the intersection. This site is located at a bus stop.</p>

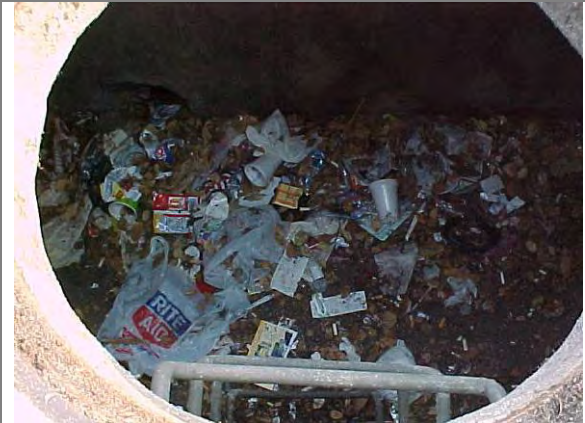
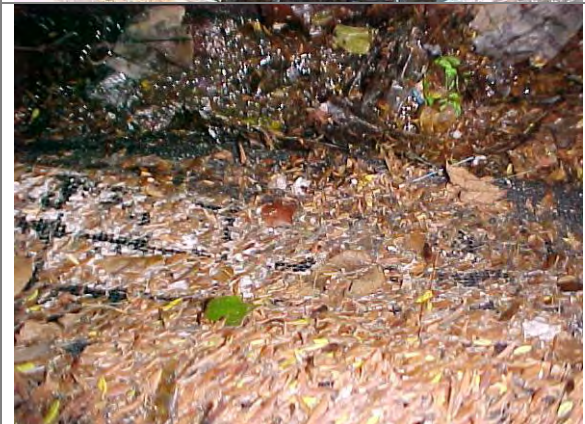
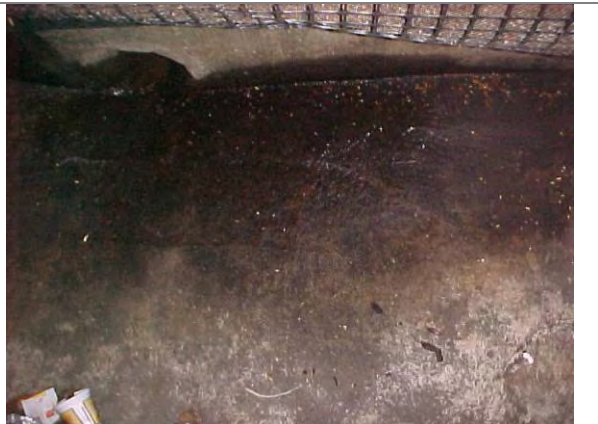
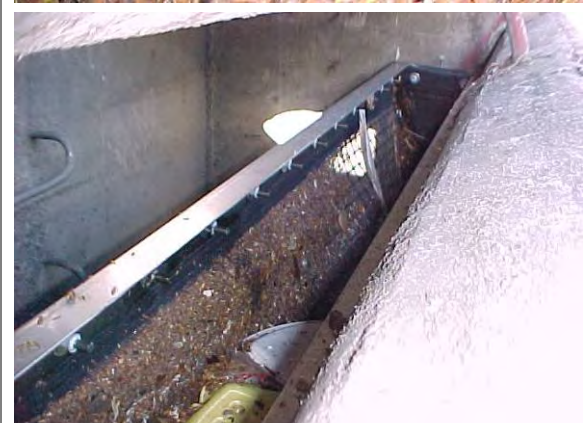
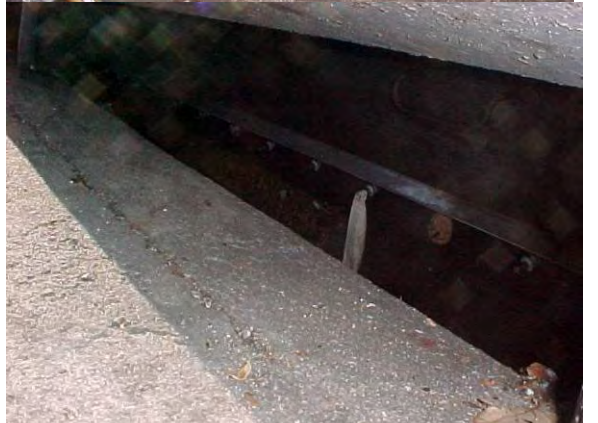
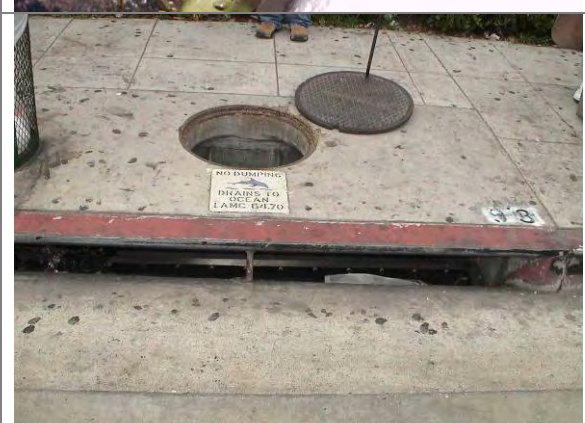
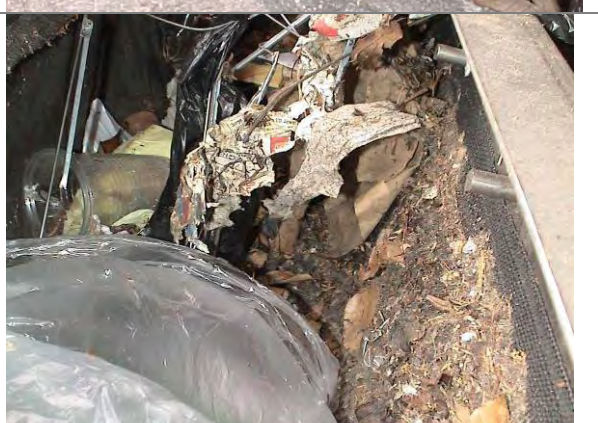
Site : CC-014-D Location: Figueroa St and Adams (Area 1 - Site F)	DrainPac

<p>Date inspected: 2/4/04</p> <p>Comments: This was the first site visit after installation. The photo on the top left is a "birds-eye" view of the insert. Notice there is still some water from the previous day's storm event. The photo on the top left shows the relatively clean catch basin bottom due to the high capture rate of the insert.</p> <p>Date inspected: 3/23/04</p> <p>Comments: Compared to the last inspection there is significantly more trash and debris, but the insert still has capacity and appears to be functioning properly. Only a small amount of bypass is indicated by the limited amount of debris at the bottom of the catch basin.</p>

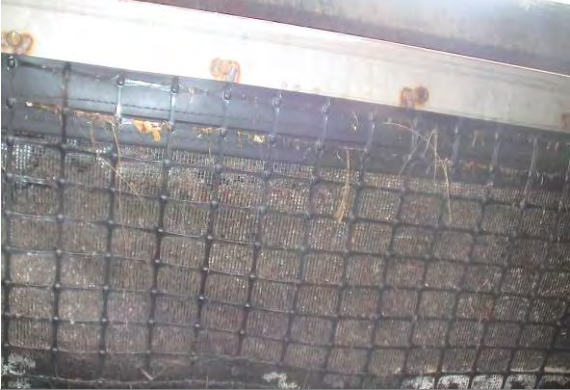
Site : CC-014-D Location: Figueroa St and Adams (Area 1 - Site F)	DrainPac

Comments: Since the last visit a lot more trash has accumulated in the insert and is now nearly at capacity.

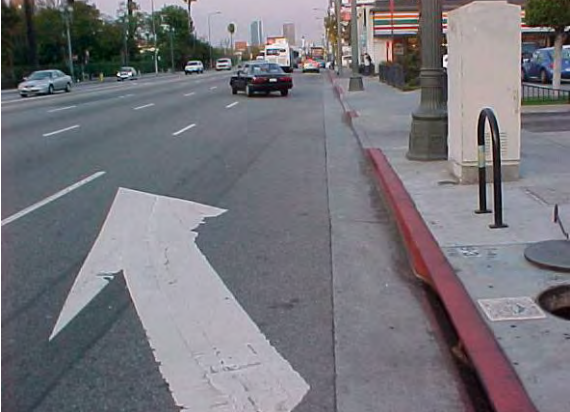
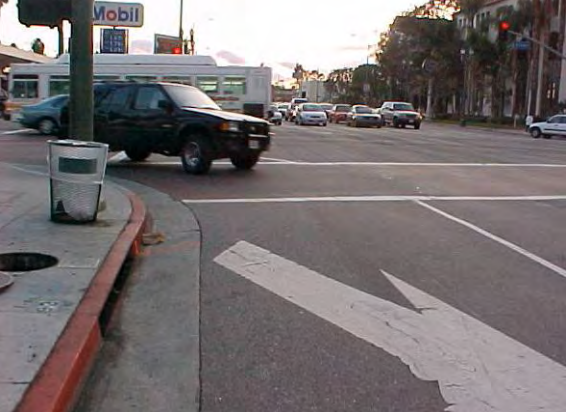
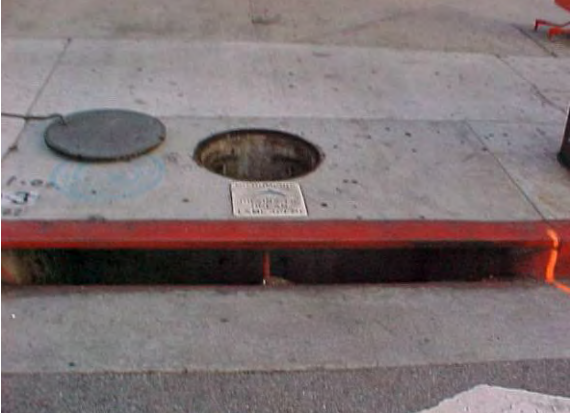
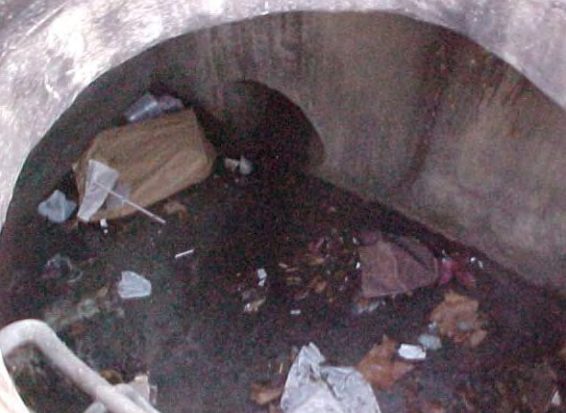
Site : CC-014-D2 Location: Figueroa St and Adams (Area 1 - Site F)	DrainPac

<p>Date inspected: 12/10/03</p> <p>Comments: Initial site visit. Top left photo is looking upstream; top right photo is looking downstream toward the intersection. This site is located at a bus stop.</p>

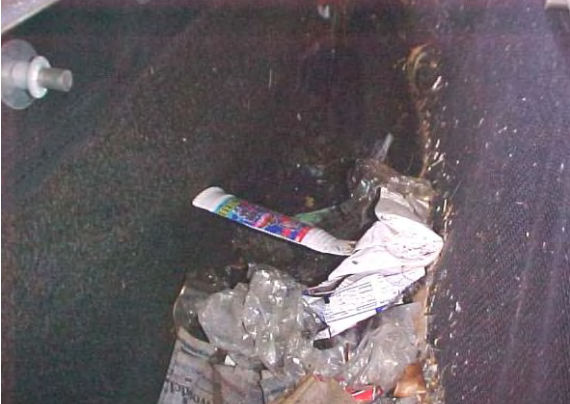
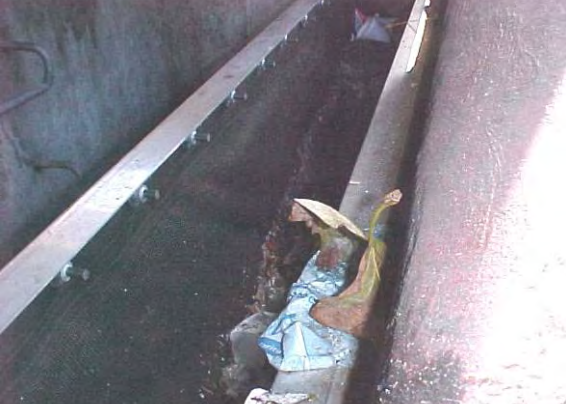
<p>Date inspected: 2/4/04</p> <p>Comments: This is the first inspection after installation and it appears to be functioning well.</p>

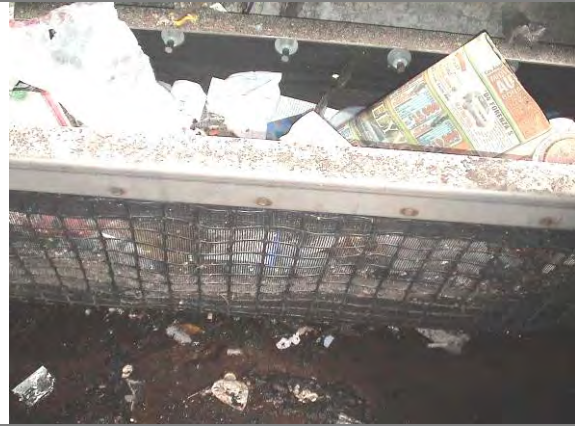
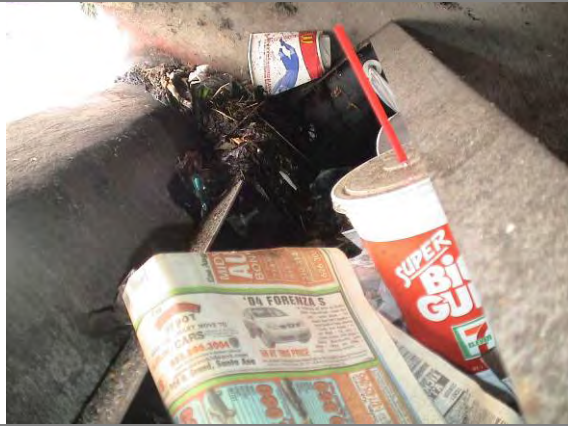
Site : CC-014-D2 Location: Figueroa St and Adams (Area 1 - Site F)	DrainPac

<p>Date inspected: 3/23/04</p> <p>Comments: After nearly two months, this insert is still functioning well and has remaining capacity.</p>
   	<p>Date inspected: 6/30/04</p> <p>Comments: More trash and debris have accumulated since the last visit. However, it appears to still have some remaining capacity.</p>

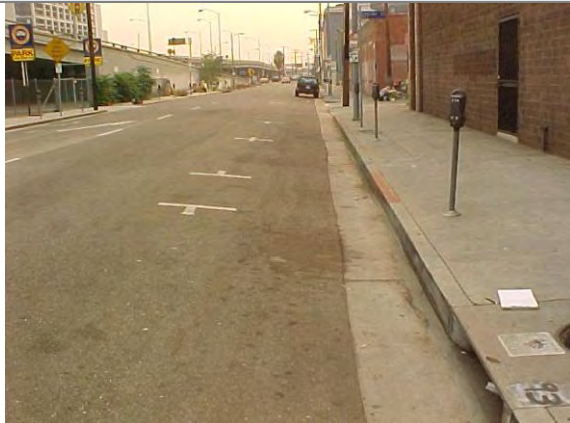
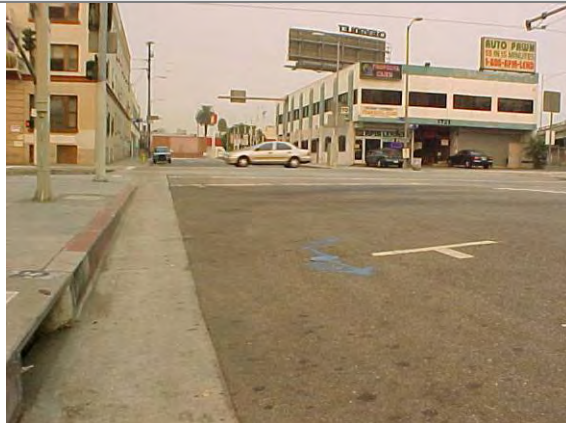
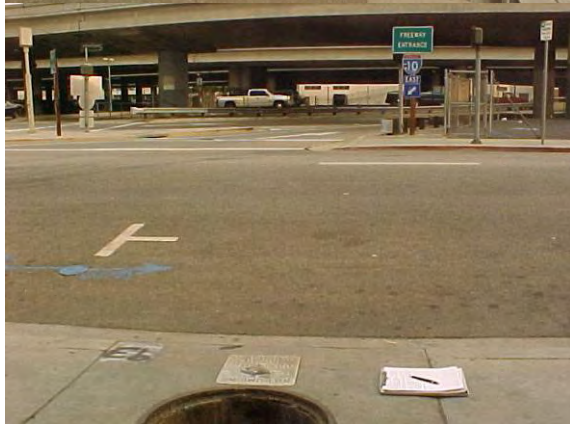
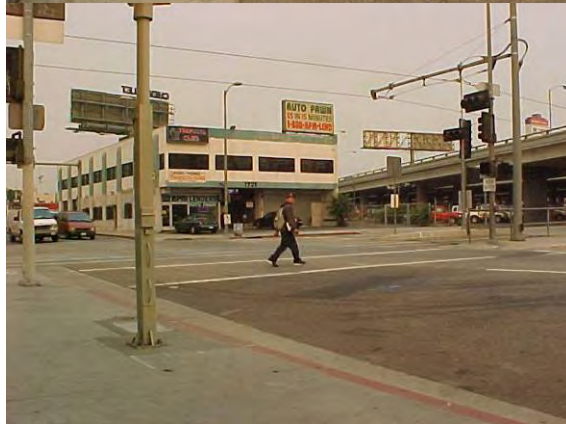
Site : CC-007-C Location: 18th and Flower St., South East Corner (Area 1 - Site G)

Comments: Initial site visit. Top left photo is looking upstream; top right is looking downstream.

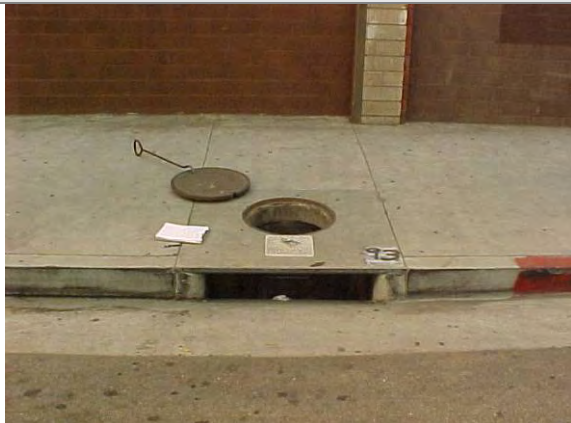
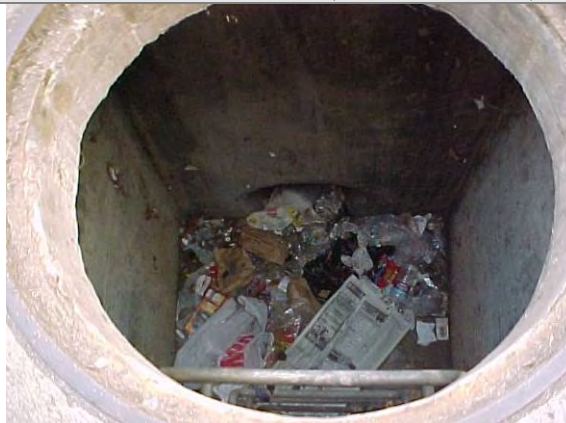
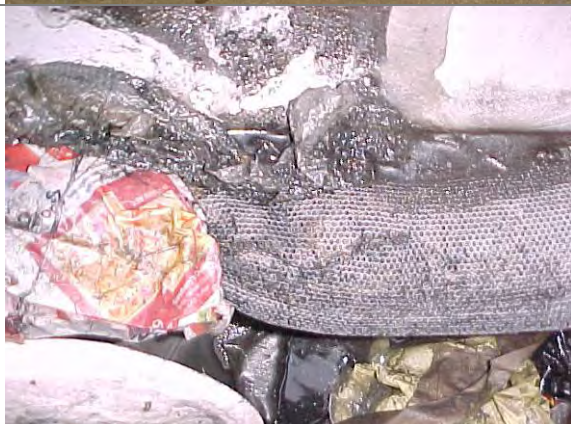
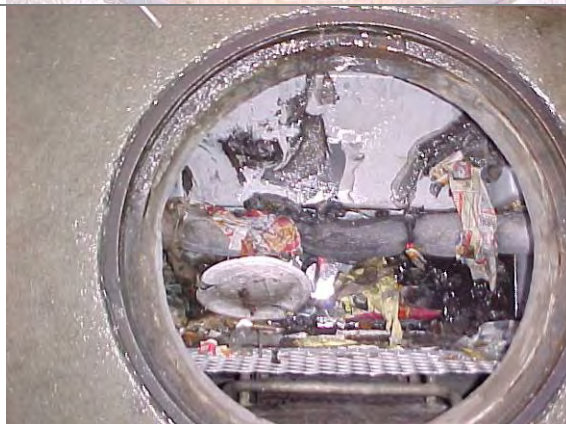
Comments: This visit occurred about a week after installation. Notice the oil collecting on the surface of the absorbent boom.

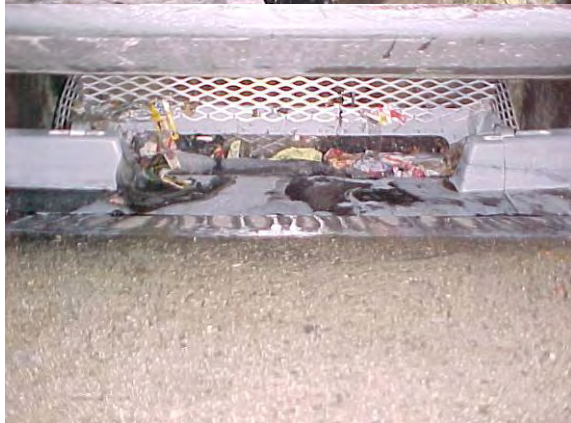
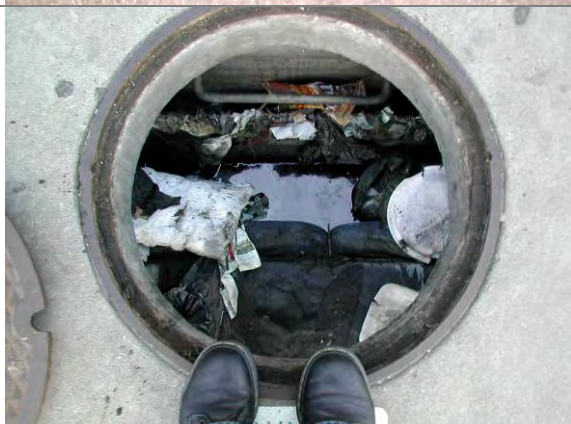
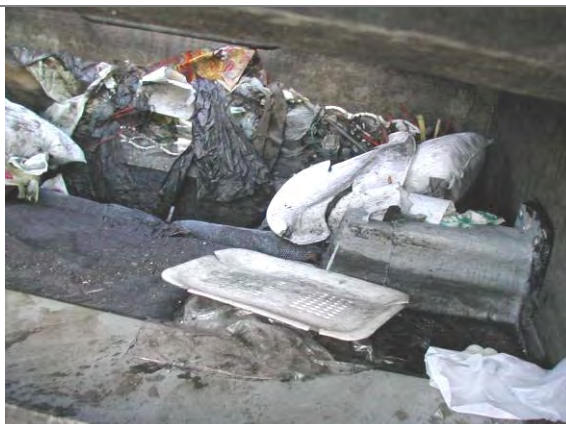
Comments: As compared to the last inspection, this insert has received a significant amount of oil; probably from a direct illicit discharge of used motor oil. Notice the puddle of oil on the lip of this insert.

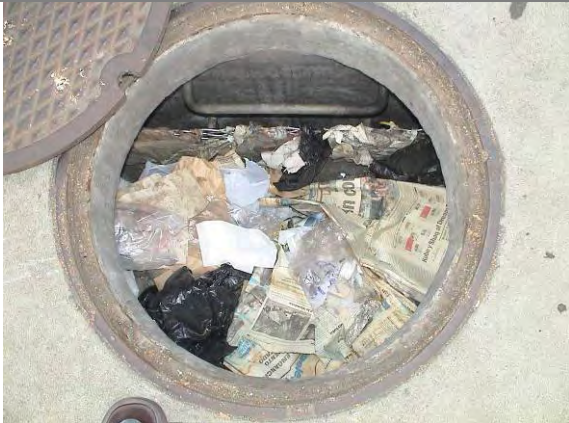
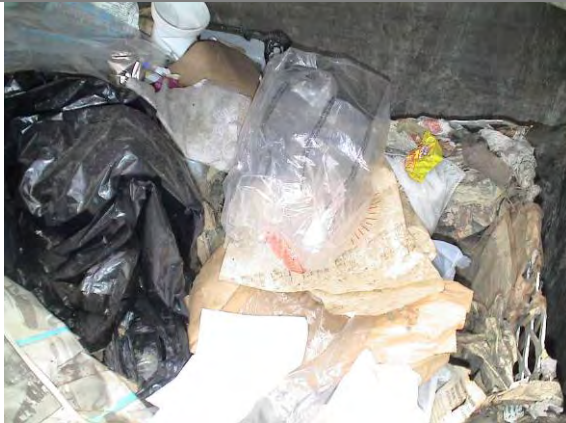
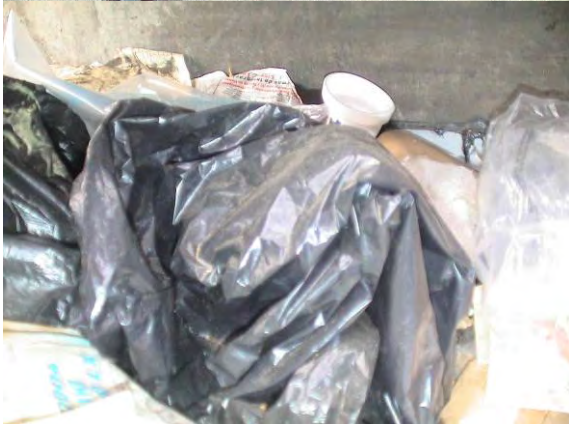
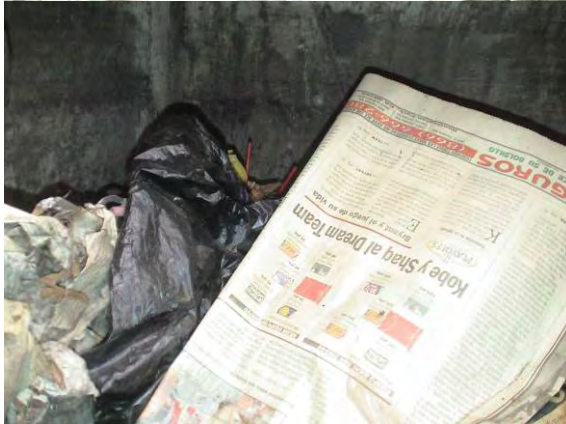
Site : CC-007-C Location: 18th and Flower St., South East Corner (Area 1 - Site G)	Curb Inlet Basket

<p>Date inspected: 3/23/04</p> <p>Comments: This insert is no longer visible due to the excessive trash and debris.</p>
   	<p>Date inspected: 6/30/04</p> <p>Comments: As before, this insert is completely overwhelmed with trash and needs to be cleaned. It should be retired during the next site visit.</p>

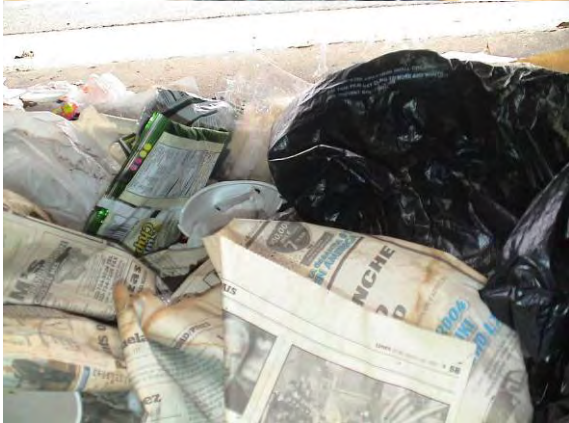
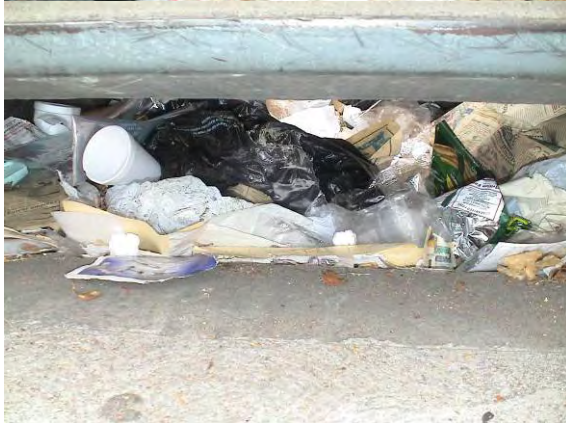
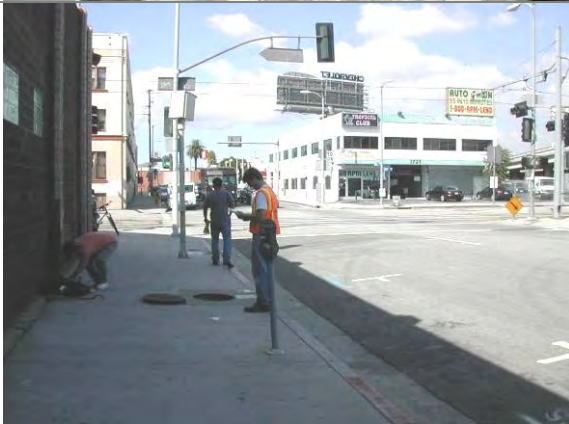
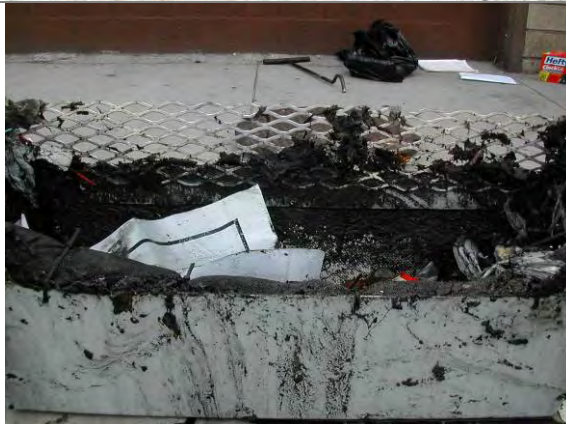
Comments: The presence of standing water indicates that this insert is clogged. It was retired after this visit.

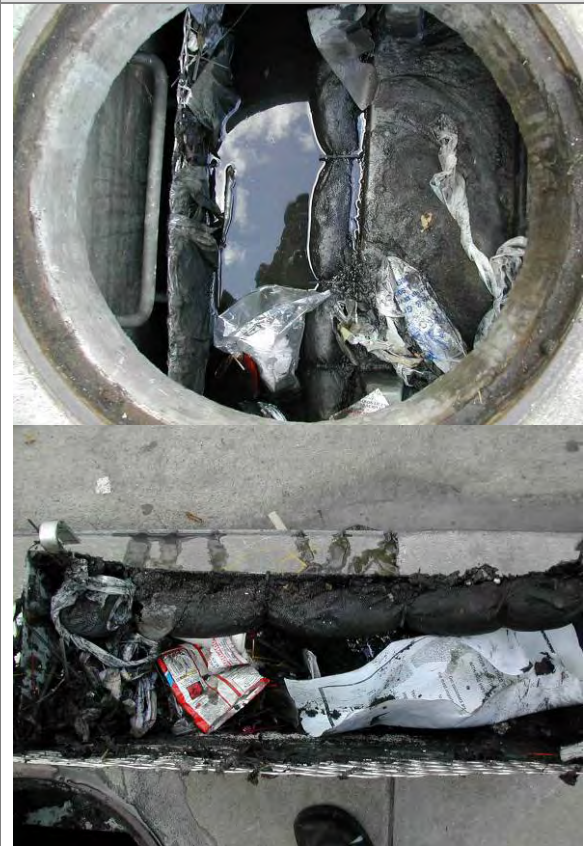
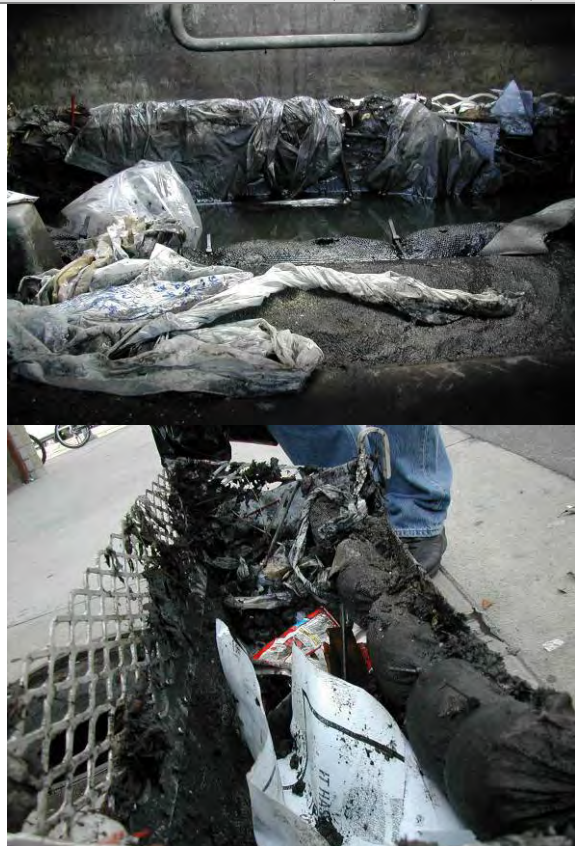
Site : CC-007-F	Location: 18th St. & Flower St, Southwest corner (Area 1 - Site G)	FloGard
 	 	<p data-bbox="1295 1344 1507 1411">Date inspected: 12/10/03</p> <p data-bbox="1269 1453 1516 1726">Comments: Initial site visit. Top left photo is looking upstream; top right is looking downstream. This is a shallow catch basin with a relatively small amount of trash deposition.</p>

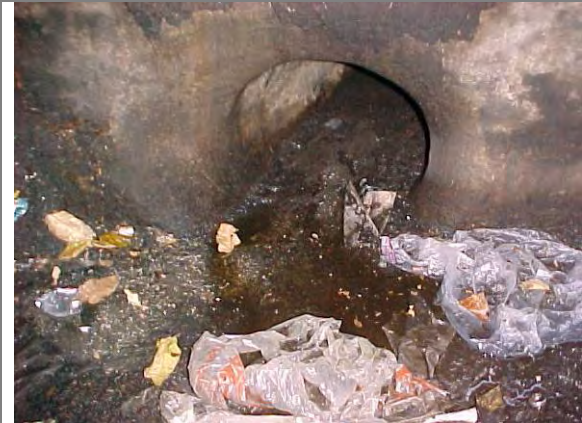
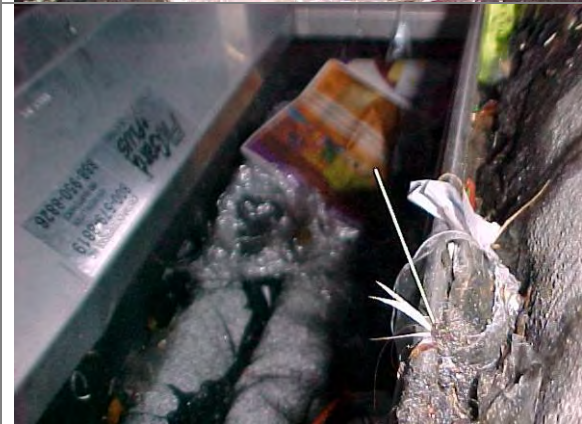
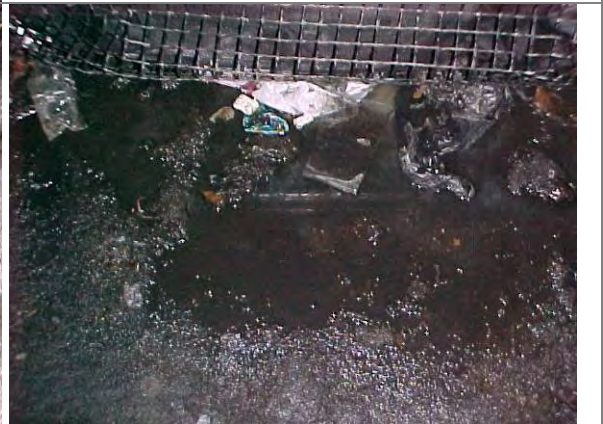
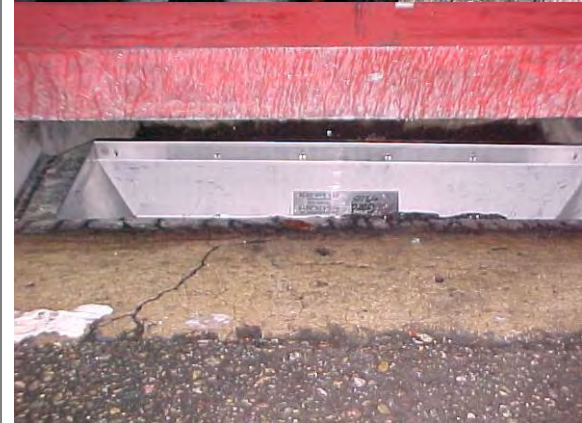
Site : CC-007-F Location: 18th St. & Flower St, Southwest corner (Area 1 - Site G)	FloGard

<p>Date inspected: 2/4/04</p> <p>Comments: Standing water indicates the filter media may be beginning to clog. Notice the floating absorbent boom of amorphous alumina silicate in the picture on the left.</p>

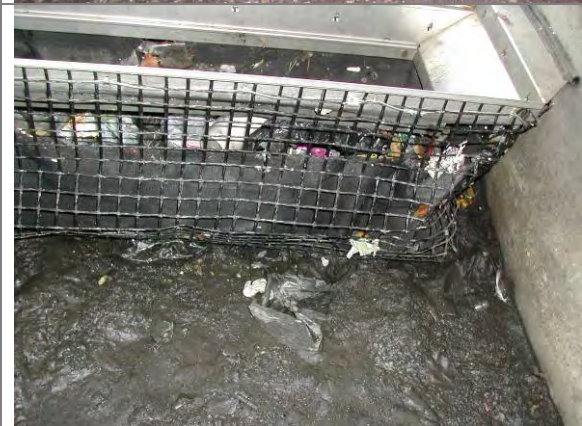
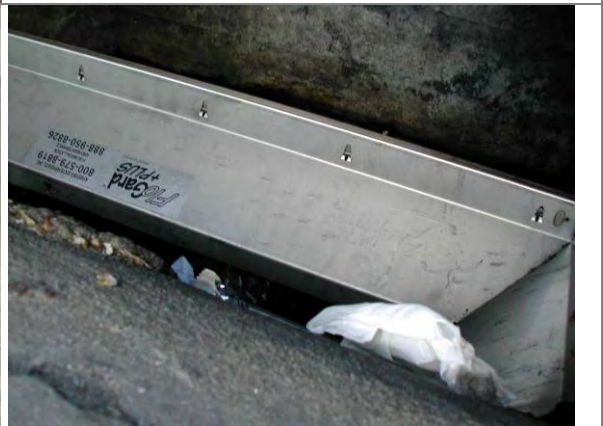
<p>Date inspected: 2/27/04</p> <p>Comments: Not much changed from last inspection except the standing water had drained and there was slightly more trash and debris.</p>

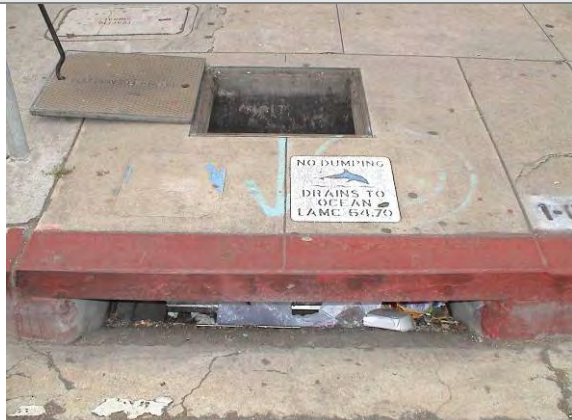
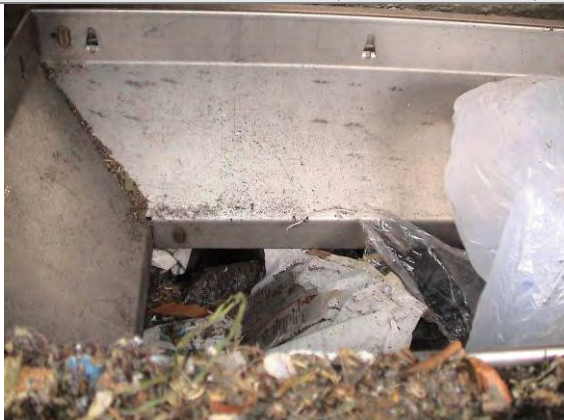
Date inspected:
3/23/04

Comments: The insert appears to have reached its trash holding capacity and probably should be retired.

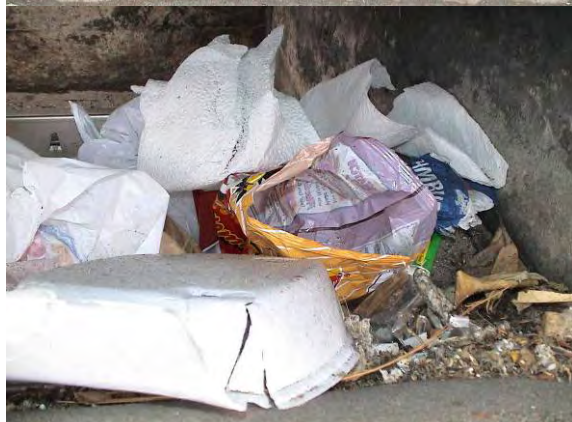
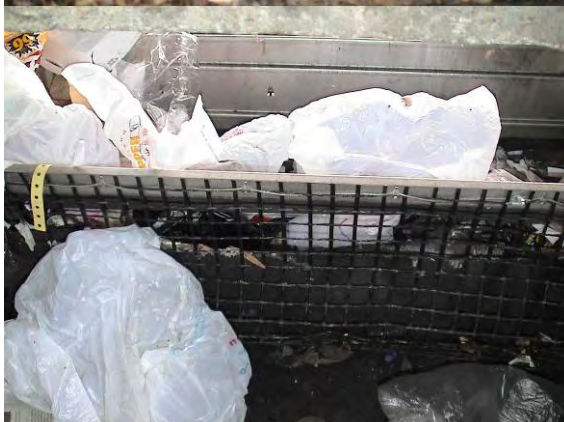
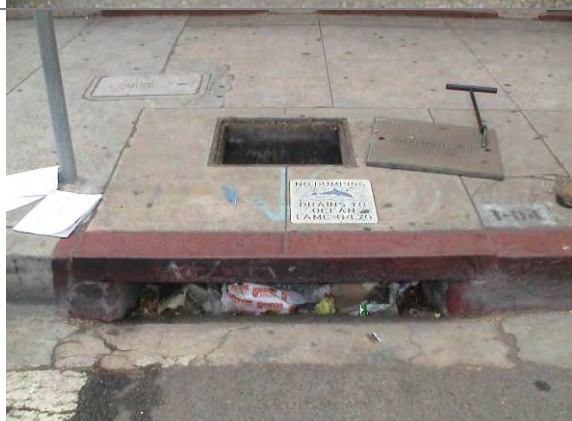
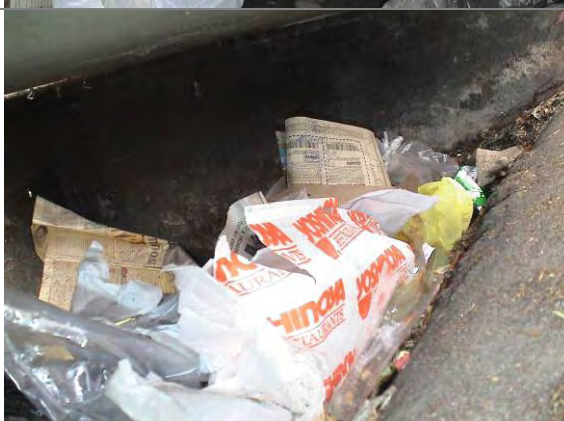
Date inspected:
6/30/04

Comments: As before, this insert appears to be at capacity and is currently overflowing with trash. Much of the trash appears to have been transported by wind rather than runoff.
