CIWMB CATCH BASIN INSERT STUDY FINAL REPORT

USED OIL RESEARCH, TESTING, AND DEMONSTRATION GRANT

Grant Number URD3-02-0005

May 24, 2005

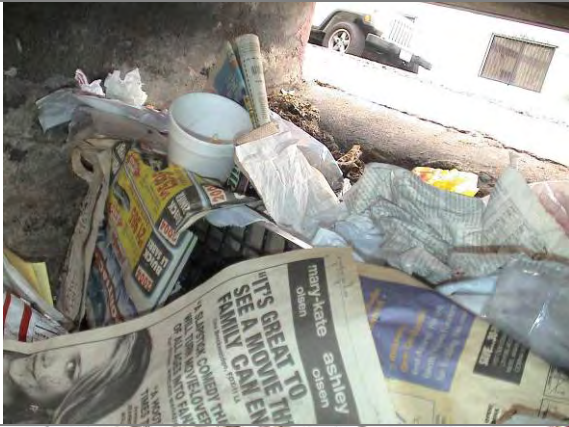
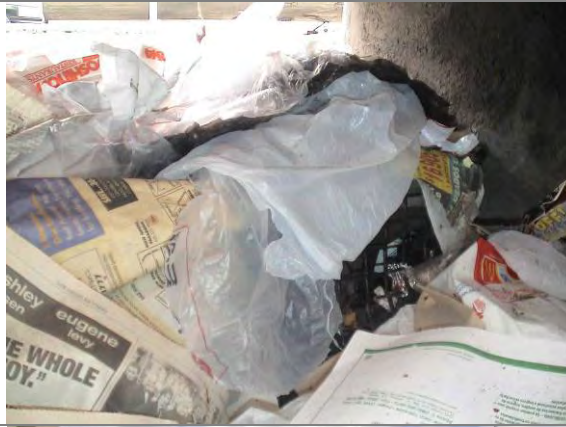
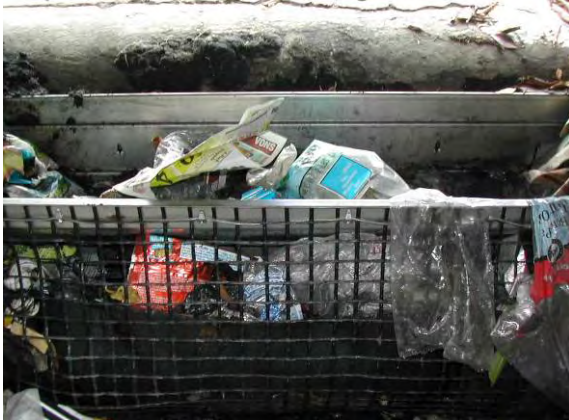
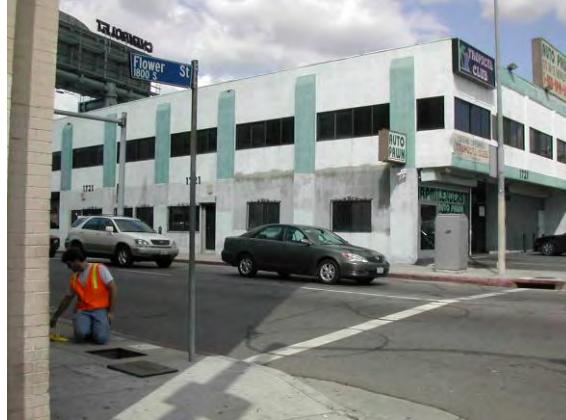
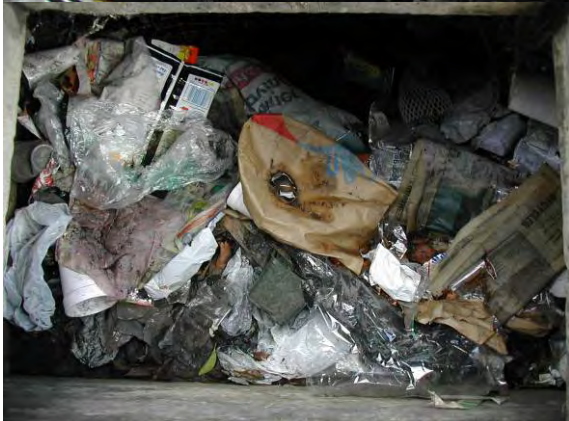
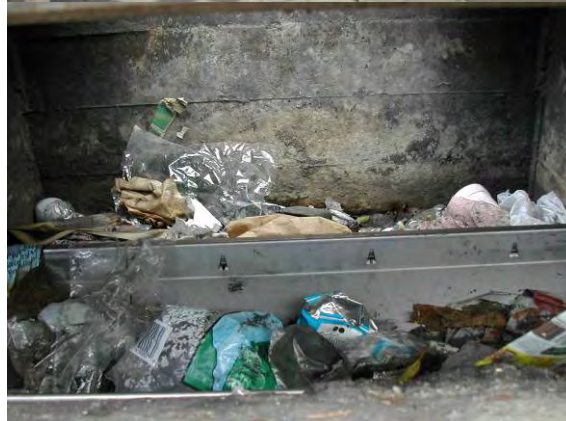
Date inspected:
10/21/04

Comments: Appears that significant trash has bypassed the insert. It was retired after this visit.

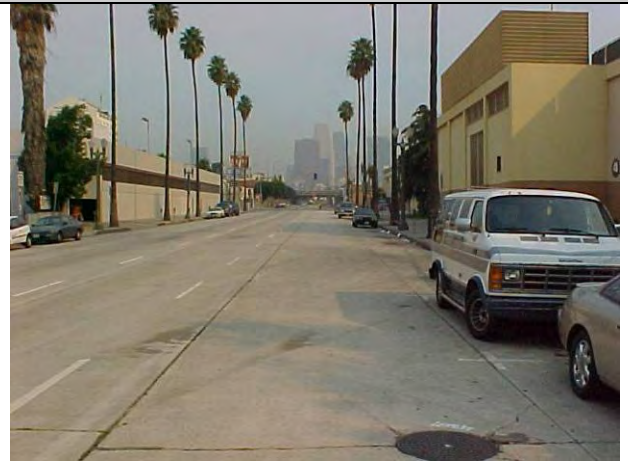
Looking upstream (~north) of CC-009F

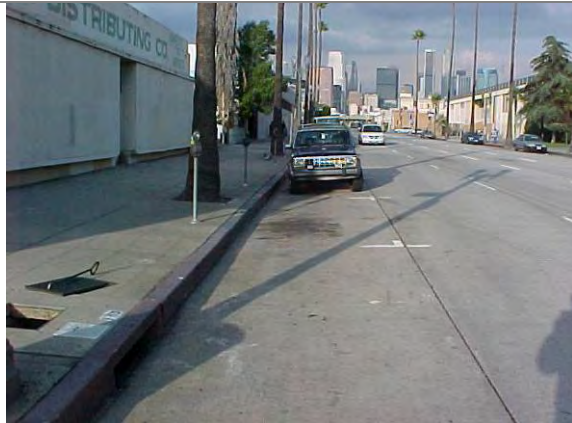
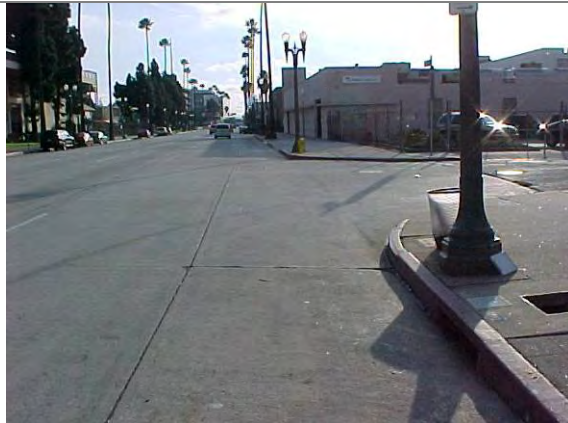
Date inspected:
12/10/03

Comments: Initial site visit. Top left photo is looking upstream; top right is looking downstream.

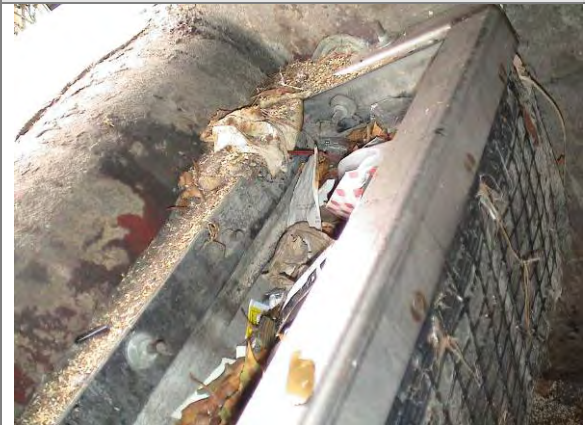
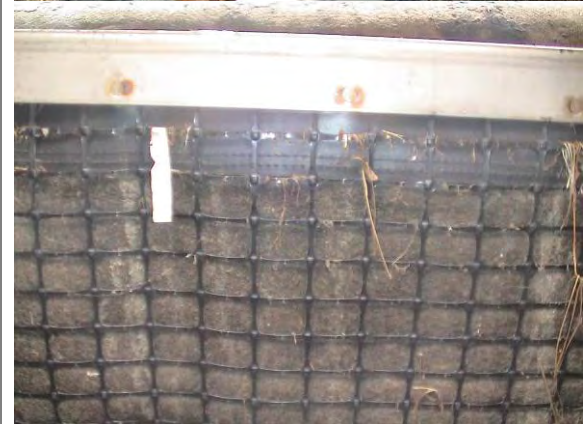
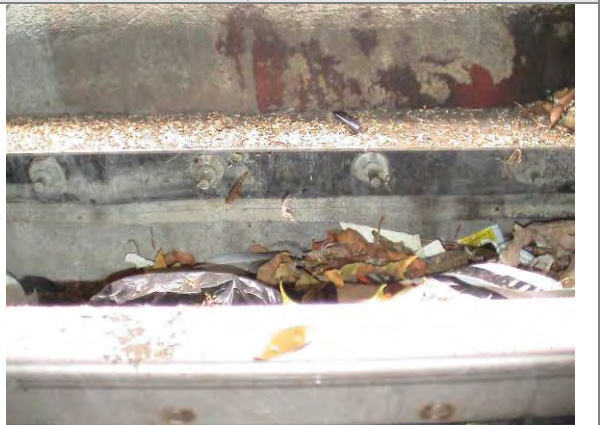
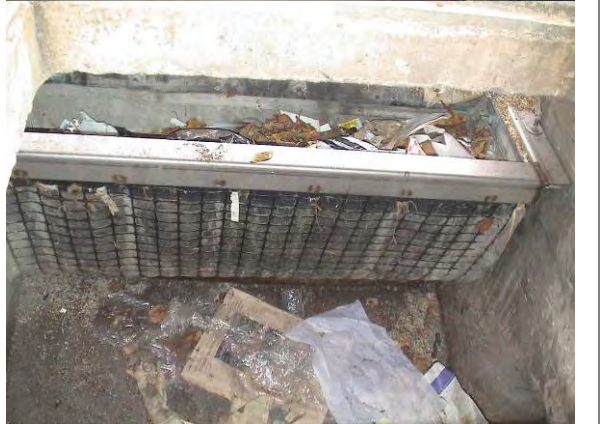
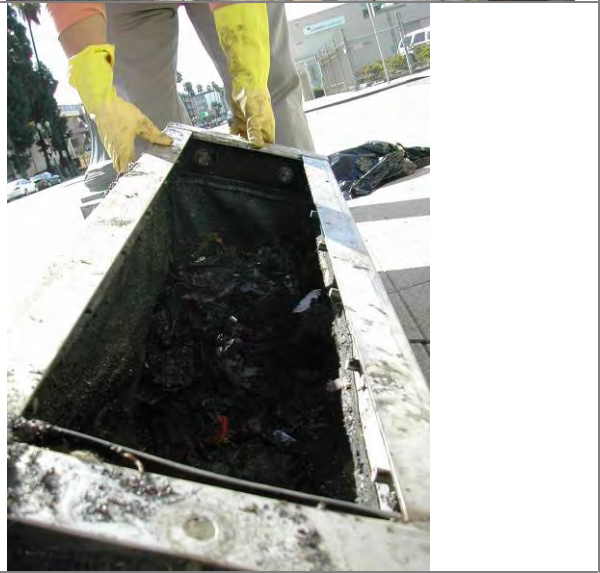
<p>Date inspected: 10/21/04</p> <p>Comments: Mostly sediment in this insert. Appears to have been cleaned since last visit.</p>

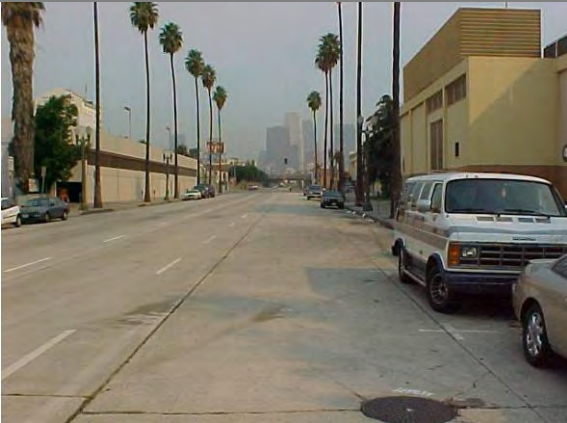
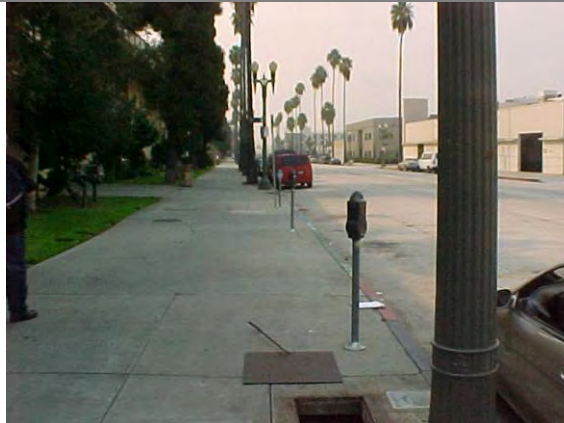
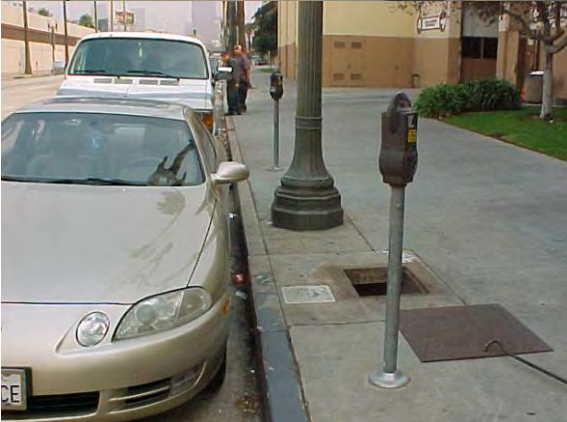
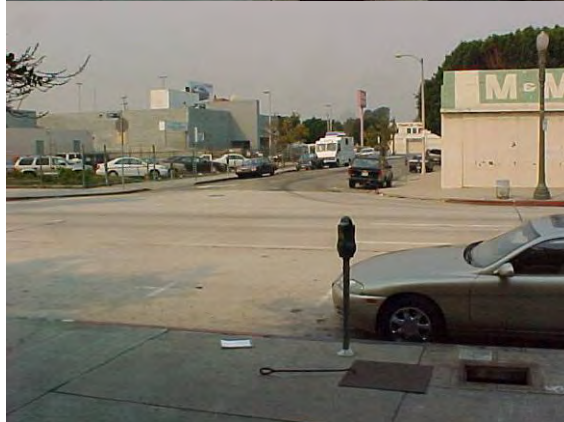
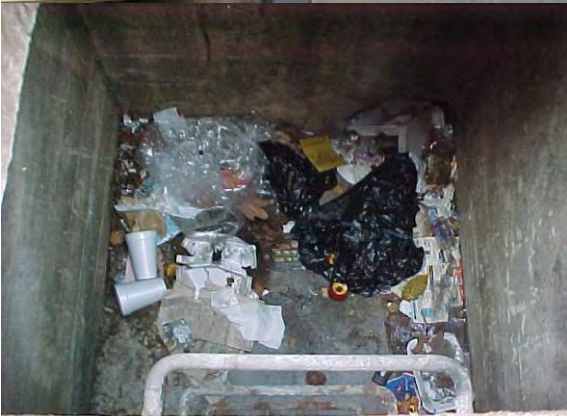
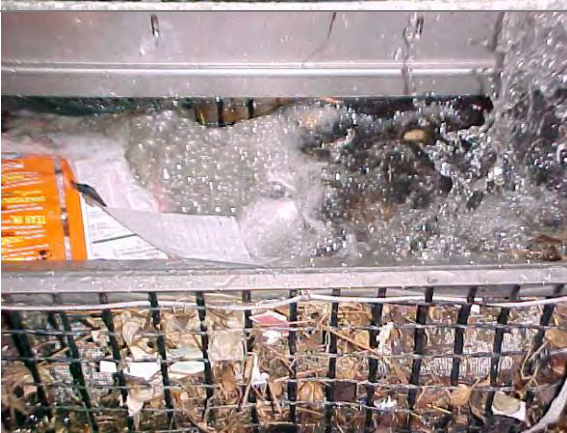
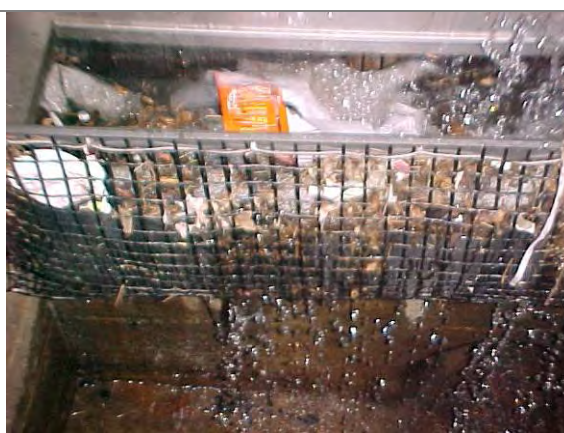
Site : CC-009-F	Location: 20th and Flower St., East Side (Area 1 - Site H)	Flo-Gard
-----------------	--	----------

Date inspected:
10/24/03

Comments: Initial site visit. Top left photo is looking upstream; top right is looking downstream.

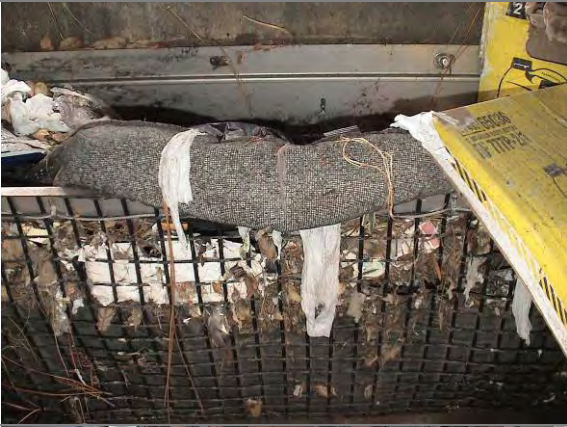
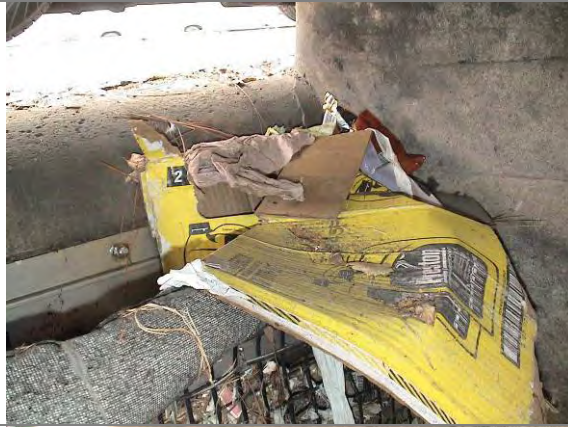
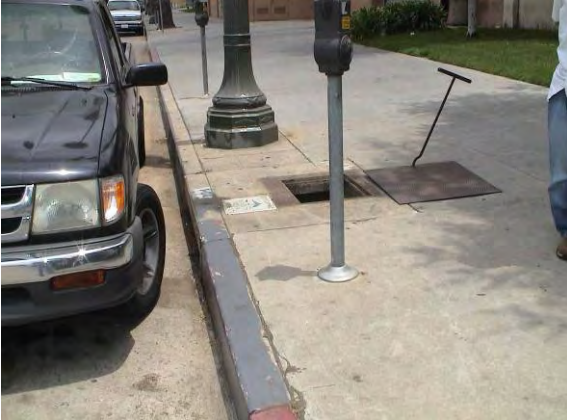
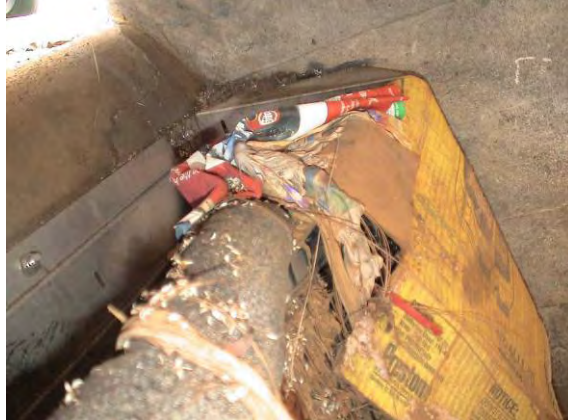
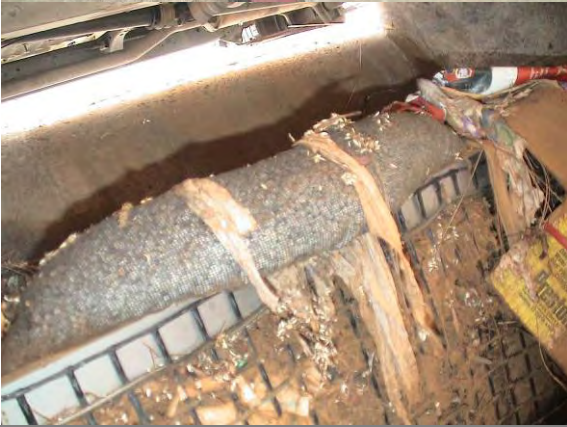
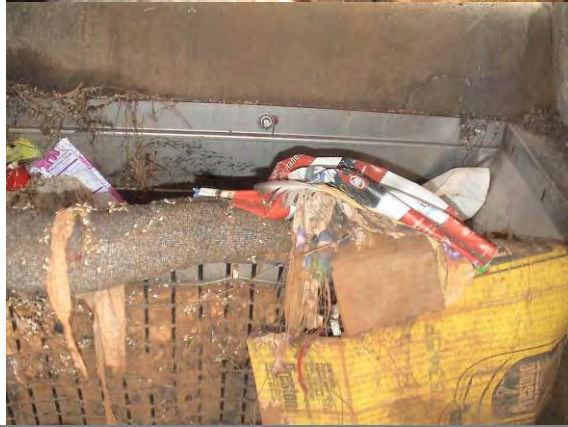
Site : CC-009-F Location: 20th and Flower St., East Side (Area 1 - Site H)	Flo-Gard

<p>Date inspected: 2/27/04</p> <p>Comments: Notice the absorbent boom has nearly floated out of the device.</p>
 	<p>Date inspected: 3/23/04</p> <p>Comments: A later inspection reveals the debris is still trapped in the insert. The upper portion of the insert appears to be less effective for trapping sediment and small debris, so this insert is at capacity even though it may not appear full. Also, the absorbent is not likely providing much treatment with the way it is hanging out of the basket.</p>

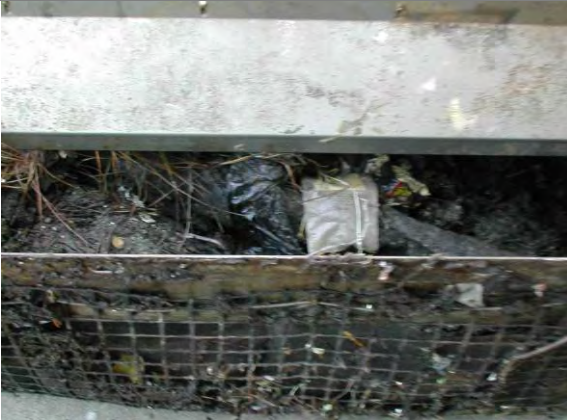
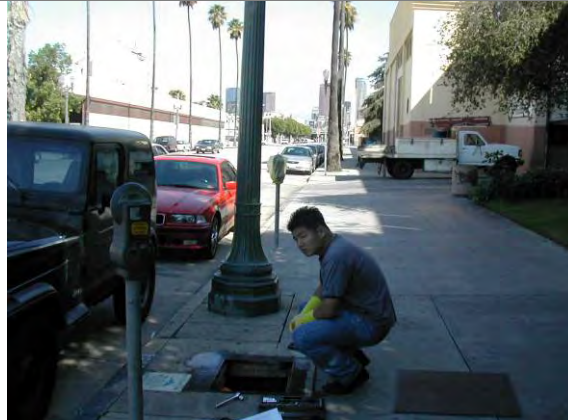
Date inspected:
6/30/04

Comments: The absorbent with this insert appears to have been dislodged.

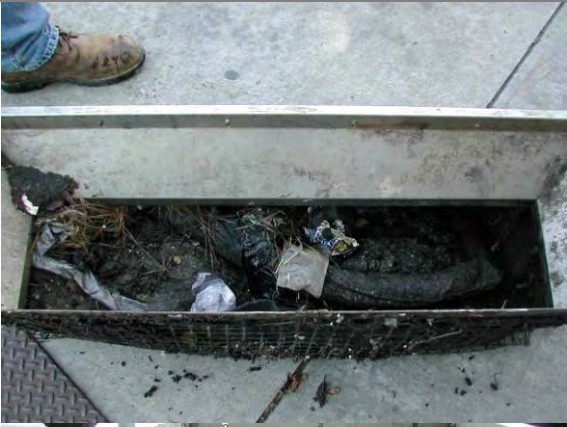
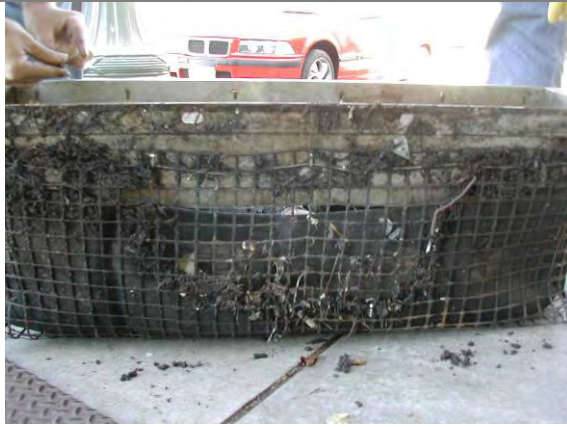
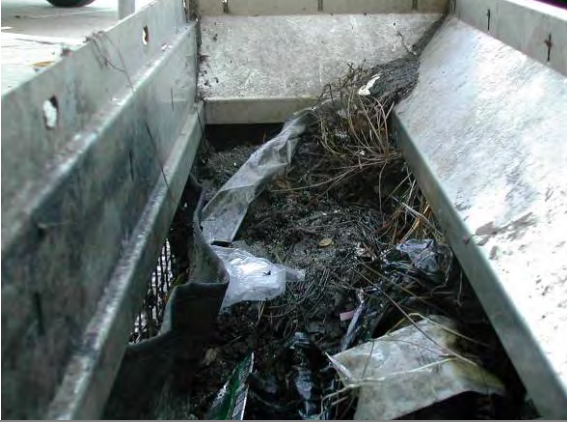
Date inspected:
10/21/04

Comments: As compared to the last visit, this insert appears have been cleaned and is in good working condition.

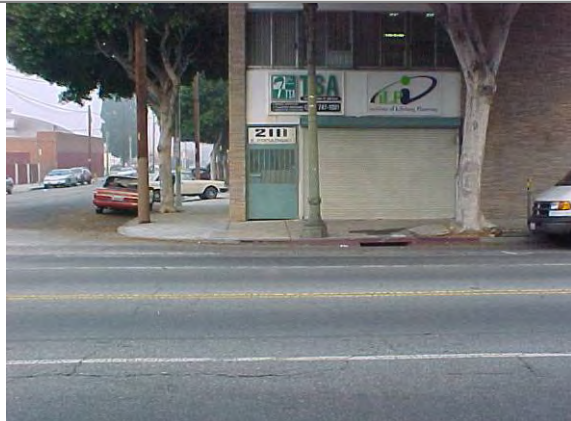
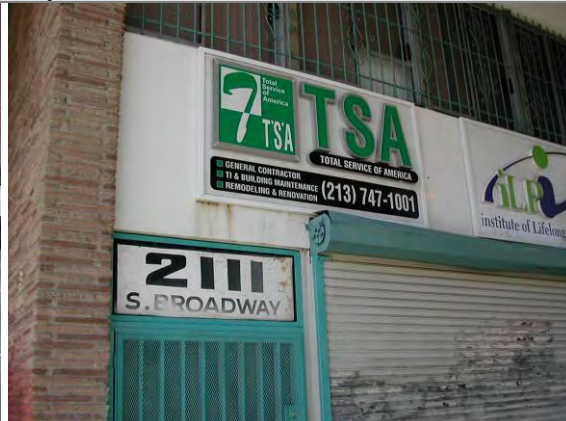
Site : CC-013-F Location: 22nd and Broadway St., NW Corner (Area 1 - Site I)

Date inspected:
10/24/03

Comments: Initial site visit. Top left photo is looking across the street toward the curb inlet.

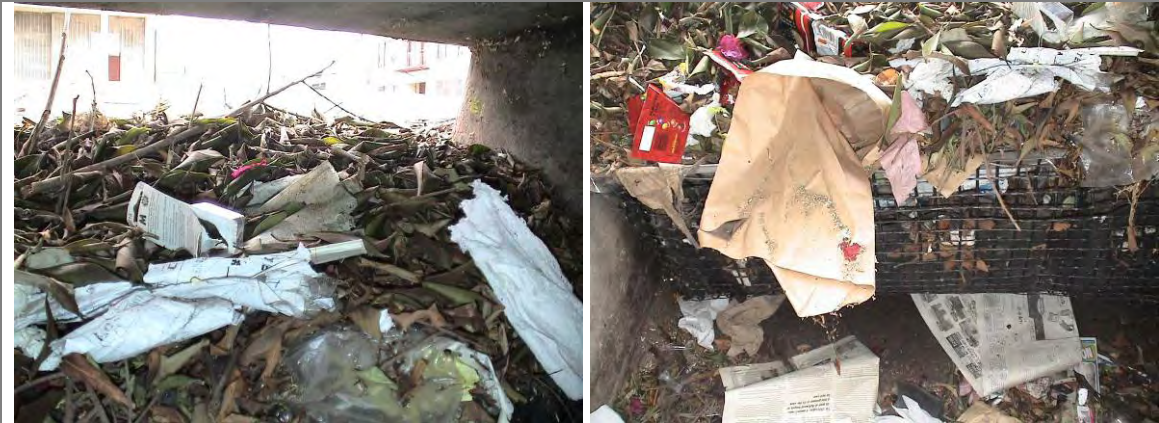
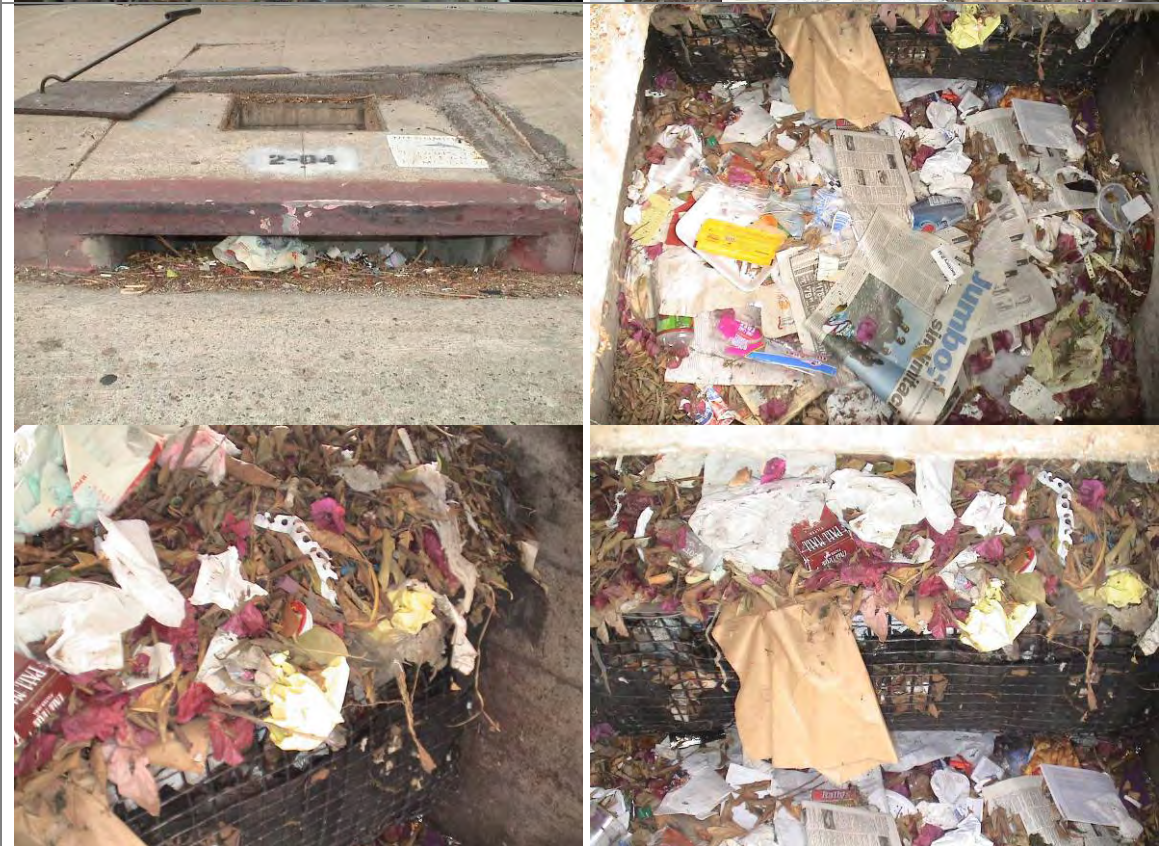
Site : CC-013-F Location: 22nd and Broadway St., NW Corner (Area 1 - Site I)	Flo-Gard
   	<p>Date inspected: 2/4/04</p> <p>Comments: This was the first site visit after installation and one storm event. The insert is already nearly at capacity.</p>
 	<p>Date inspected: 2/27/04</p> <p>Comments: About two weeks later, this site was already overwhelmed with leaves and trash.</p>
 	<p>Date inspected: 3/23/04</p> <p>Comments: Later inspections still show a lot of the leaves and trash were still trapped in the insert. The insert is completely full at this point and needs to be cleaned.</p>

<p>Date inspected: 6/30/04</p> <p>Comments: As before, this insert is completely overwhelmed with trash and debris and needs to be retired.</p>

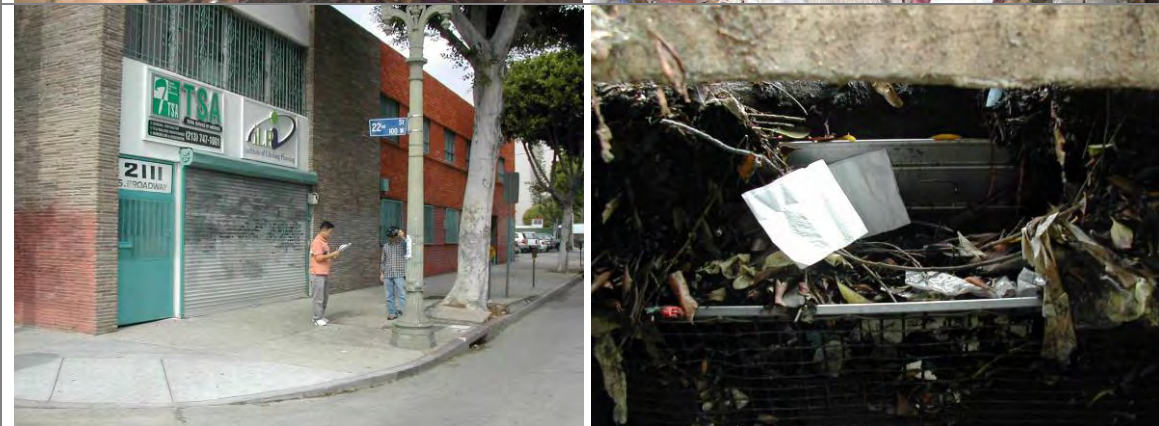
<p>Date inspected: 10/21/04</p> <p>Comments: It was retired after this visit.</p>

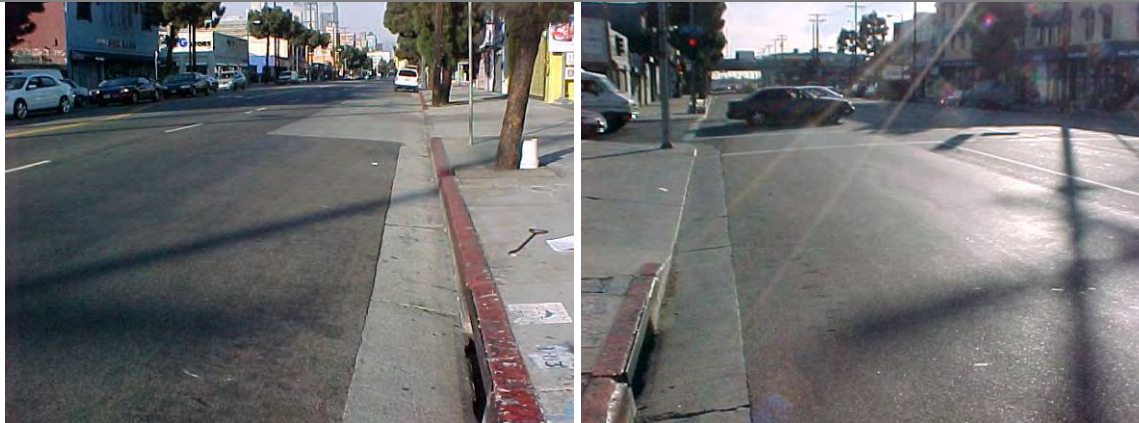
Site : FL-003-C Location: 16th St. (Venice Blvd) & Main St. (Area 1 - Site J)

Date inspected:
10/24/03

Comments: Initial site visit. Top left photo is looking upstream; top right is looking downstream. There is a Chevron gas station on the corner that may be contributing to some of the runoff to this CB.

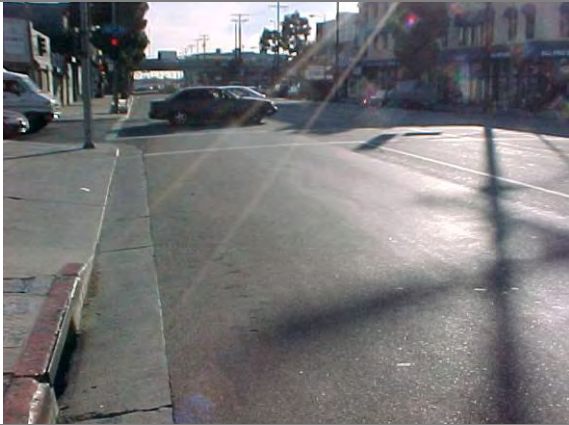
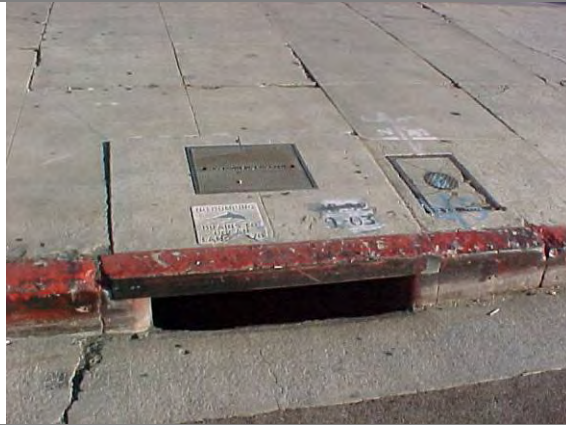
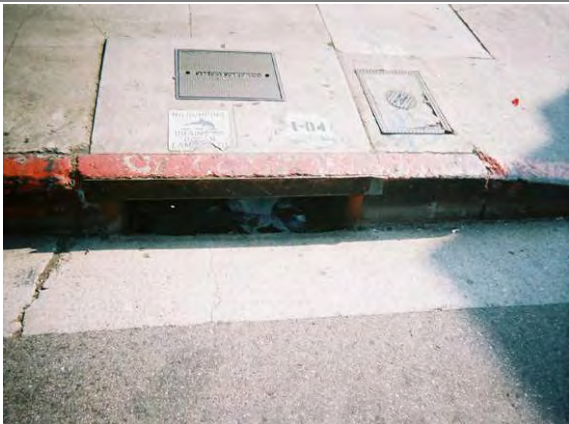
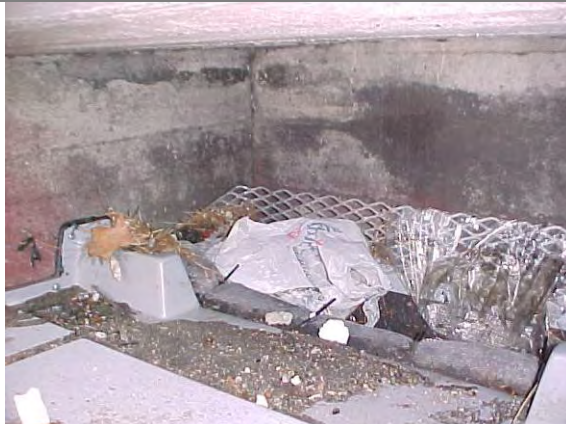
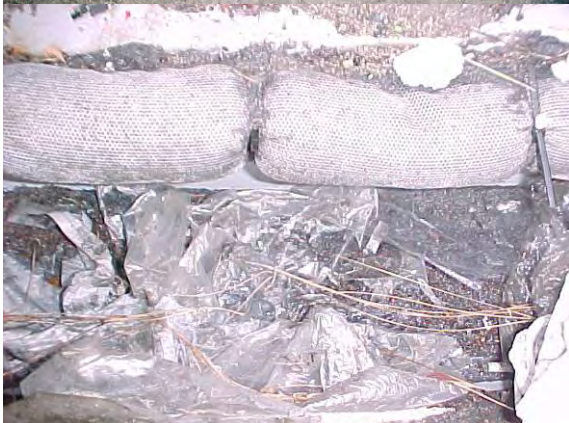
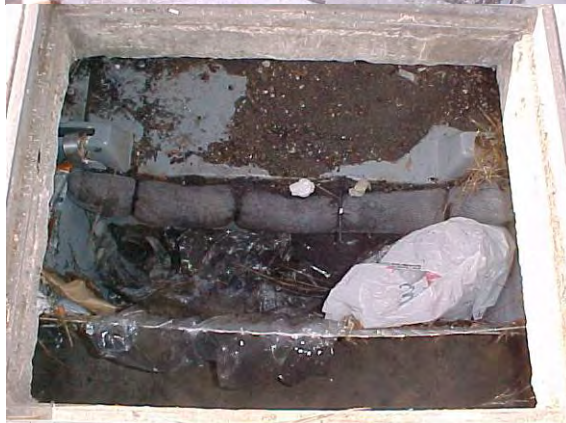
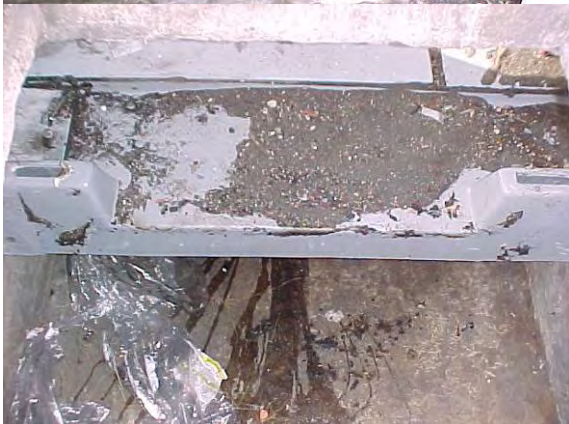
Date inspected:
2/4/04

Comments: Notice the coarse sand accumulating on the shelf of this insert. This may help reduce the chance of clogging, but the plastic bags are the overflow screen. Note the insert has been removed in the bottom picture for subsequent transport to the UCLA testing laboratory.

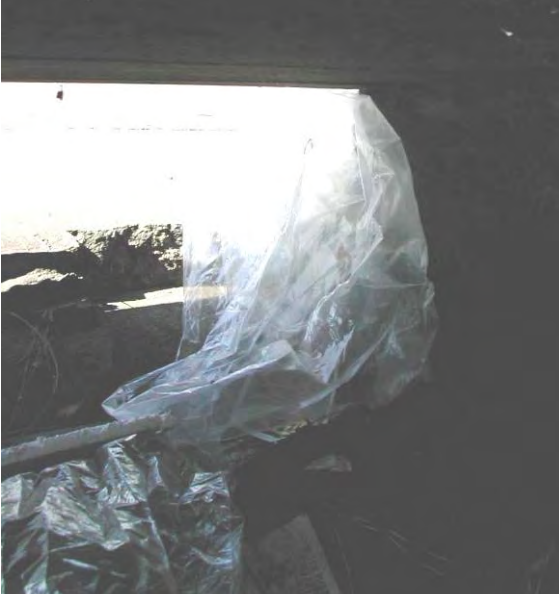
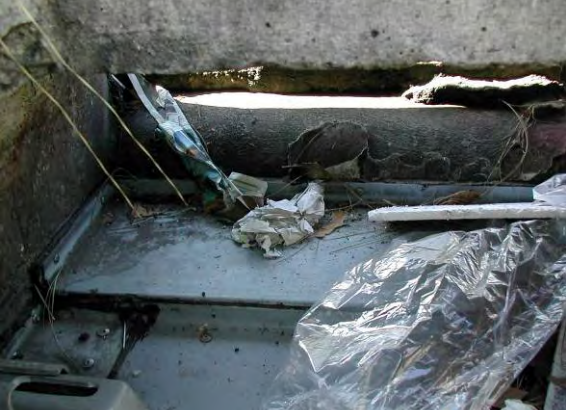
Site : FL-003-C	Location: 16th St. (Venice Blvd) & Main St. (Area 1 - Site J)	Curb-Inlet Basket

<p>Date inspected: 2/27/04</p> <p>Comments: Note the insert has been removed for laboratory testing and only the debris shelf and mounting brackets remain.</p>

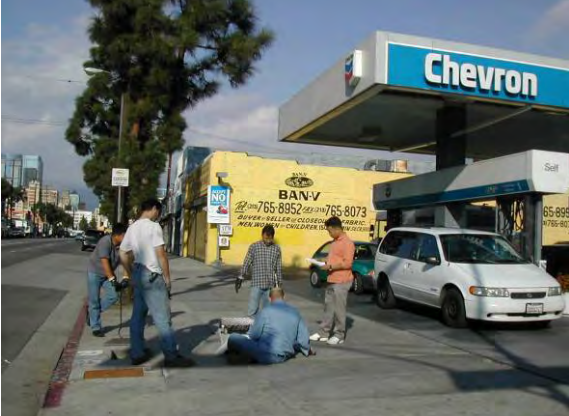
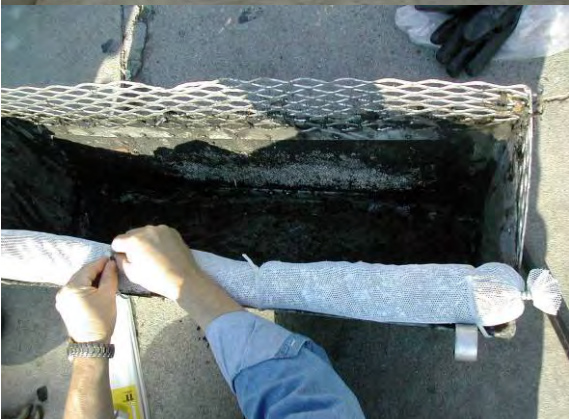
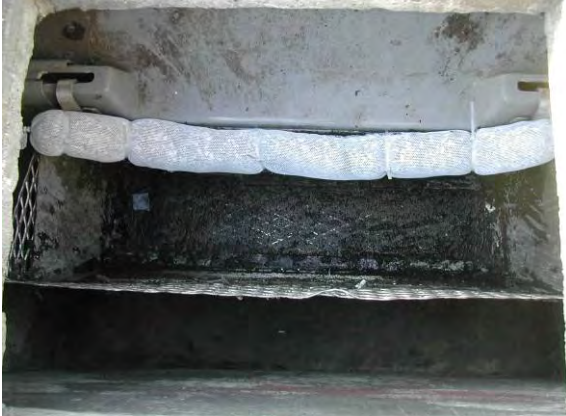
<p>Date inspected: 10/21/04</p> <p>Comments: The contents of this insert were removed and a new absorbent was installed in preparation for the wet season.</p>

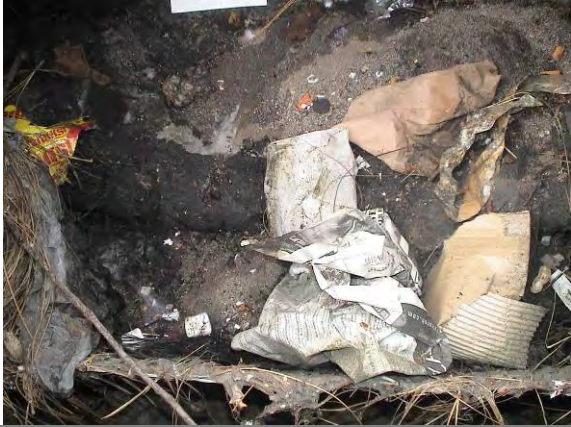
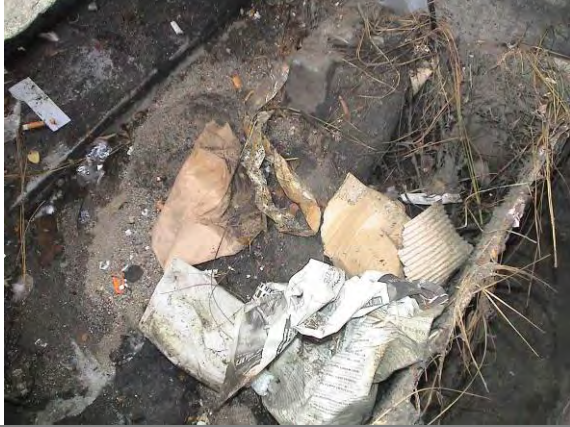
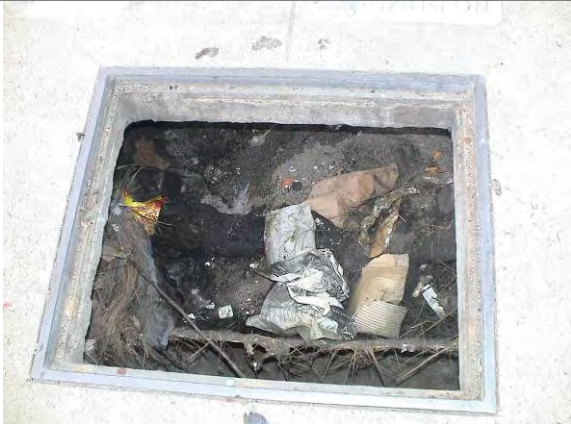
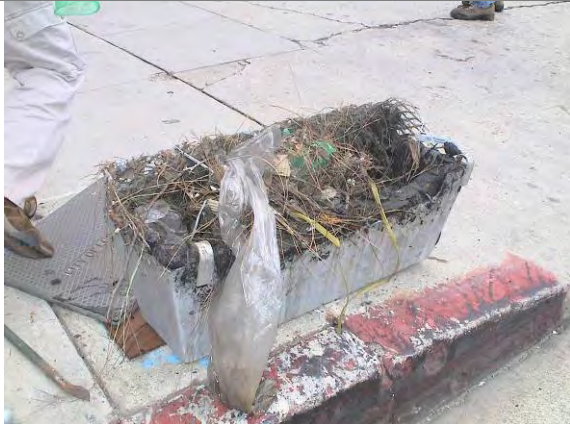
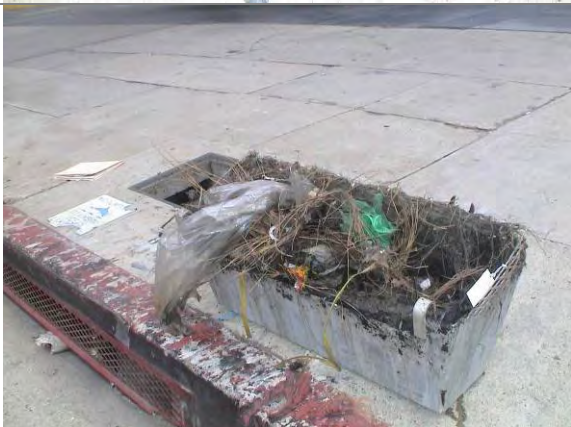
<p>Date inspected: 03/22/05</p> <p>Comments: Since the last visit this insert shows significant accumulation of pine needles and sediment. After this visit, this insert was taken to the laboratory for its final tests.</p>

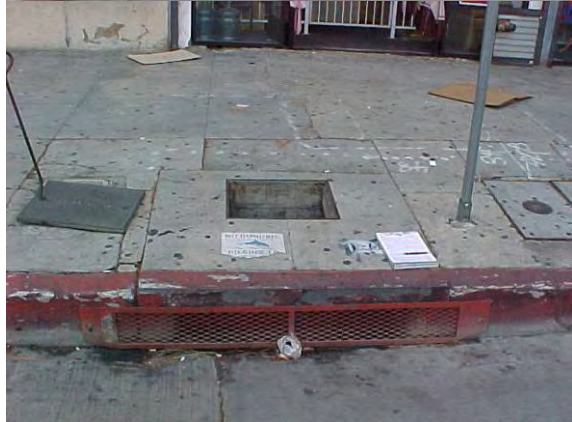
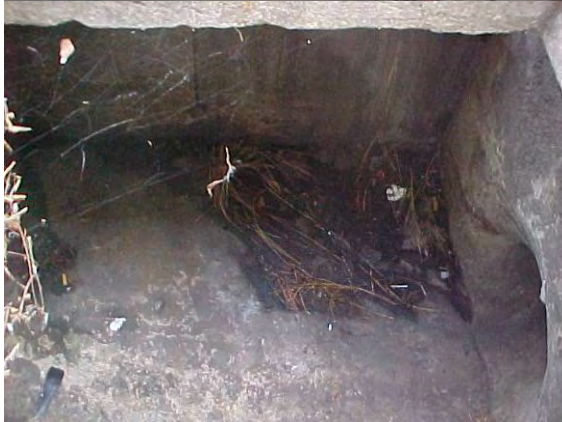
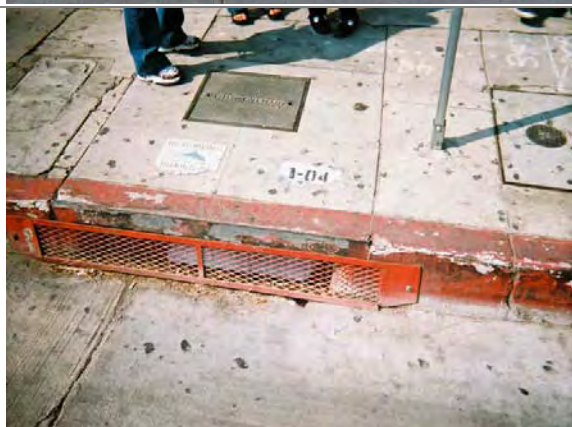
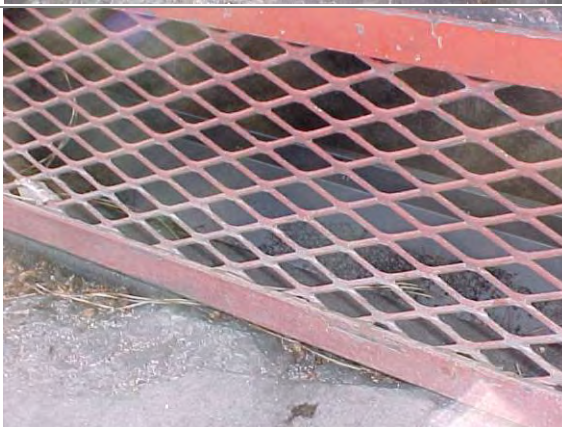
Date inspected:
12/10/03

Comments: Initial site visit. Top left photo is looking upstream; top right is looking downstream. Notice the inlet to this CB has an expanded metal screen, so that only small debris and sediment makes it into the CB.

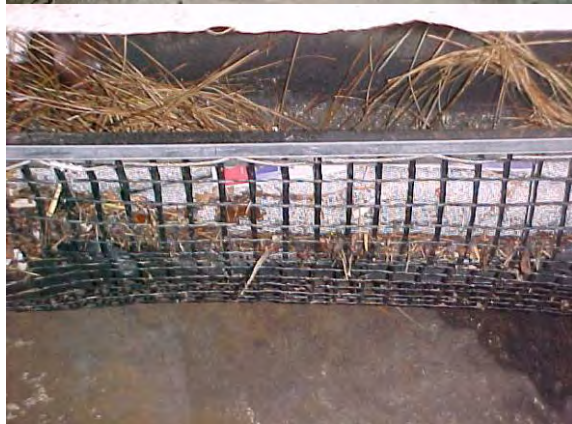
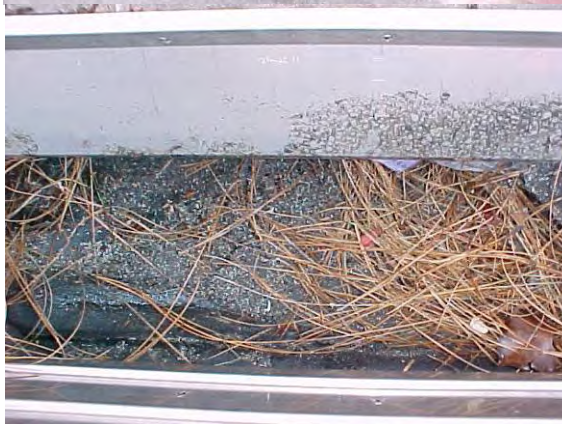
Date inspected:
2/4/04

Comments: This is the first site visit after installation. Notice the relative minor amount of sediment and debris in this insert - mostly pine needles and sand. The bottom of the catch basin is clean. This insert was removed from the CB and subsequently transported to the UCLA laboratory during this visit.

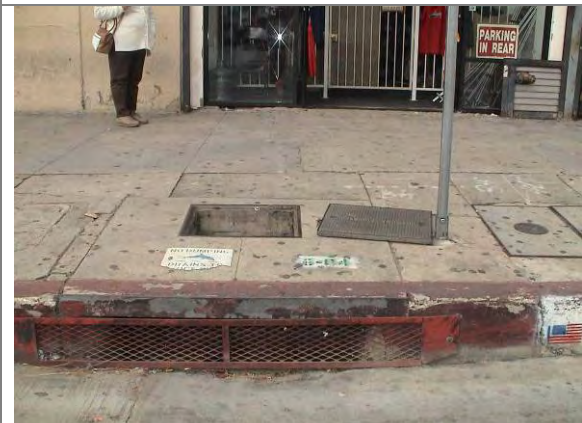
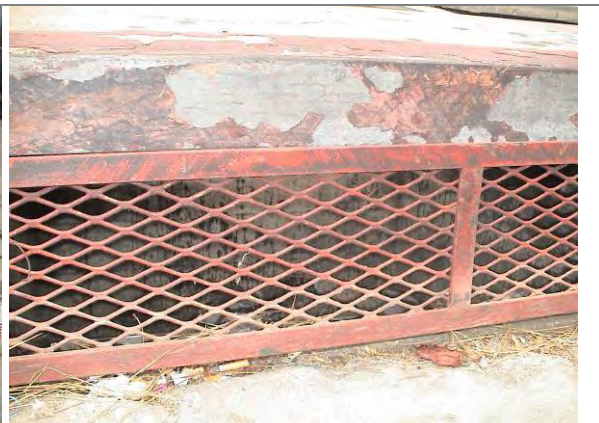
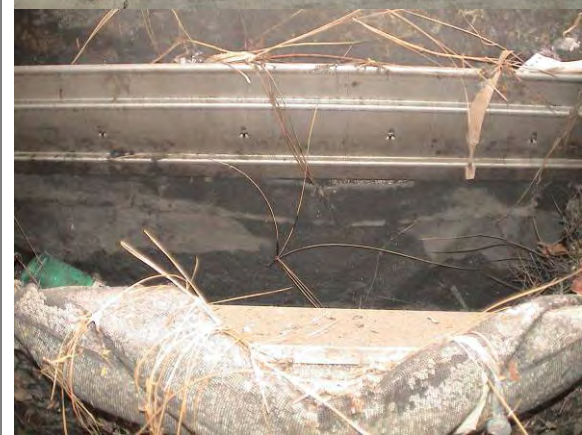
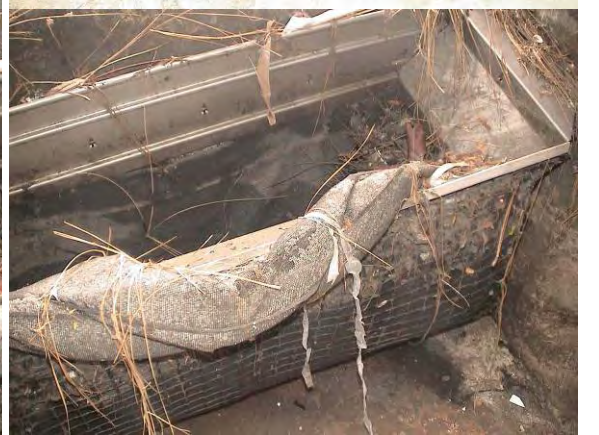
<p>Date inspected: 03/22/05</p> <p>Comments: As with many other sites with this insert, the absorbent media is sticking out of the insert. After this visit, this insert was taken to the laboratory for its final tests.</p>

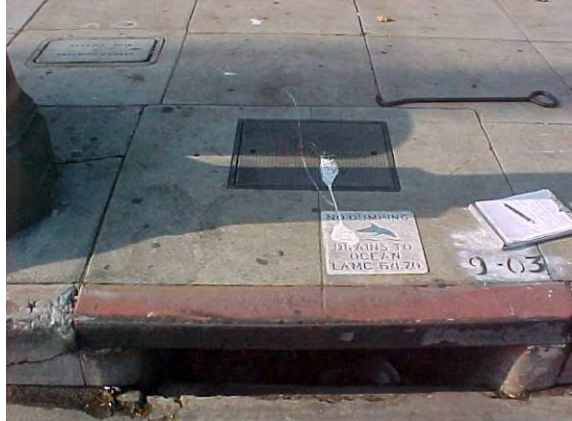
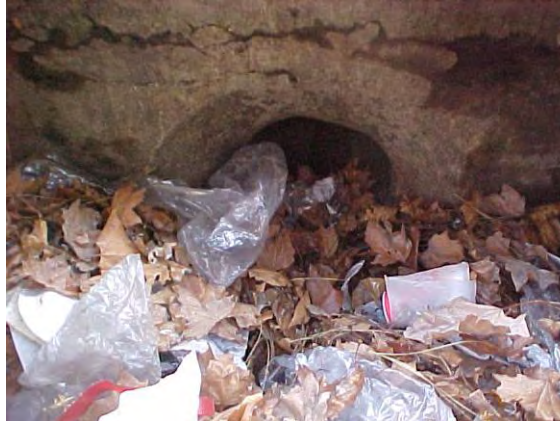
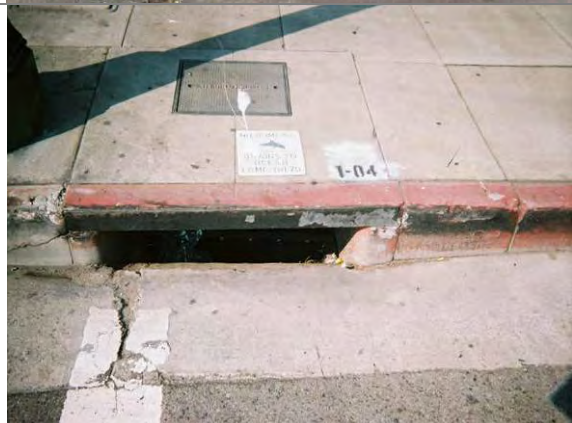
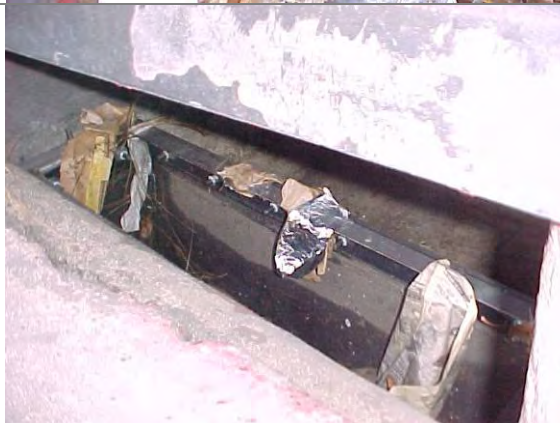
Date inspected:
12/10/03

Comments: Initial site visit. Top left photo is looking upstream; top right is looking downstream. This site apparently receives lots of leaf litter and street trash. Notice the outlet in the bottom photo is nearly clogged with debris.

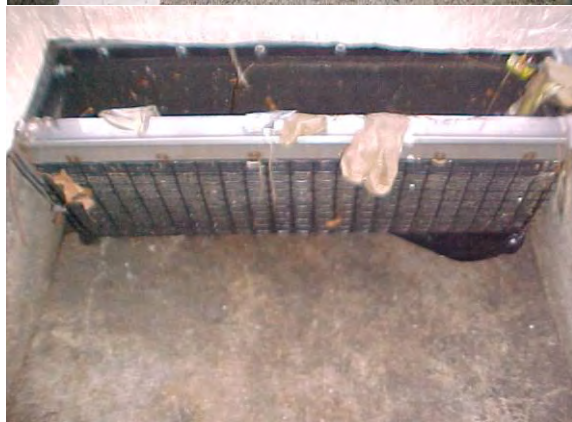
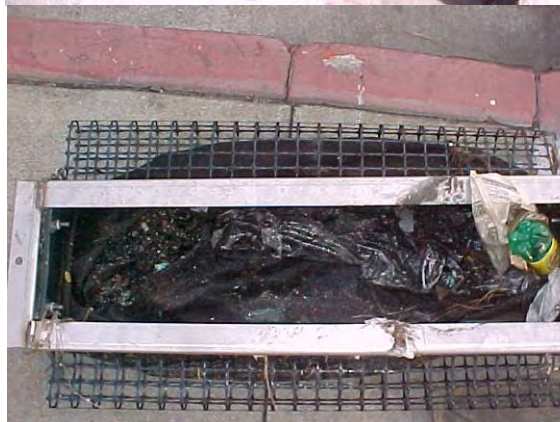
Date inspected:
2/4/04

Comments: This is the first site visit after installation and one rain event. Only a minor amount of debris was found in the insert. This insert was removed from the CB and subsequently transported to the UCLA laboratory during this visit.

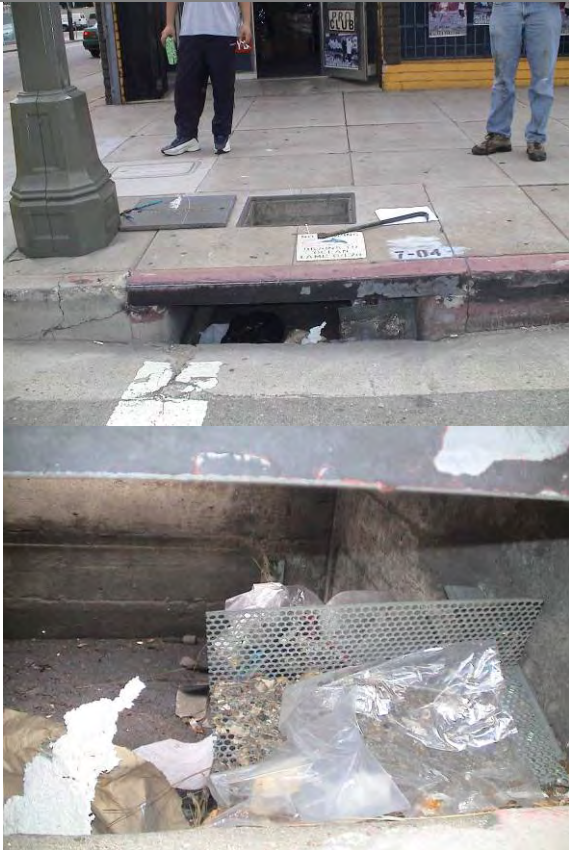
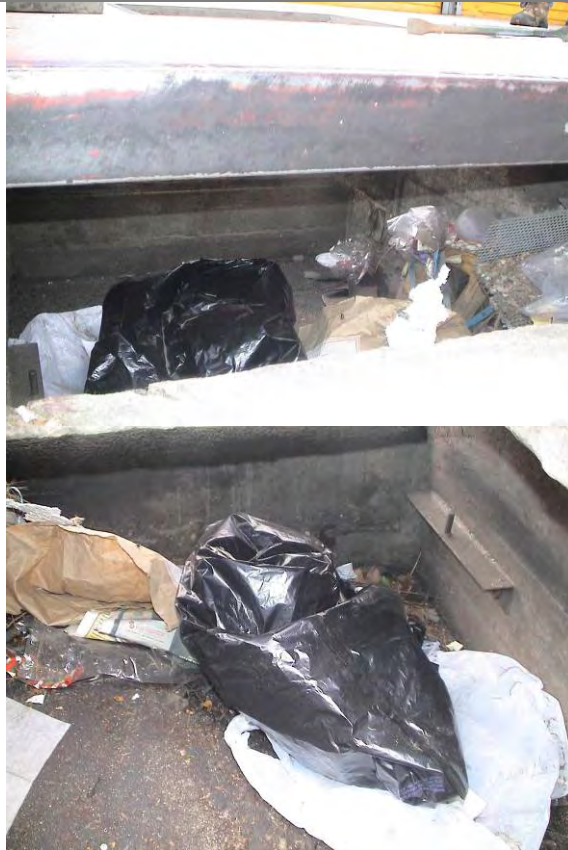
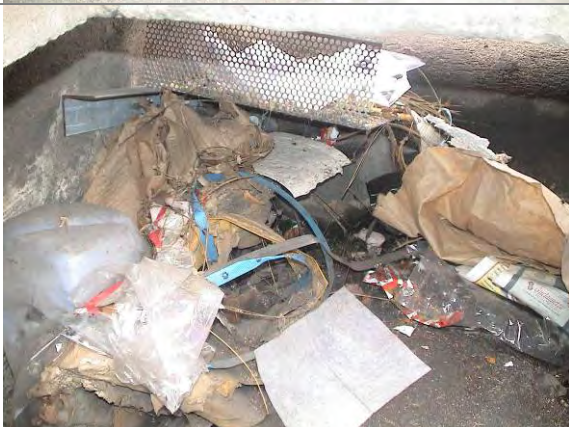
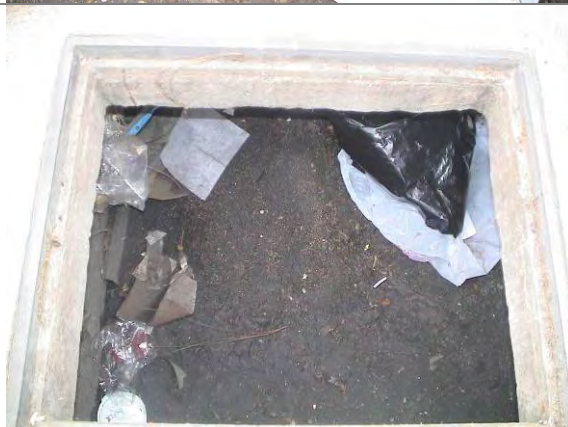
Date inspected:
03/22/05

Comments: After this visit, this insert was taken to the laboratory for its final tests.

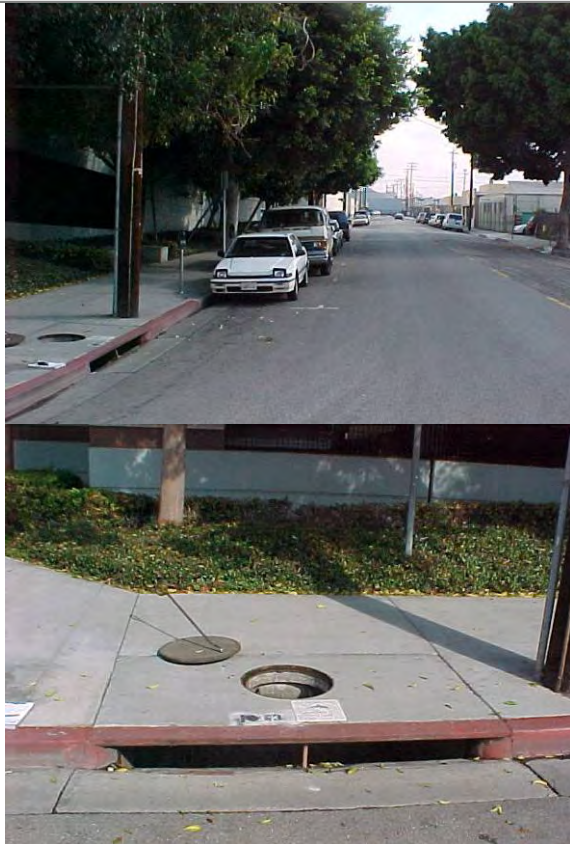
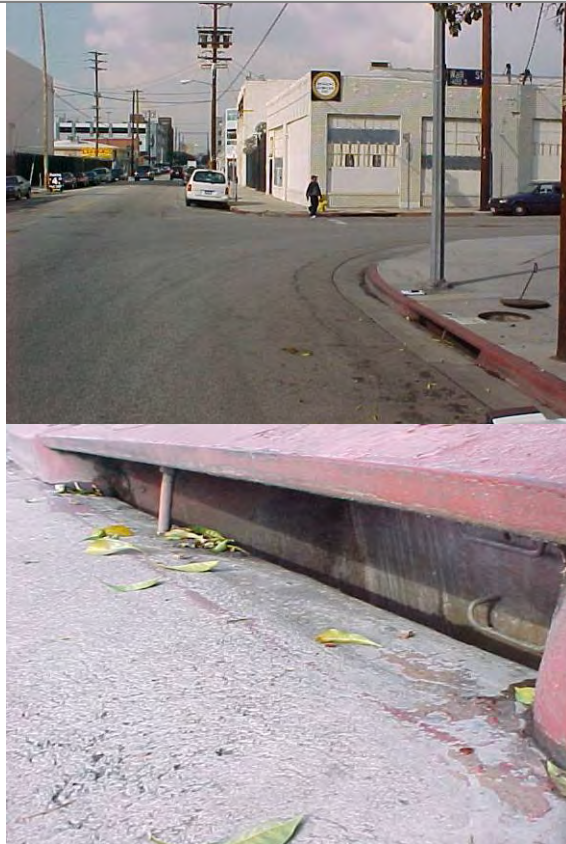
Date inspected:
12/10/03

Comments: Initial site visit. Top left photo is looking upstream; top right is looking downstream. This was originally an FL site, but was changed to a CC site because the inlet was 7' and the laboratory is set up for 3.5' wide inserts.
