CIWMB CATCH BASIN INSERT STUDY FINAL REPORT

USED OIL RESEARCH, TESTING, AND DEMONSTRATION GRANT

Grant Number URD3-02-0005

May 24, 2005

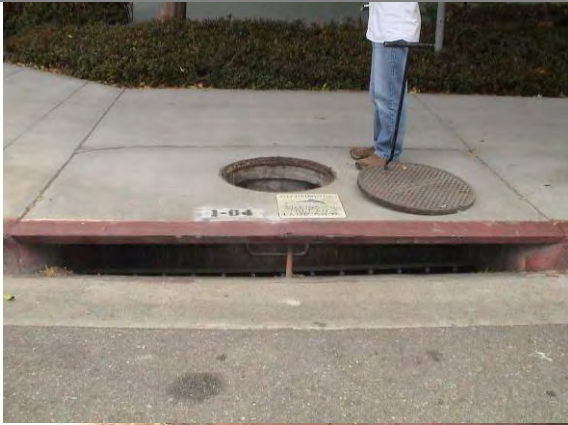
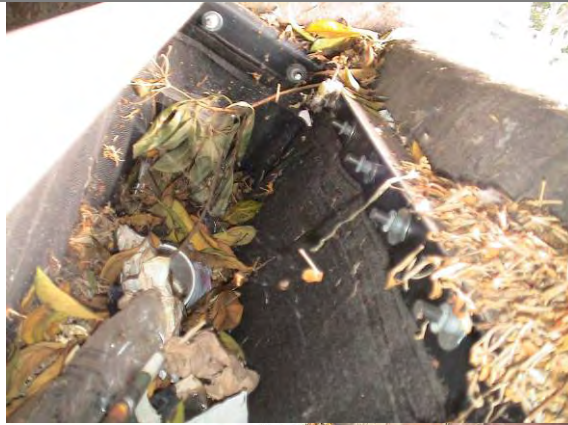
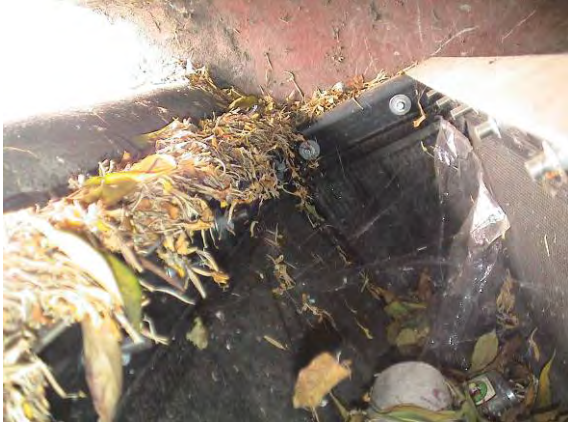
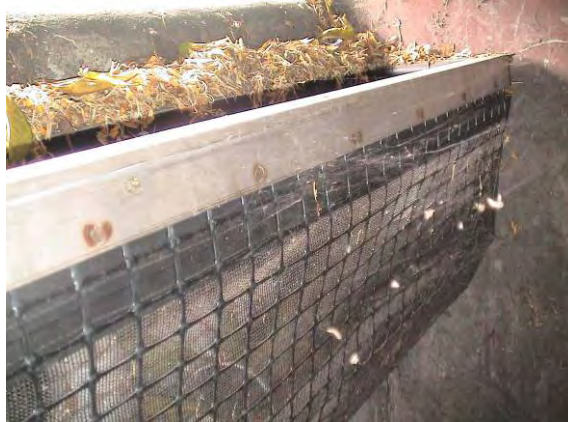
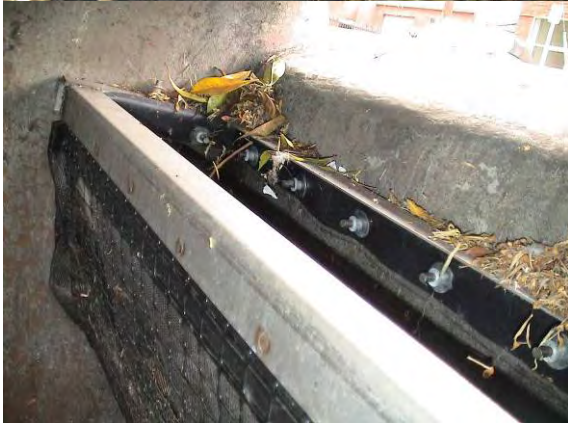
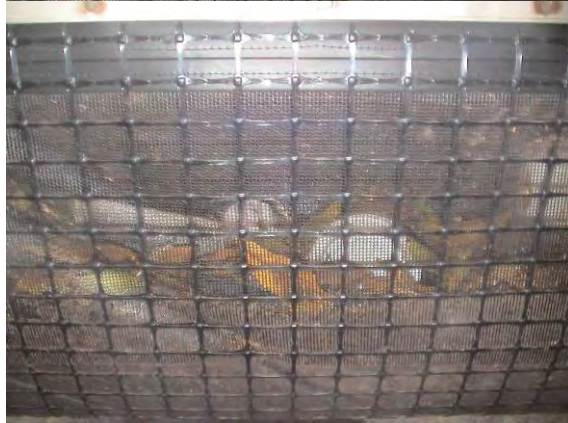
Site : CC-004-D Location: 15th and Wall St. (Area 1, Site K)	DrainPac

<p>Date inspected: 1/30/04</p> <p>Comments: Couple of days after installation. No debris inside of insert.</p>
       	<p>Date inspected: 3/23/04</p> <p>Comments: Still relatively clean since last visit; significant capacity remaining.</p>

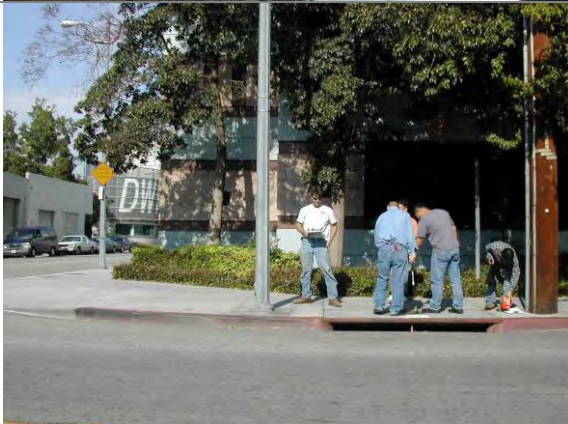
Date inspected:
6/30/04

Comments: This insert has not received much additional trash and debris since last inspection and is still well below capacity.

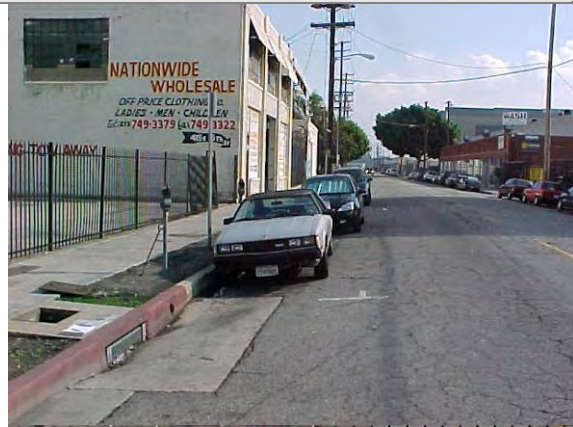
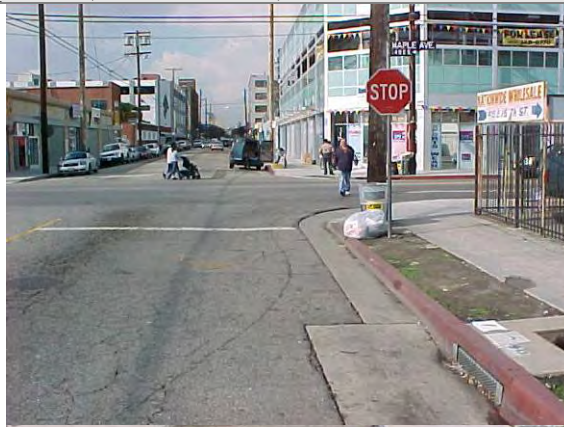
Date inspected:
10/21/04

Comments: As before, this site received a relatively small amount of debris. This site was retired after this visit.

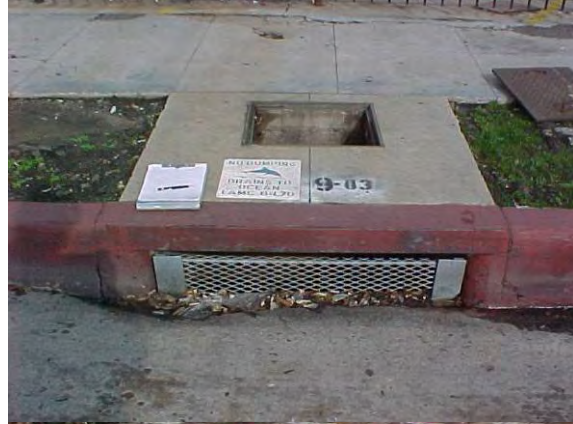
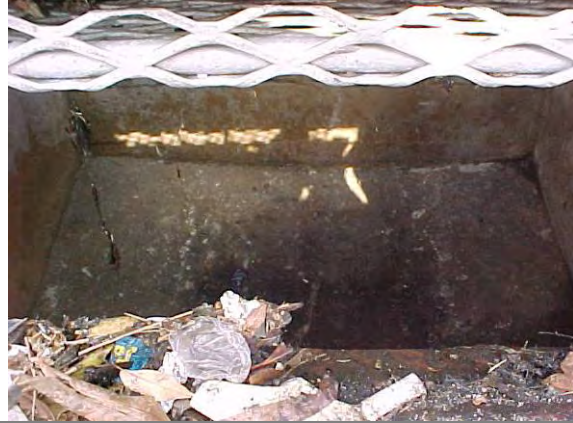
Date inspected:
3/23/04

Comments: This is the only site that already had a curb screen. Notice how clean the insert is with mostly only water and oil in the sedimentation chamber of the insert.

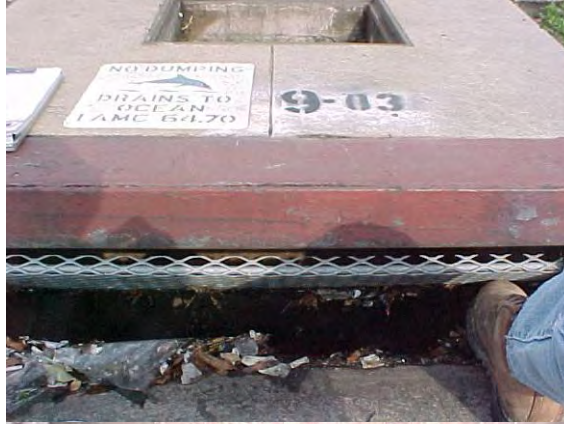
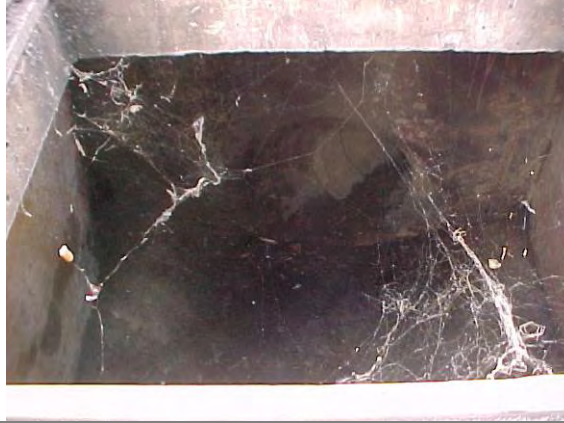
Date inspected:
12/10/03

Comments: Initial site visit. Top left photo is looking upstream; top right is looking downstream. Note that black widows were observed in this catch basin. This site originally was to be an FL site, but it was decided that the screen would not allow for a good comparison between technologies that do not have screens. The overburden of trash loadings now observed for nearly all of the sites indicates that sites with these screens may be among the best for evaluating the performance of catch basin inserts at removing fine sediment and oil and grease.

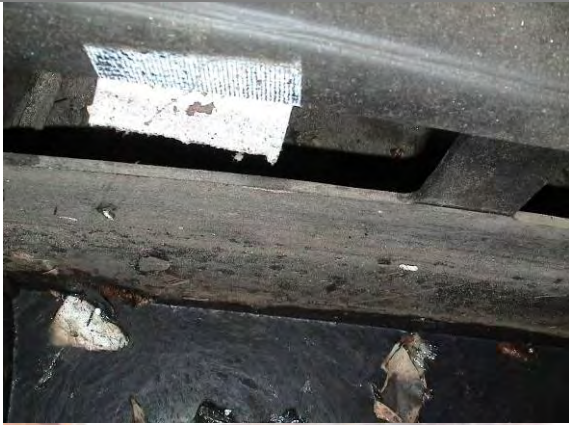
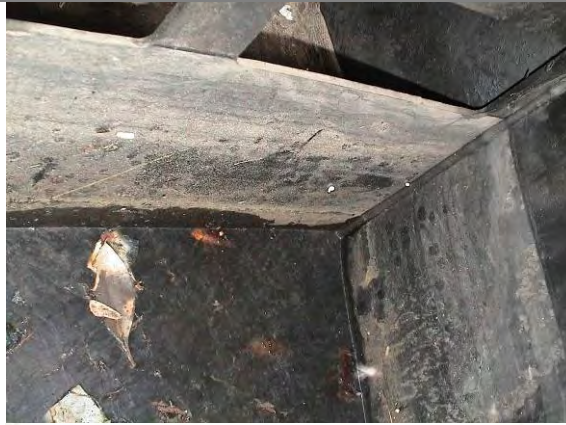
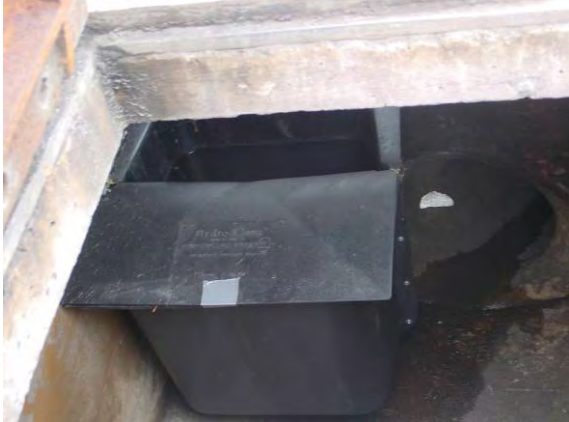
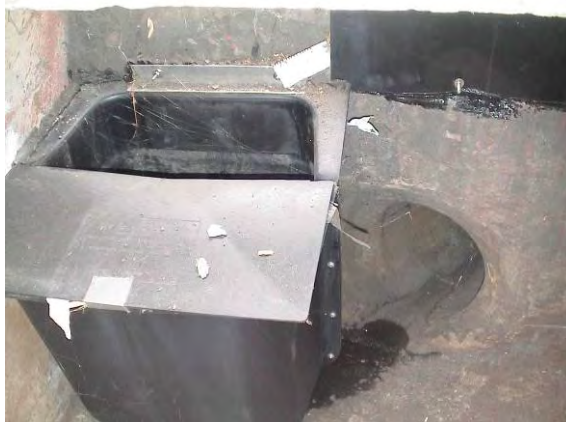
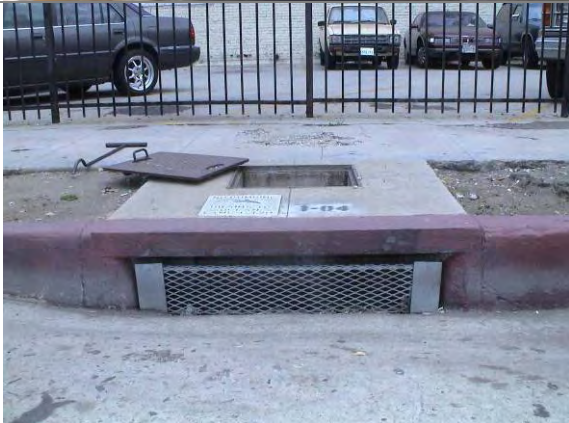
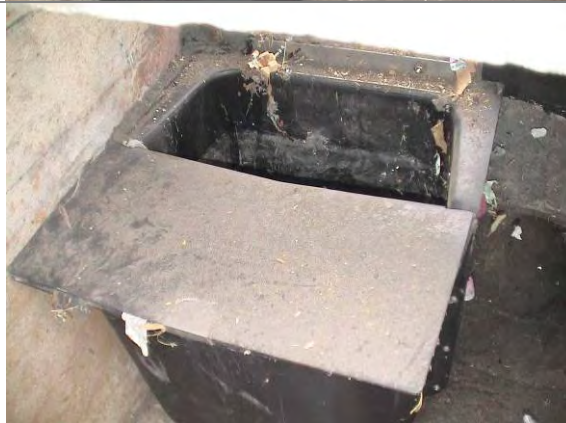
Date inspected:
6/30/04

Comments: This insert is still relatively clean and the standing water has nearly all evaporated. This indicates the curb side screen is a very effective method for keeping catch basin inserts in working order.

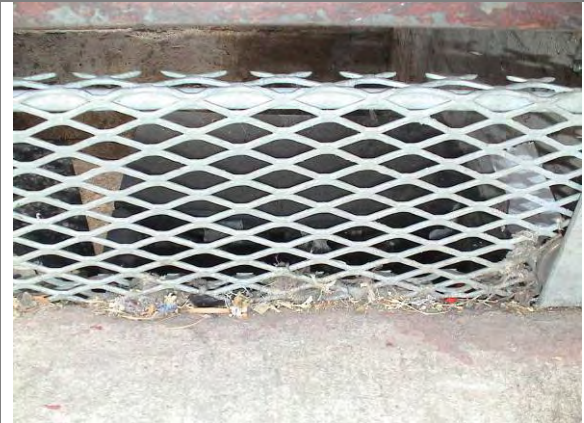
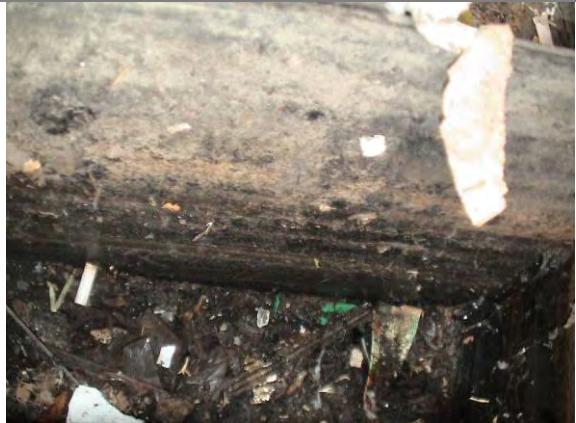
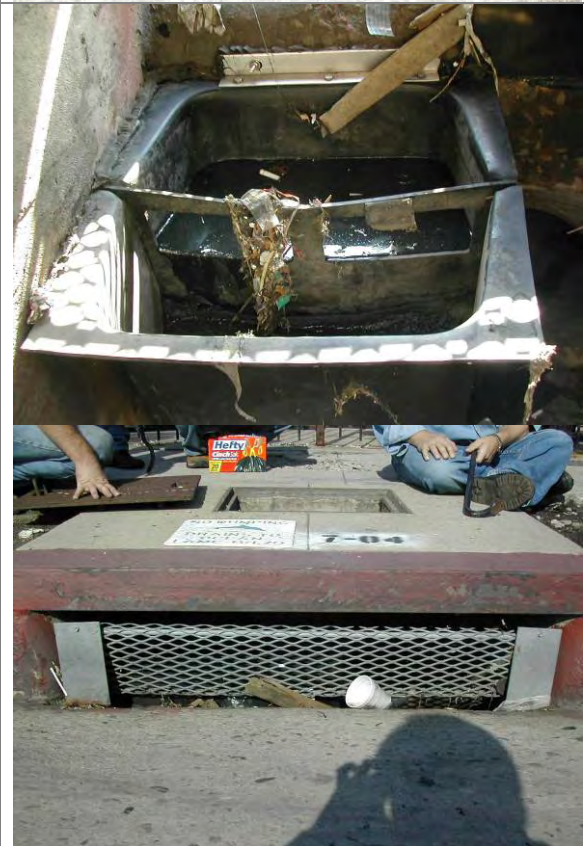
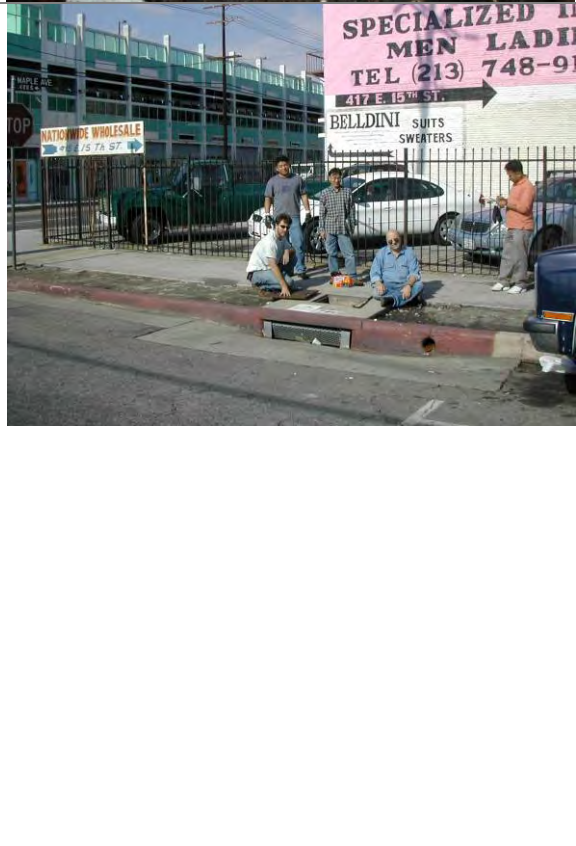
Site : CC-004-H	Location: 15th and Maple St. (Area 1, Site K)	HydroKleen

<p>Date inspected: 10/21/04</p> <p>Comments: As before, this site showed limited trash accumulation, indicating the effectiveness of the trash screen.</p>

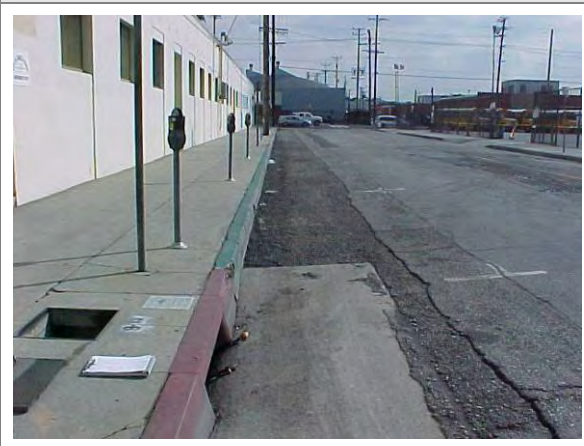
Site : FL-004-C	Location: 15th and San Julian St. (Area 1, Site K)	Curb-Inlet Basket

<p>Date inspected: 12/10/03</p> <p>Comments: Initial site visit. Top left photo is looking upstream; top right is looking downstream. This catch basin is located across the street from the LA Unified School District bus storage yard. Notice this catch basin is in-line with the</p>

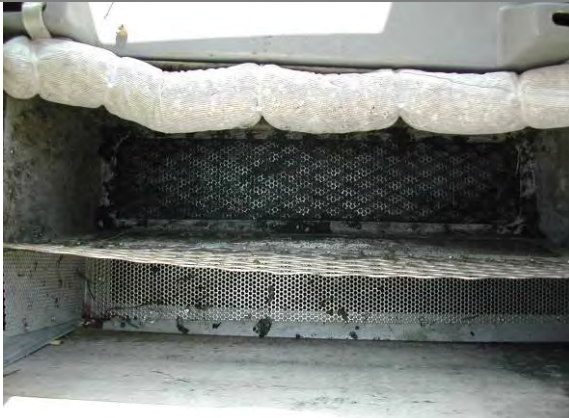
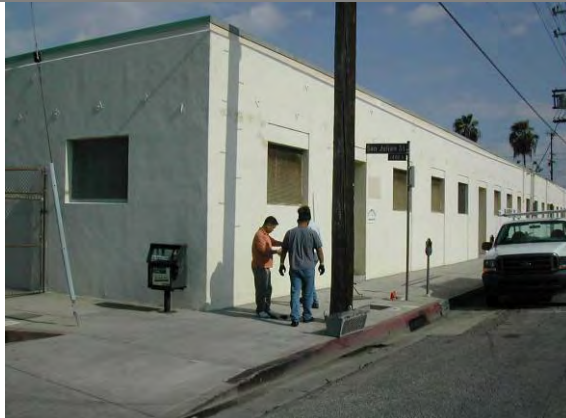
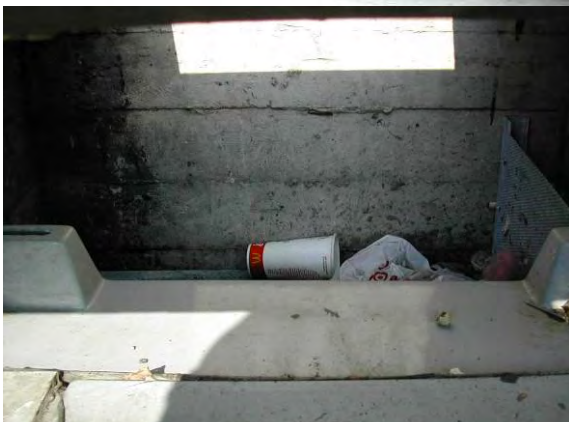
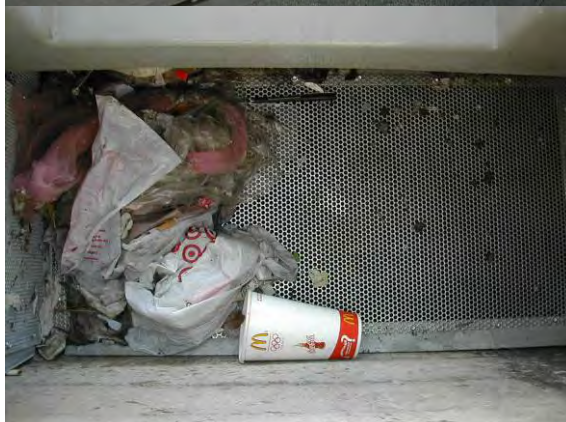
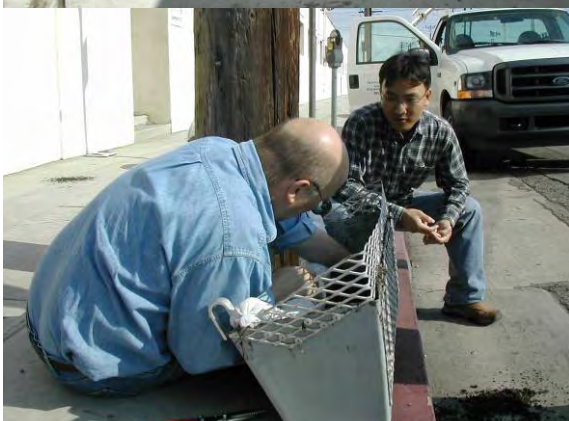
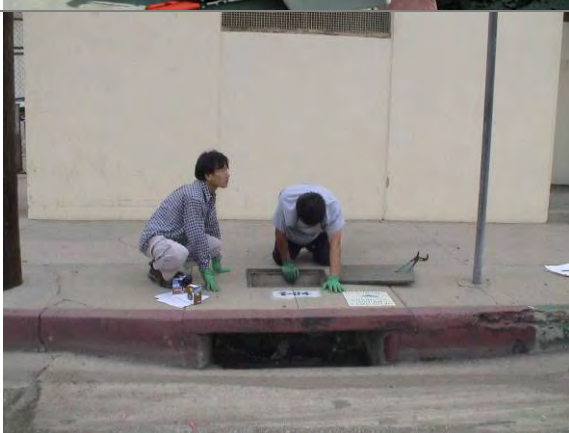
Site : FL-004-C Location: 15th and San Julian St. (Area 1, Site K)	Curb-Inlet Basket
 	<p>storm drain system (e.g., there are both inlet and outlet pipes) and there is evidence of dry-weather flows.</p>
 	<p>Date inspected: 2/4/04</p> <p>Comments: Couple of days after installation and one storm event. Notice the school bus parked in next to curb in the top right photo. This street gets lots of school bus traffic because the LACUSD properties nearby. The bottom left photo shows the shelf and mounting bracket of the insert after removal. The insert was subsequently taken to the UCLA laboratory for testing.</p>

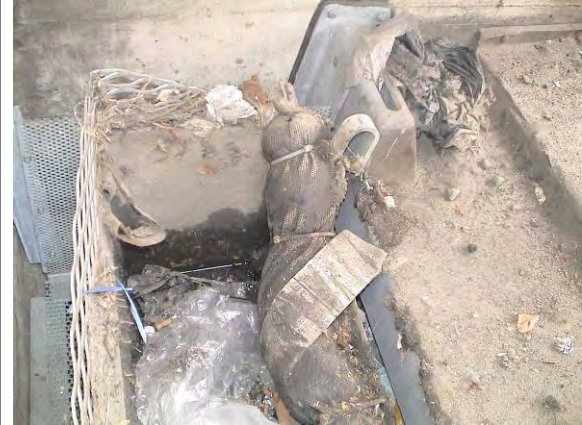
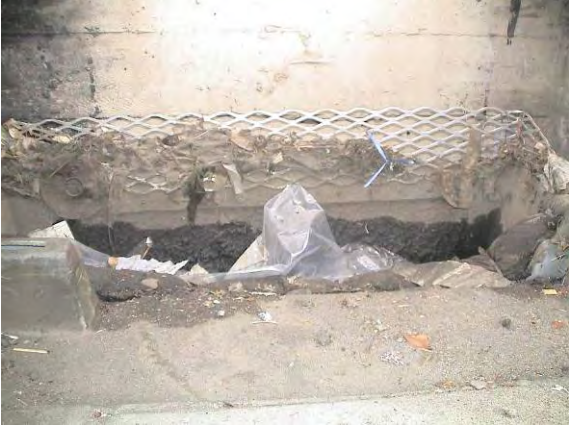
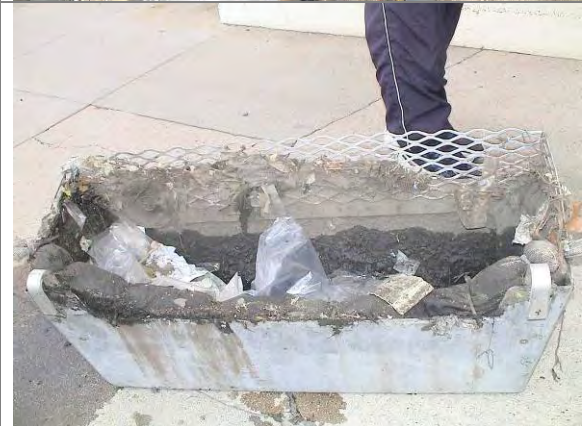
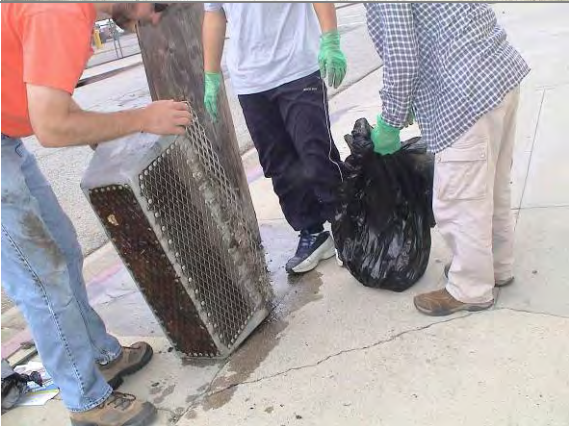
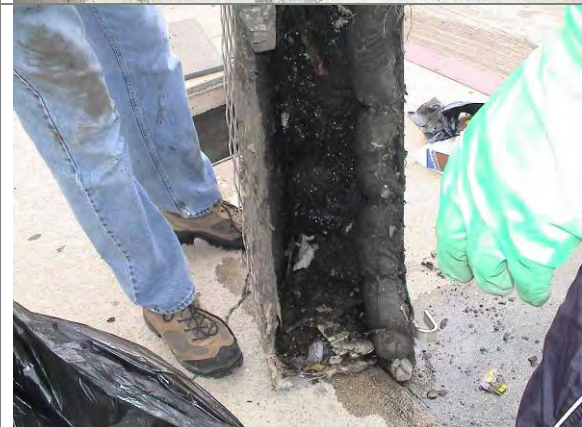
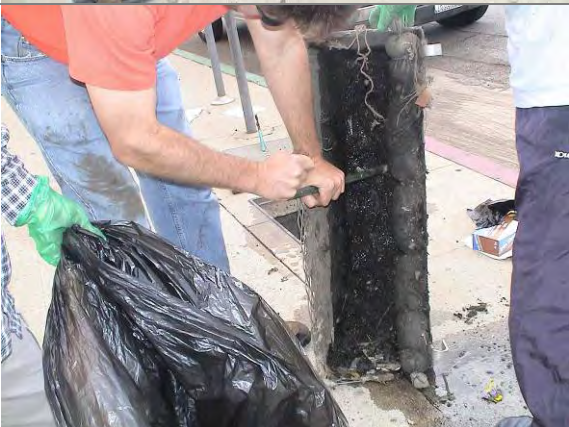
Date inspected:
10/21/04

Comments: During this inspection it was noted that the City had installed one of their complete capture devices. Luckily, our insert was compatible with this design and did not get removed.

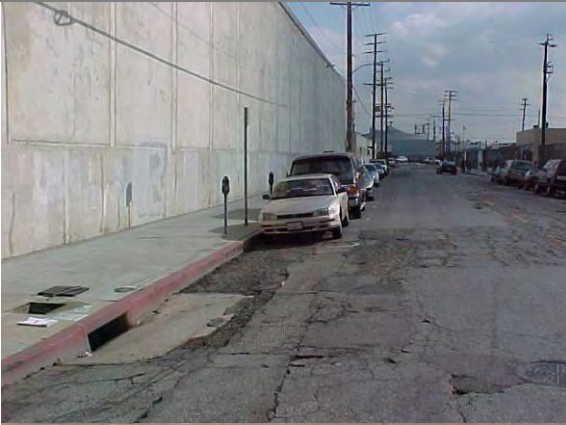
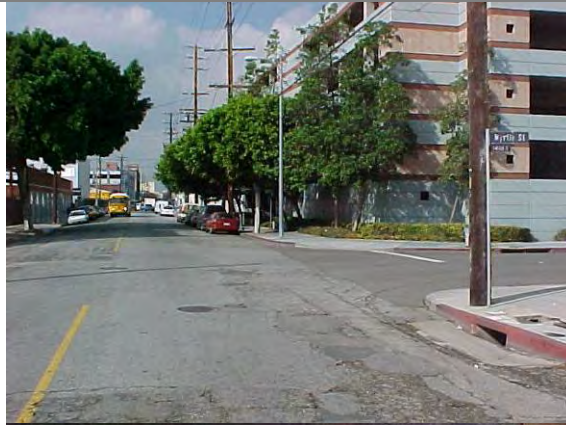
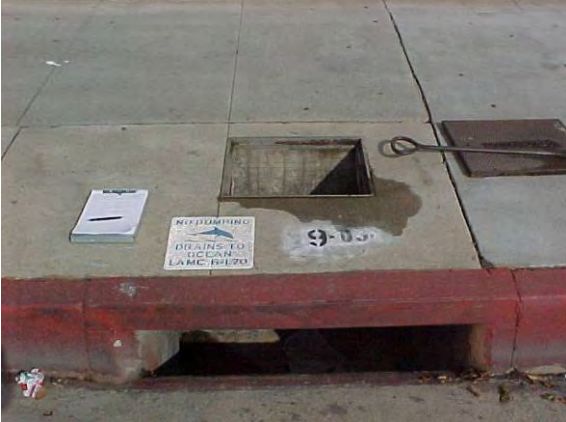
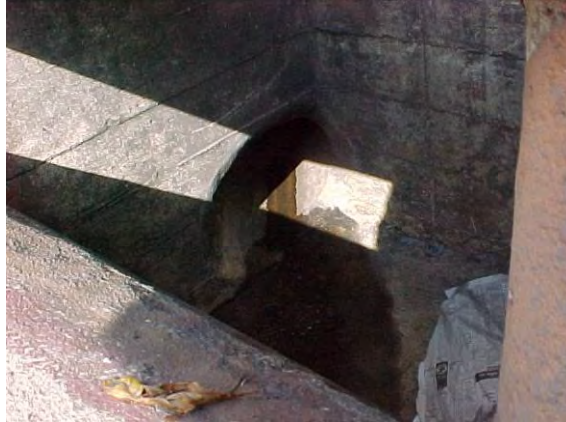
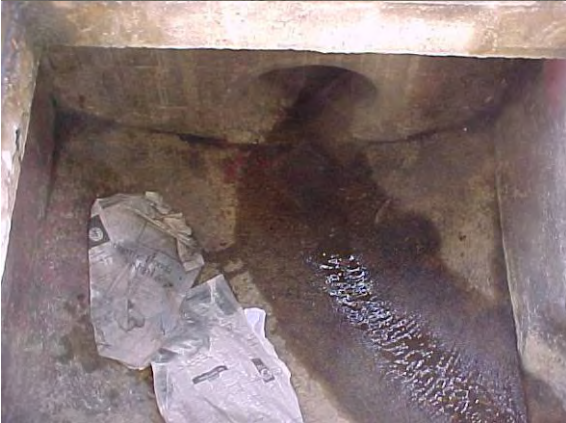
Date inspected:
12/10/03

Comments: Initial site visit. Top left photo is looking upstream; top right is looking downstream. This is an inline catch basin with a small amount of trash and minor dry weather flow.

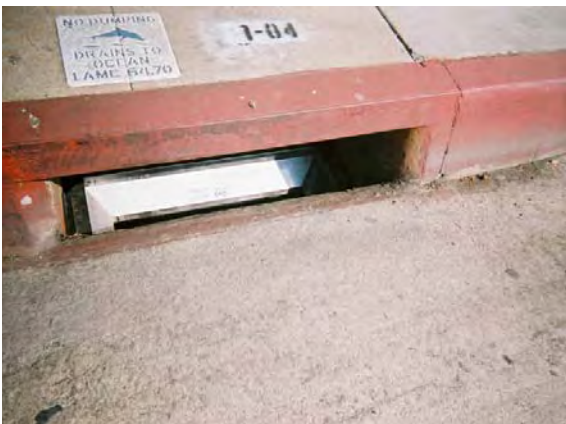
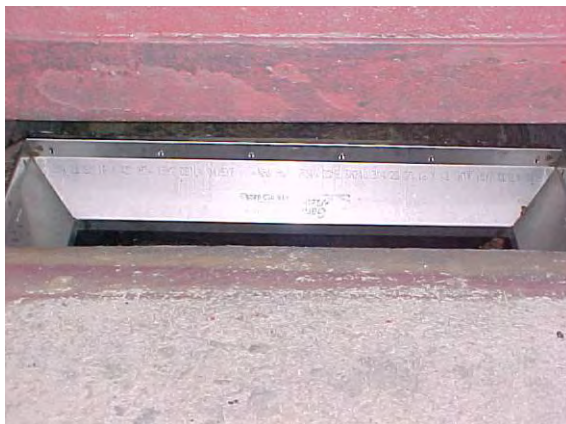
Date inspected:
2/4/04

Comments: First site visit after installation and one storm event. This catch basin appears to have only received a small amount of trash and debris. The insert was removed and subsequently transported to the UCLA laboratory for testing.

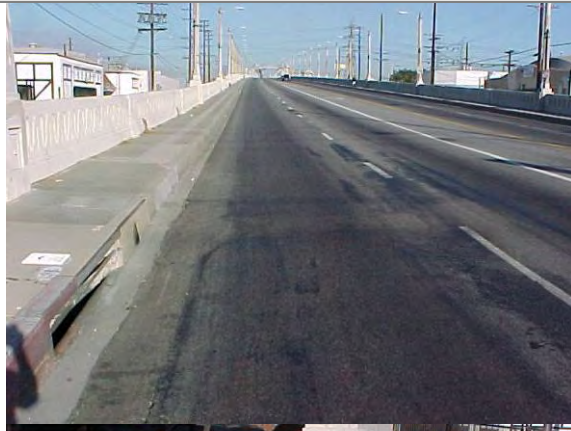
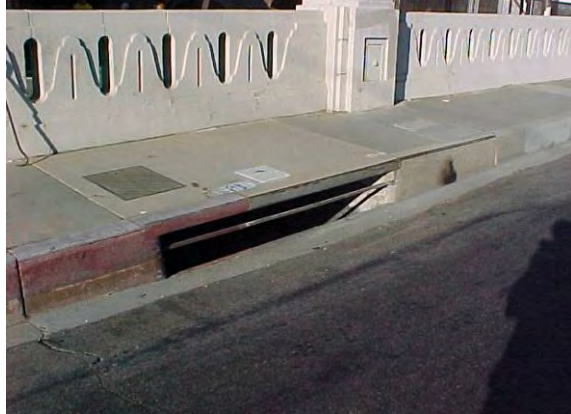
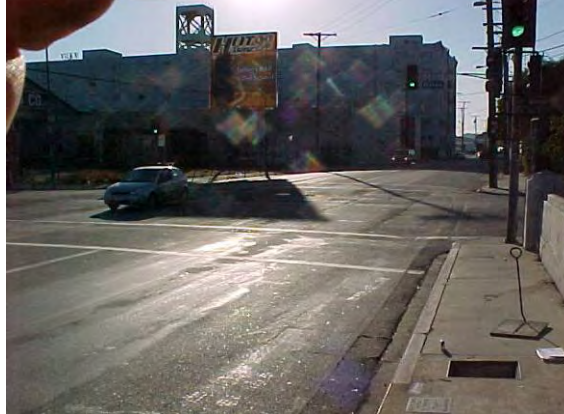
Date inspected:
10/24/03

Comments: Initial site visit. Top two photos are looking upstream; Middle left is looking downstream. Note all runoff to this site is roadway runoff.

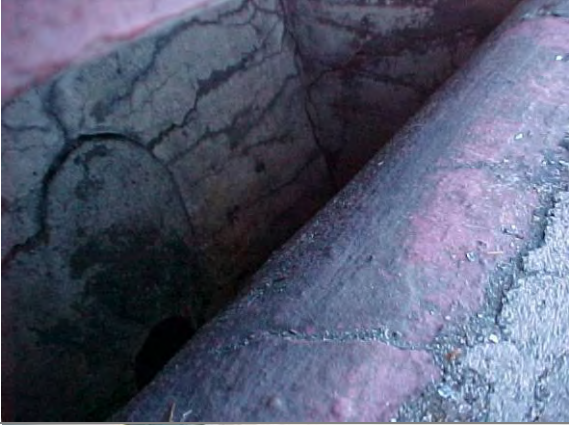
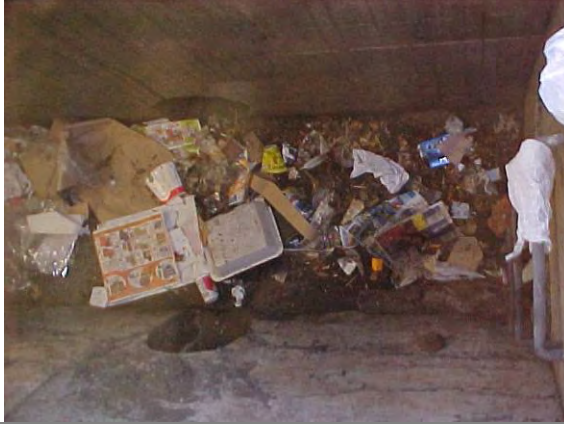
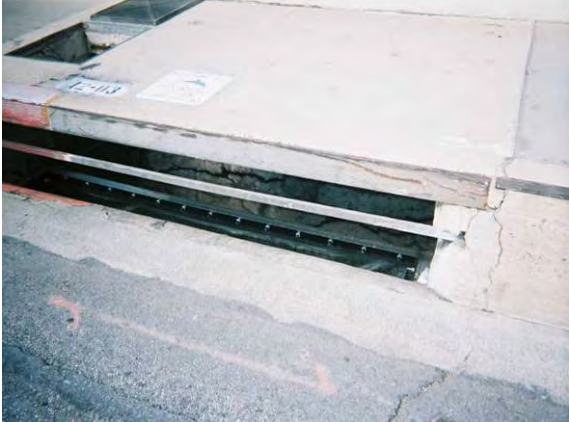
Date inspected:
2/4/04

Comments: This was the first site visit after installation. Some trash was present, but not nearly at capacity.

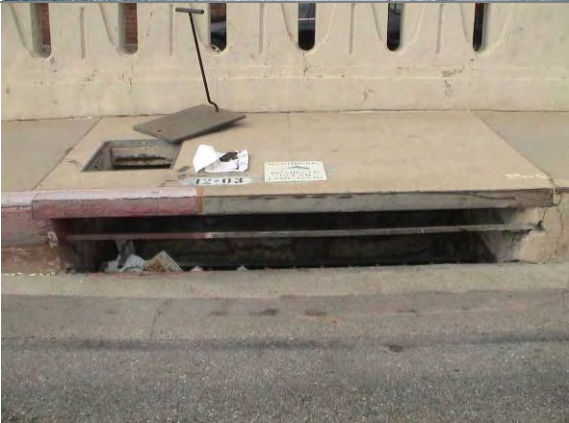
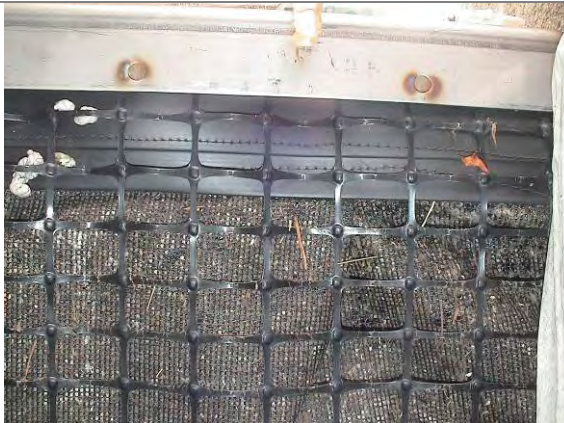
Date inspected:
3/23/04

Comments: Significant trash and debris captured in the insert since last visit. Appears to be at capacity and should be cleaned before the next wet season.

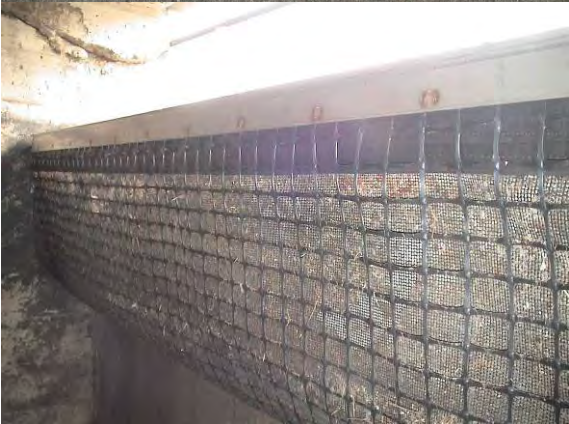
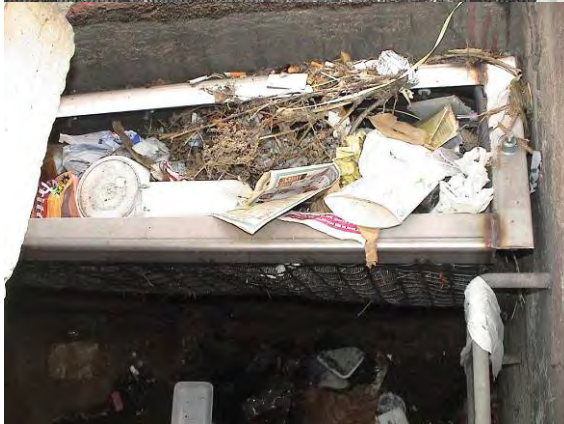
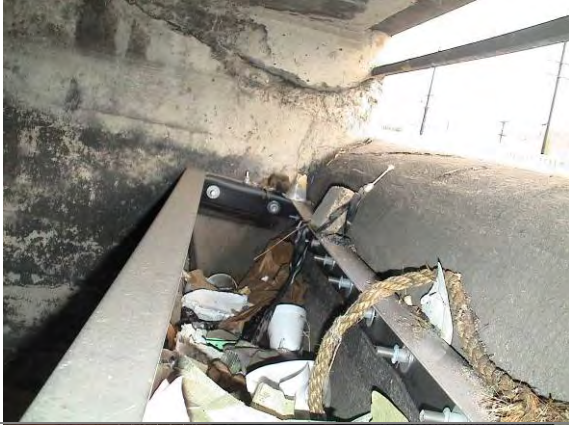
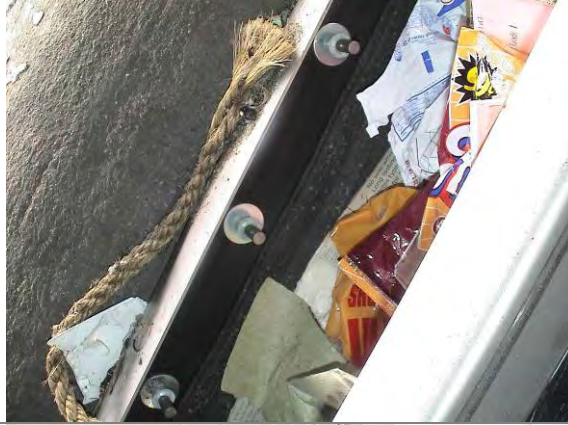
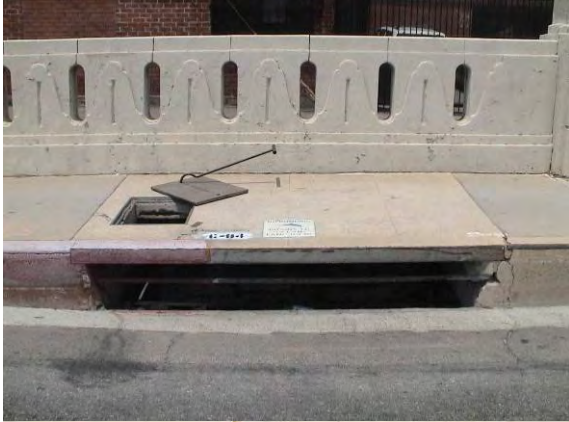
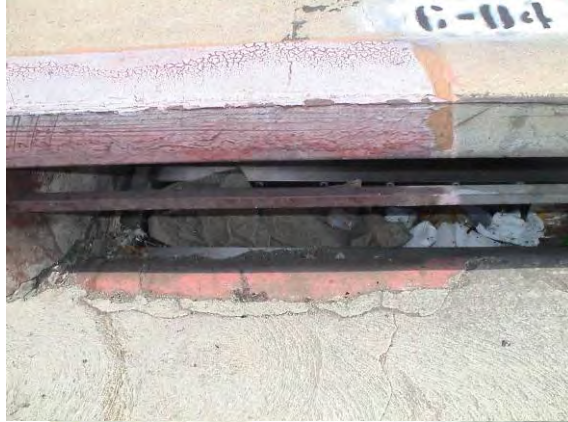
Date inspected:
6/30/04

Comments: More trash and debris have accumulated in this insert. It probably should be retired during the next site visit.

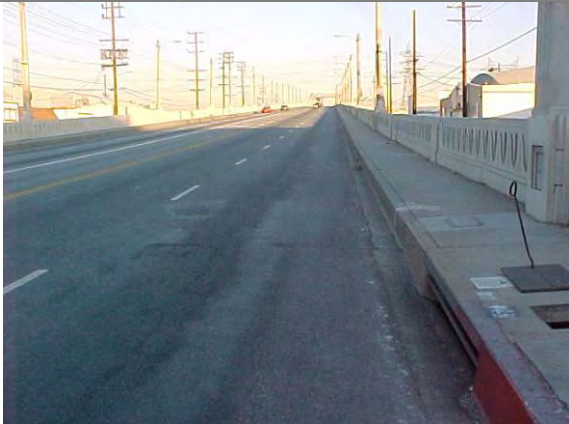
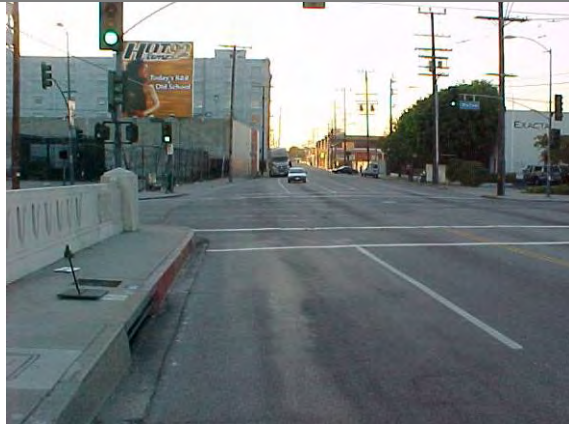
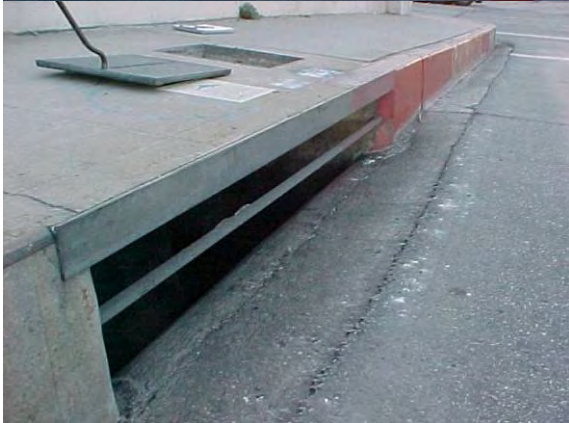
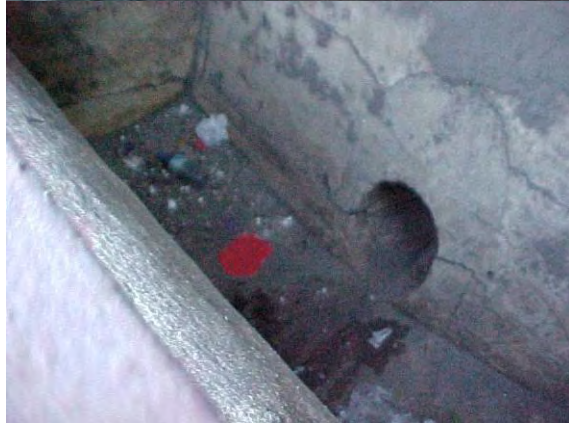
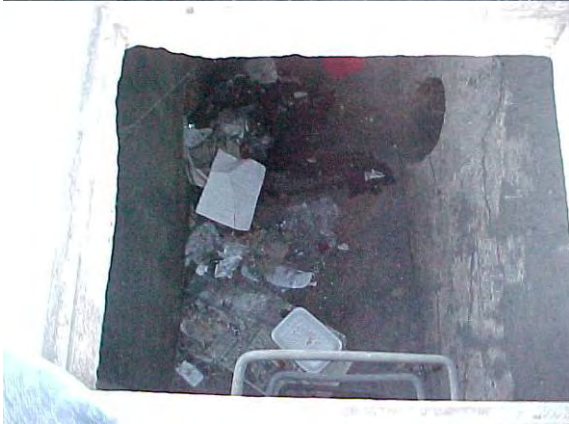
Date inspected:
10/24/03

Comments: Initial site visit. Top two photos are looking upstream; Middle left is looking downstream. All runoff to this site is roadway runoff. Notice the amount of trash deposited in the catch basin is much less than the catch basin across the street.

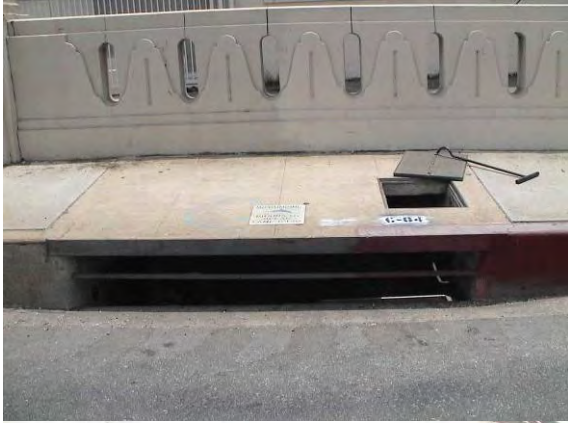
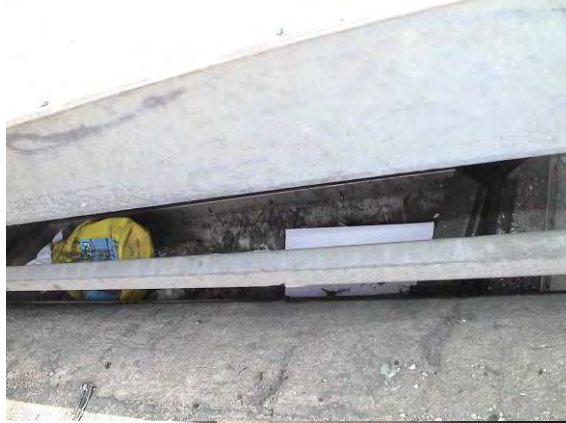
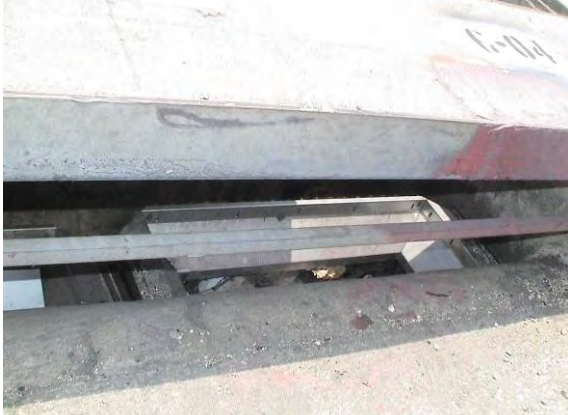
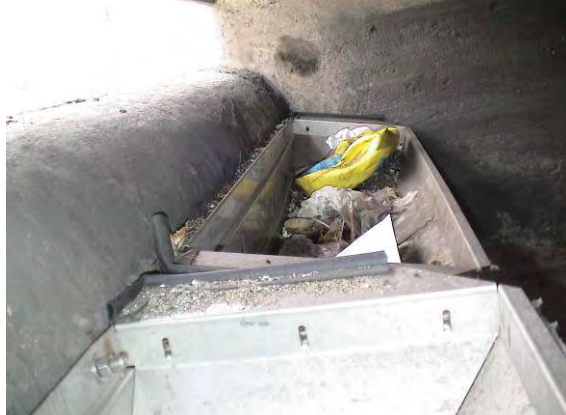
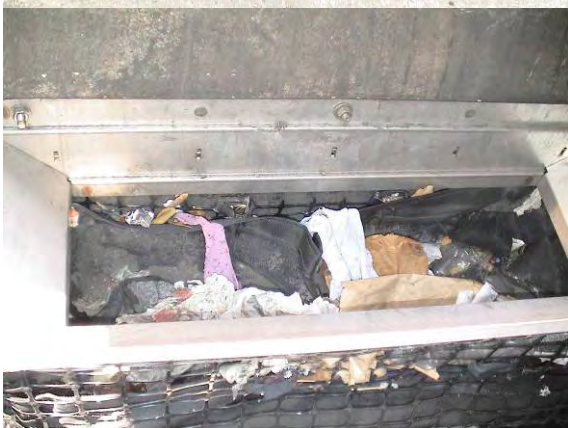
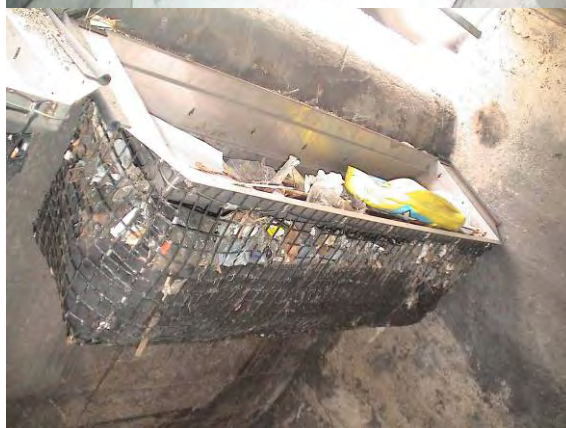
Date inspected:
6/30/04

Comments: Since the last visit, not much additional trash and debris have accumulated in the insert. Nonetheless, it is nearly at capacity and should be retired.

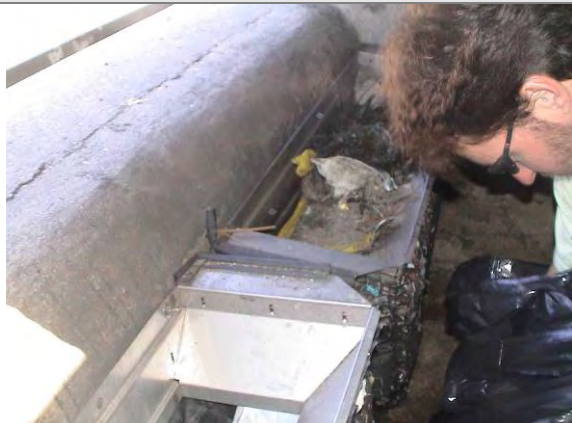
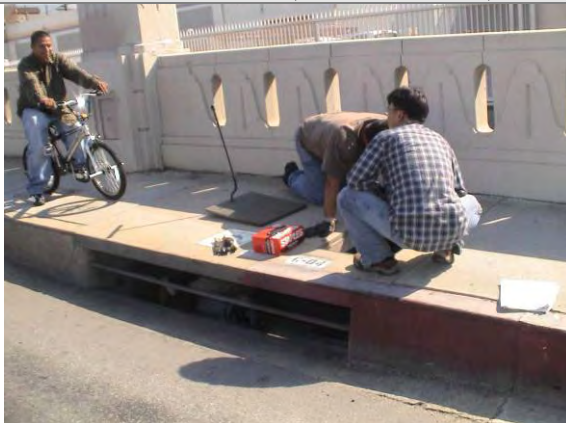
Date inspected:
10/22/04

Comments: As compared to the last visit, this insert appears to have been cleaned, but still a significant amount of debris had been captured.

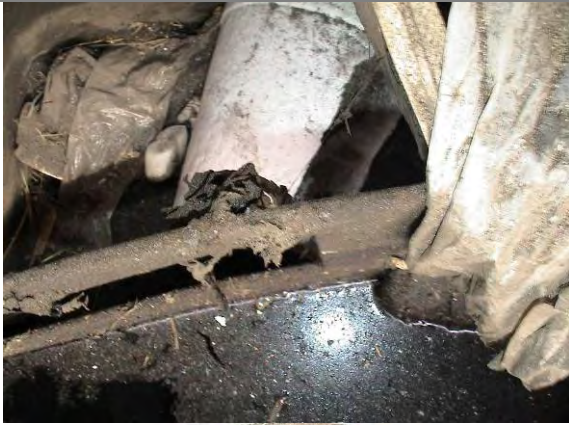
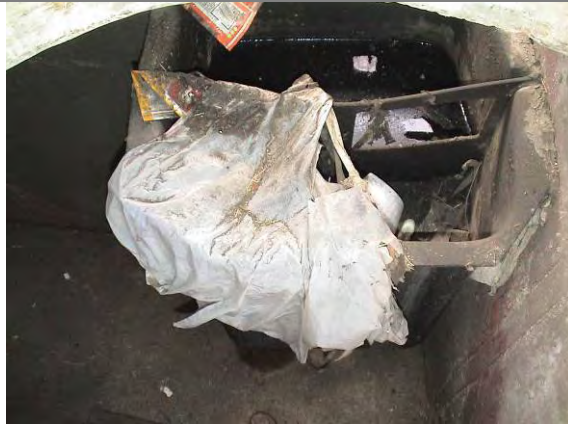
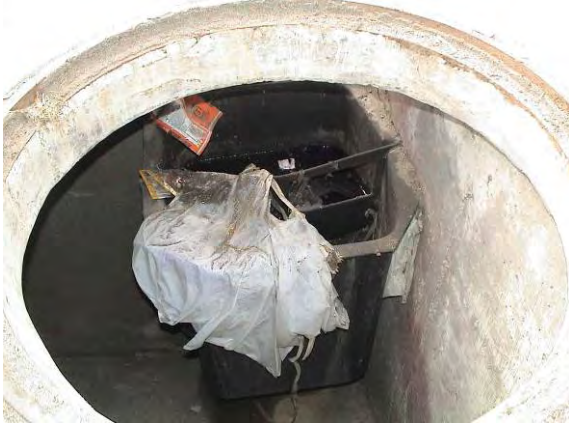
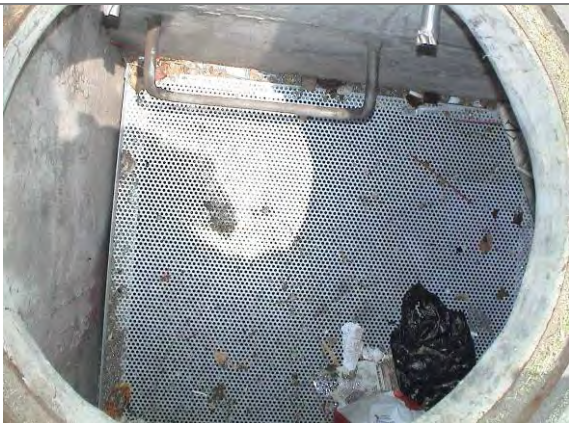
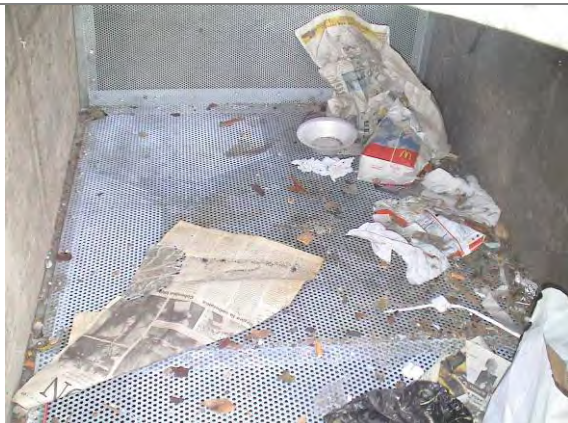
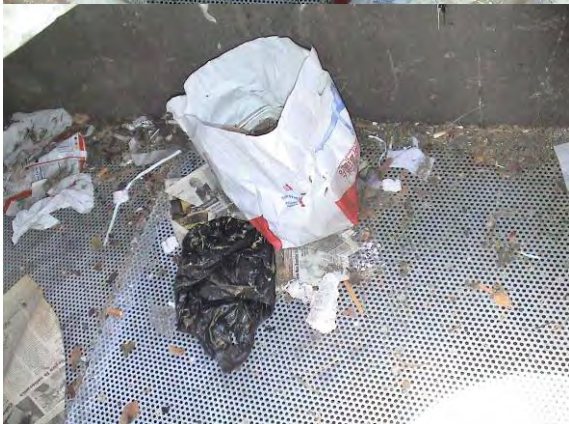
Site : CC-007-H Location: Santa Fe and Violet, South East Corner (Area 2 - Site M)	HydroKleen
 	<p>Date inspected: 2/4/04</p> <p>Comments: Two devices were placed in this catch basin to accommodate the larger opening. It appears runoff is reaching both inserts, but the floatable debris is accumulating more on the upstream end (top left photo).</p>
 	<p>Date inspected: 3/23/04</p> <p>Comments: Evidence of by-pass shown by plastic bag hanging over the top of the insert.</p>

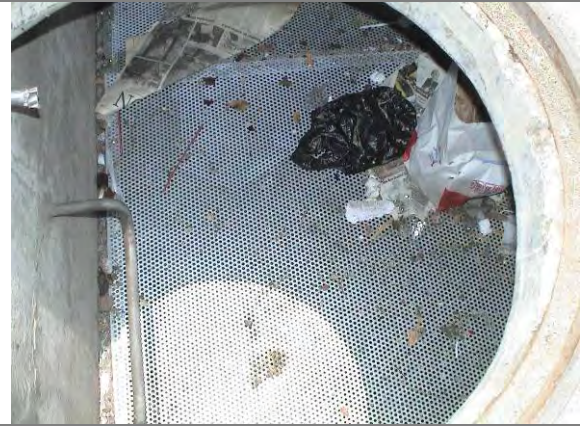
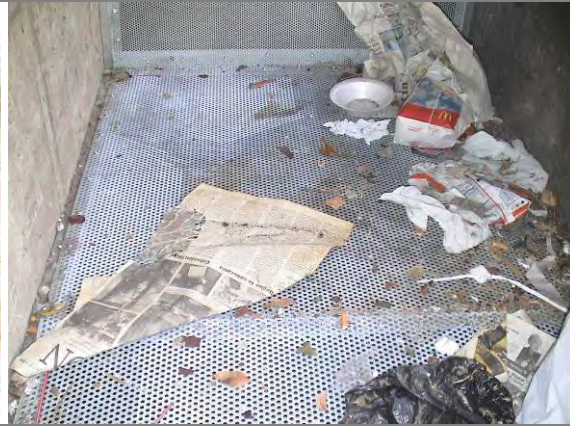
Date inspected:
6/30/04

Comments: Without our knowledge, the insert has been removed and replaced with this trash screening device by the City. Wing Tam is trying to locate our insert so that we can take it to the UCLA laboratory for its final analysis.

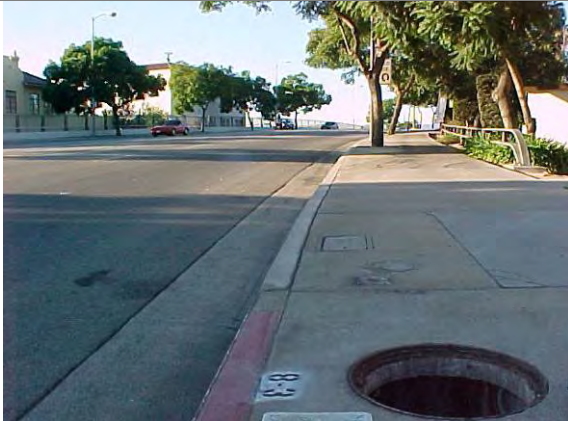
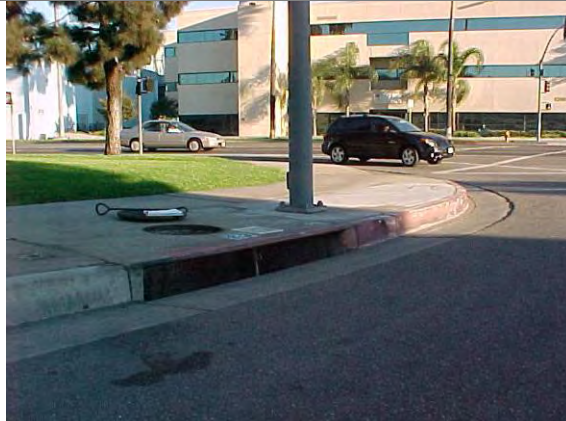
Date inspected:
10/20/03

Comments: Initial site visit. Top left photo is looking upstream; top right is looking downstream.

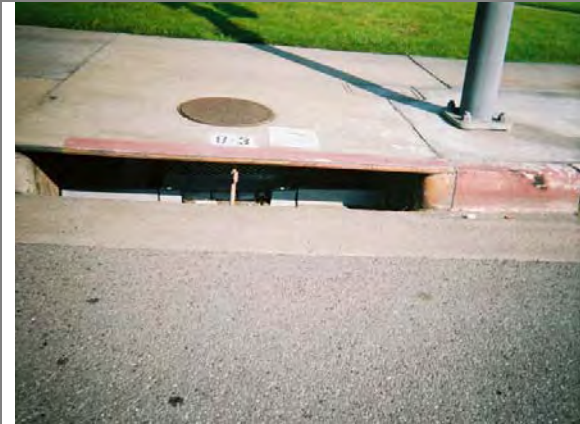
<p>Date inspected: 2/4/04</p> <p>Comments: This visit was shortly after installation.</p>
       	<p>Date inspected: 3-23-04</p> <p>Comments: Sediment and pine needle debris have completely filled this insert. However, there is no evidence of clogging or significant bypass.</p>

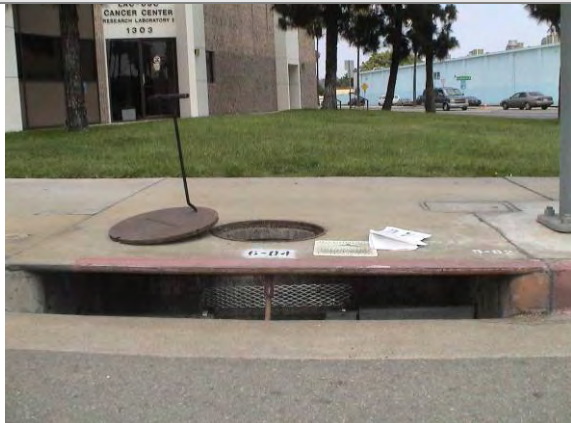
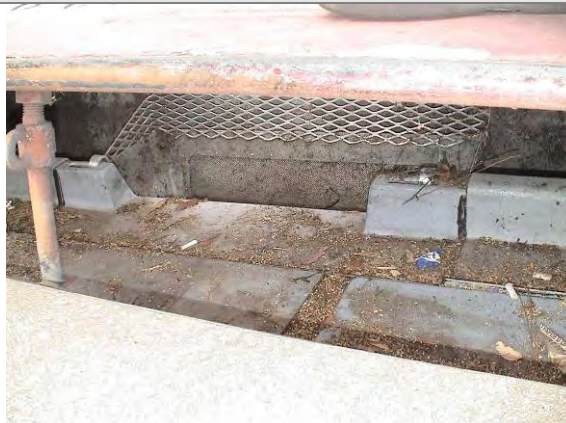
Date inspected:
6/30/04

Comments: This insert has recently been cleaned. Notice the absorbent boom is no longer present; probably due to vactor truck.

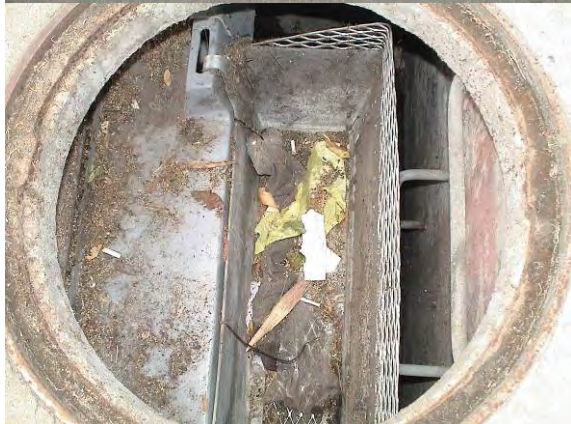
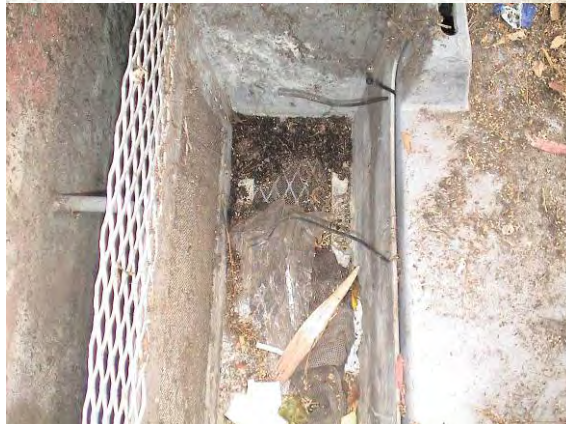
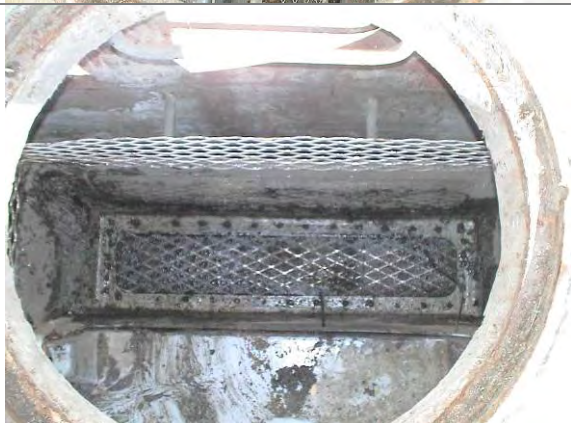
Date inspected:
10/22/04

Comments: This insert appears to have been recently cleaned and the absorbent boom removed.
