CIWMB CATCH BASIN INSERT STUDY FINAL REPORT

USED OIL RESEARCH, TESTING, AND DEMONSTRATION GRANT

Grant Number URD3-02-0005

May 24, 2005

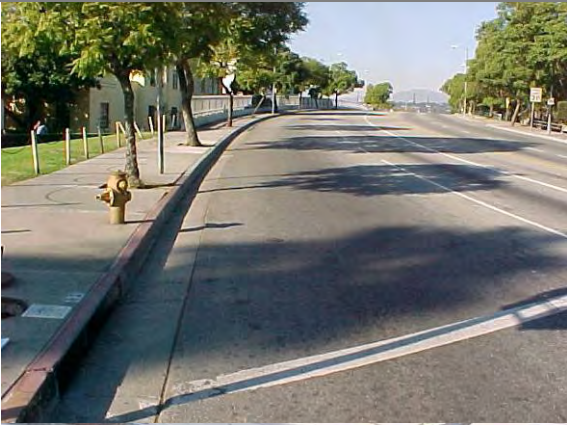
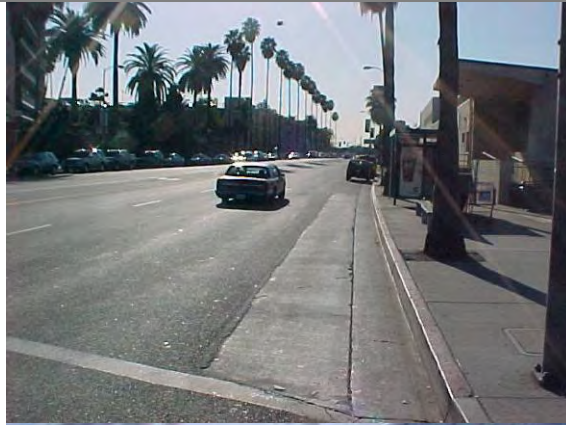
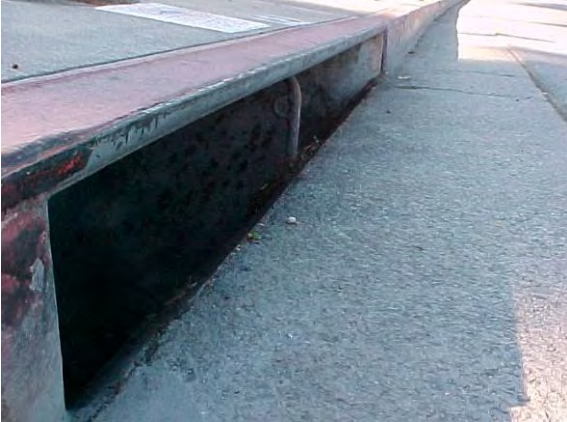
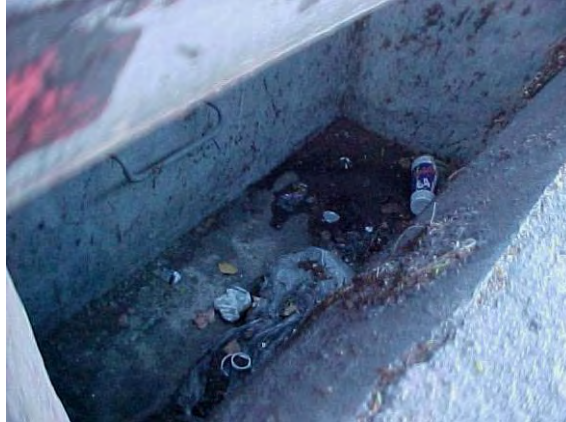
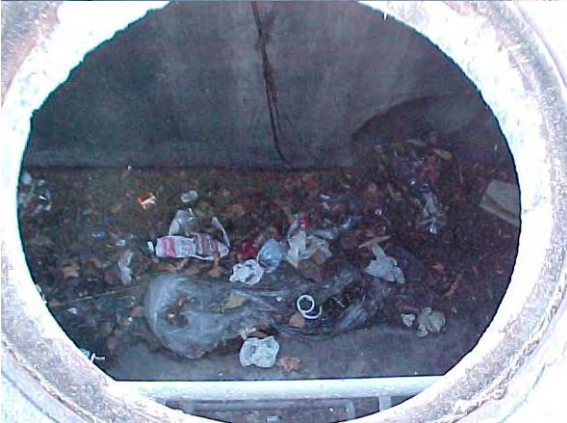
Date inspected:
10/20/03

Comments: Initial site visit. Top left photo is looking upstream; top right is looking downstream. There was about 1 garbage bag of trash present in the bottom of the catch basin during this visit. Notice the location of this catch basin is on the edge of the road, not in the middle as shown in the location map above.

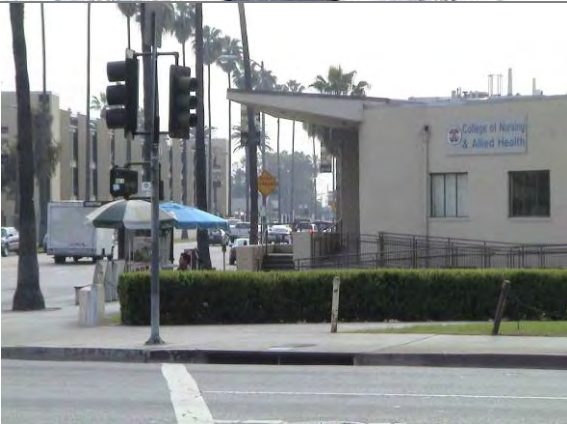
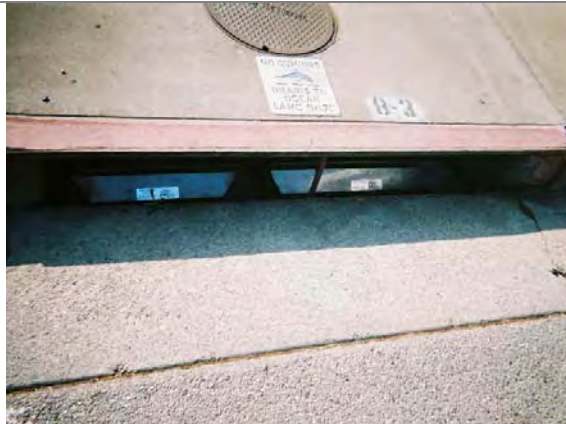
Date inspected:
2/4/04

Comments: This visit was shortly after installation. The installation consists of two Flo-Gard Plus inserts side-by-side to cover the entire 7' curb opening.

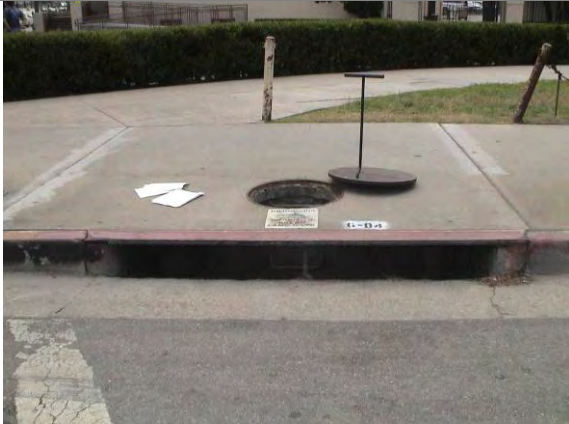
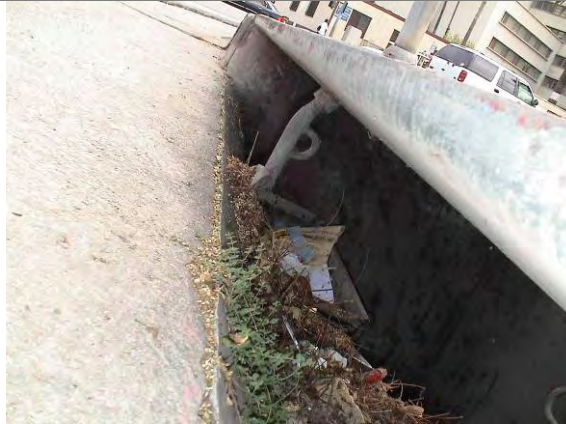
Date inspected:
3/23/04

Comments: As with the one across the street, this insert is filled with pine needles almost to capacity, but notice only the upstream insert is at capacity.

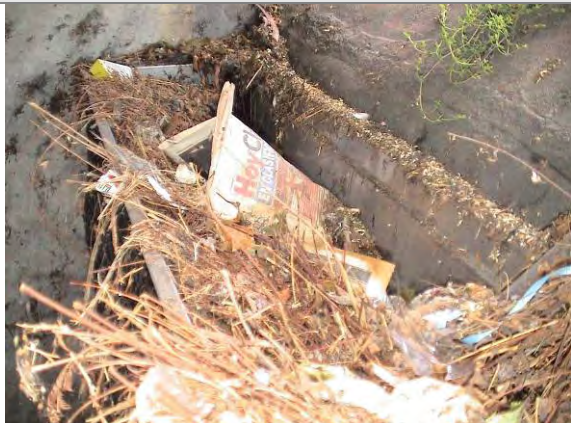
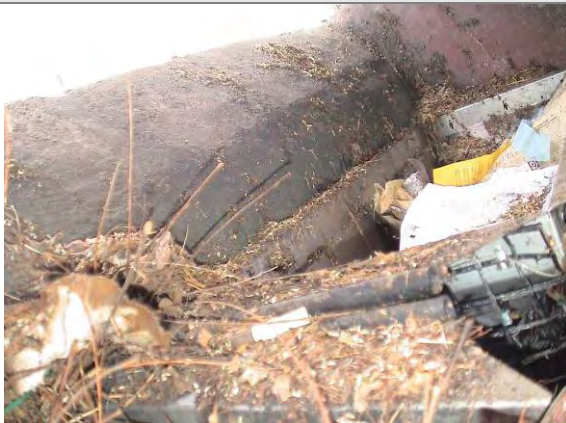
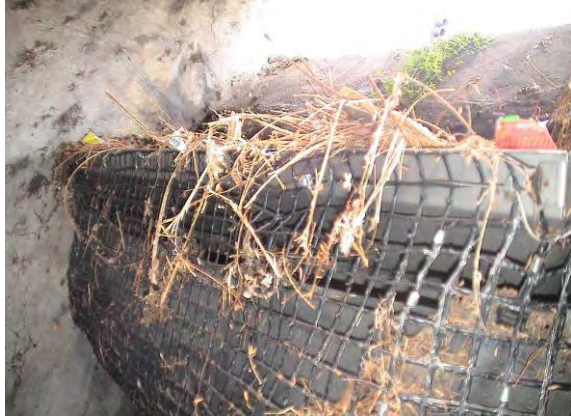
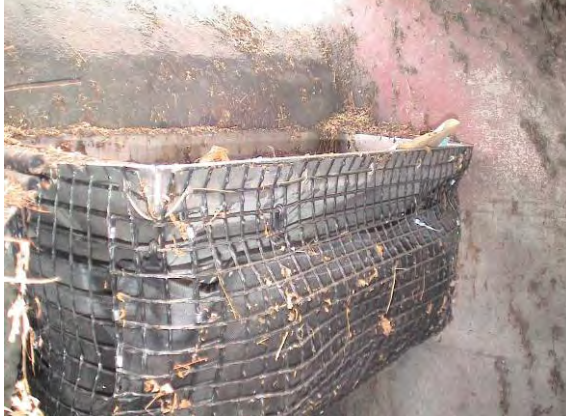
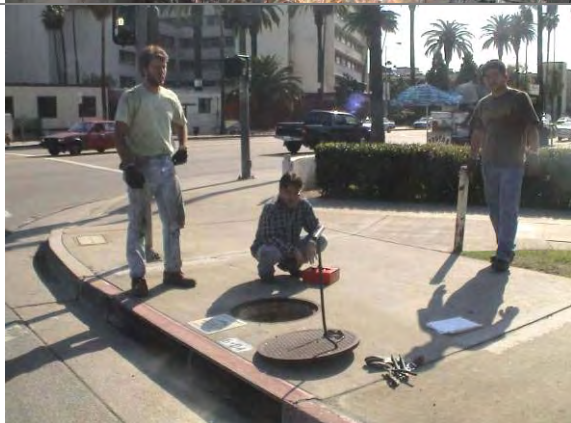
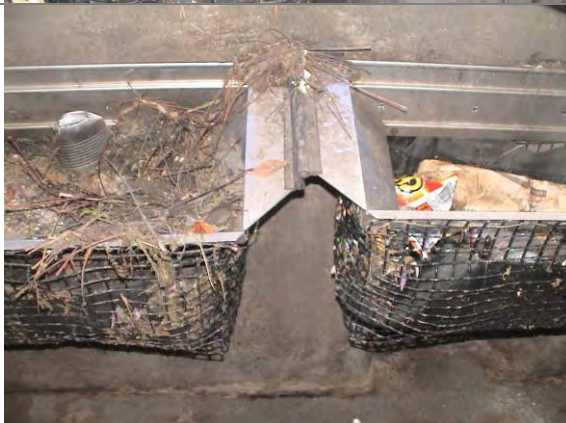
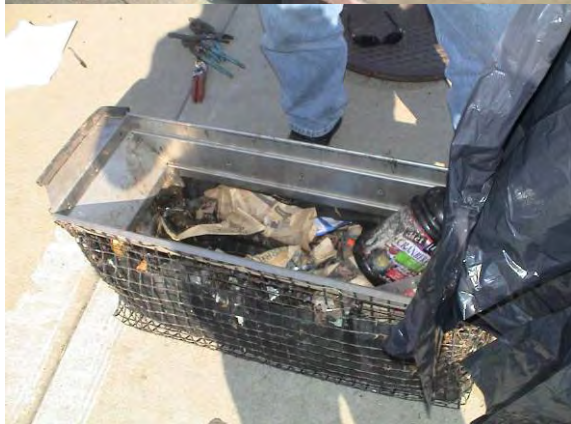
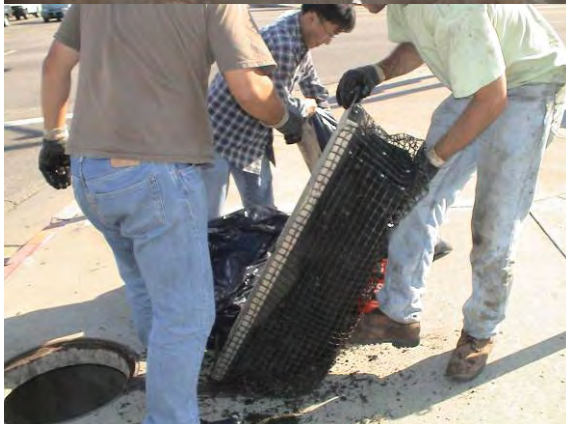
Date inspected:
6/30/04

Comments: Similar to the one across the street, this insert was recently cleaned as indicated by the month and year painted on the curb. However, both installations are at full capacity indicating the insert was not actually cleaned.

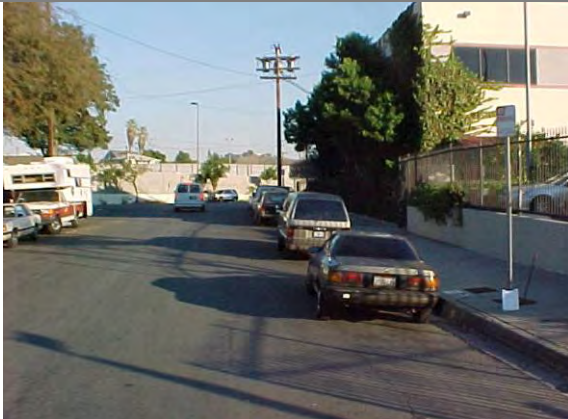
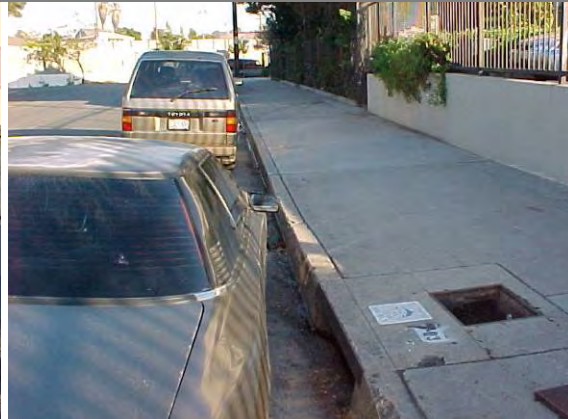
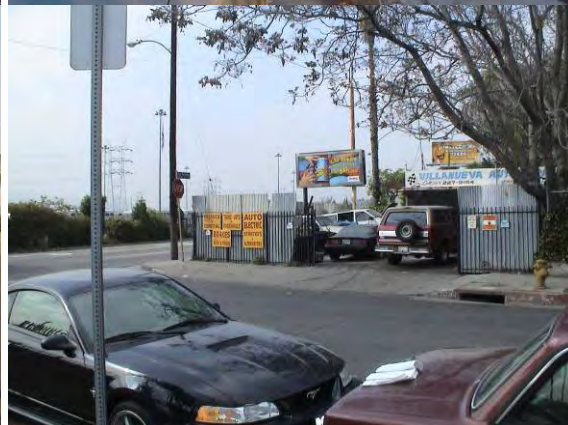
Date inspected:
12/11/03

Comments:
Initial site visit. Top photos are looking upgradient. Auto repair shop across the street; appears to be parking customer's vehicles on street in front off catch basin.

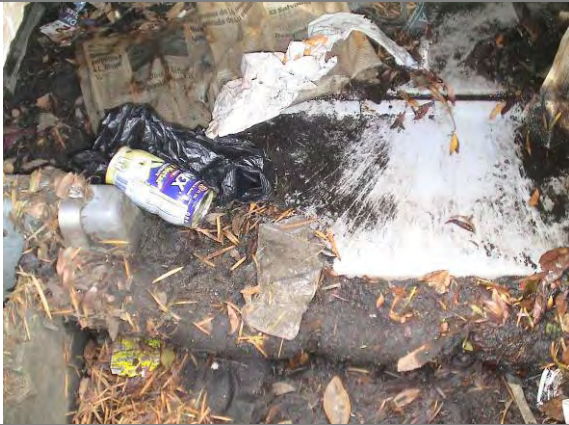
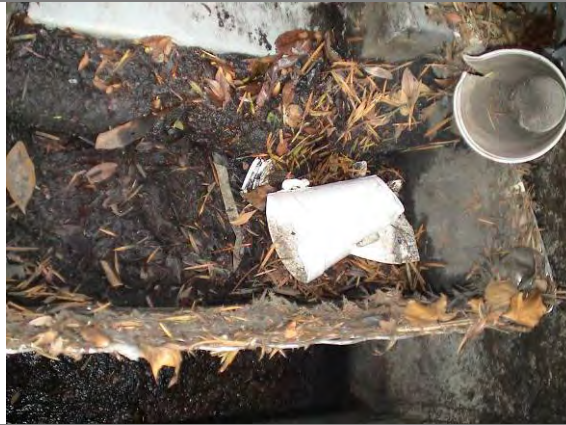
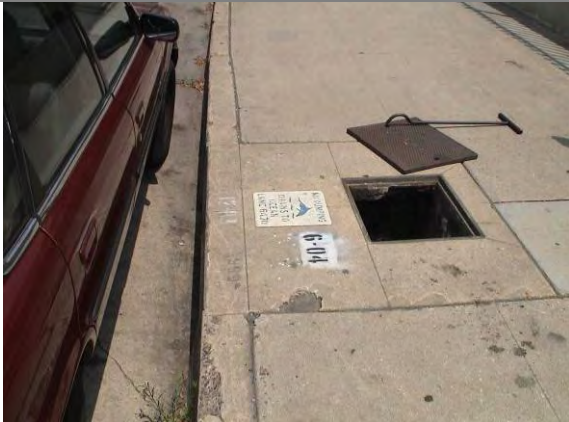
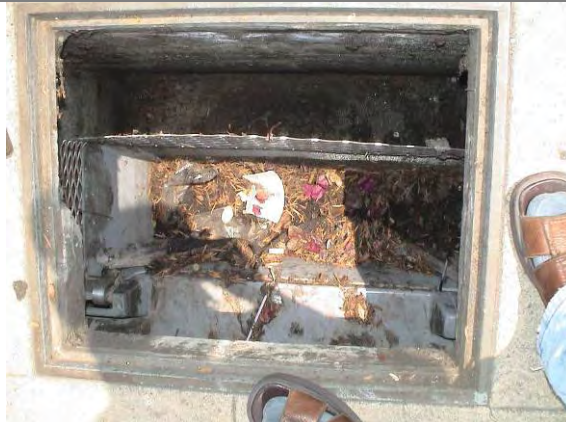
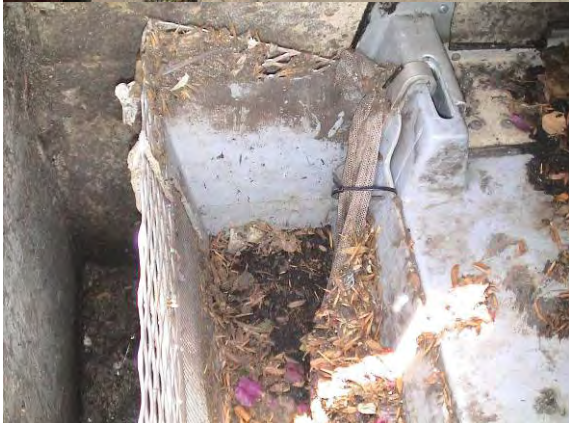
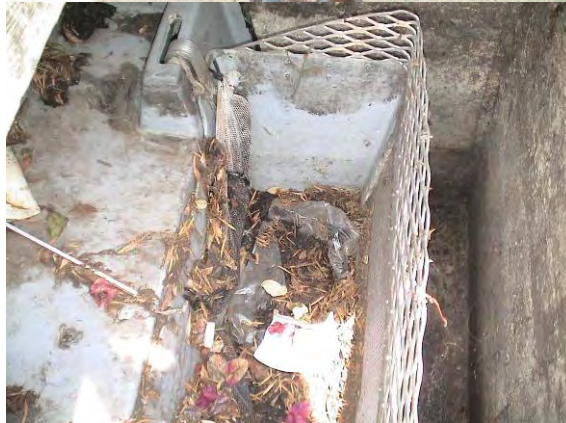
<p>Date inspected: 2/4/04</p> <p>Comments: This site has high sediment and O&G loads. Oil was flowing in the gutter and into this insert during the visit. The picture on the right was taken a few days after installation.</p>
 	<p>Date inspected: 3/23/04</p> <p>Comments: This insert at this site has collected a lot of sediment and oily residue appears on the absorbent boom and the captured sediment.</p>

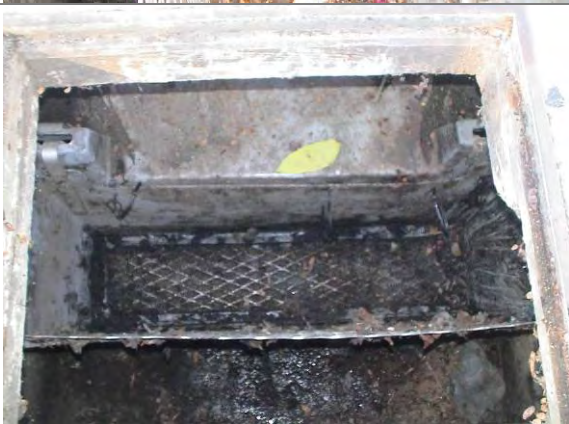
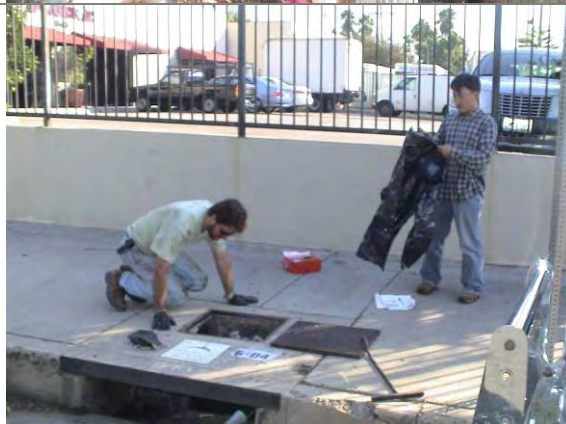
Date inspected:
6/03/04

Comments: This insert has recently been cleaned by the LADPW staff. Notice the absorbent boom is no longer present. The media may have been sucked out with a vacor truck.

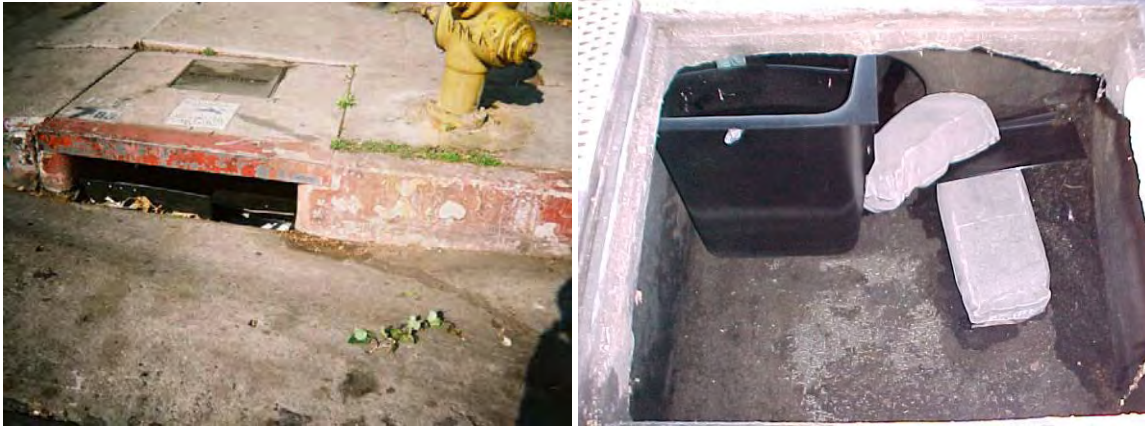
Date inspected:
2/4/04

Comments: First site visit after installation and a single storm event. The insert was installed backwards with the filtration chamber before the sedimentation chamber. The media was placed in the sedimentation chamber, which caused it to float out of the chamber during storm flows. This device was removed from this location during this visit.
