# Characterization of Impact Damage in Composite Plates

# Ajit Mal and Sauvik Banerjee

Mechanical & Aerospace Engineering Department University of California, Los Angeles

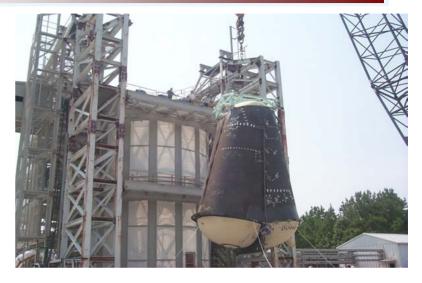
X-33 LH2 composite tank failure

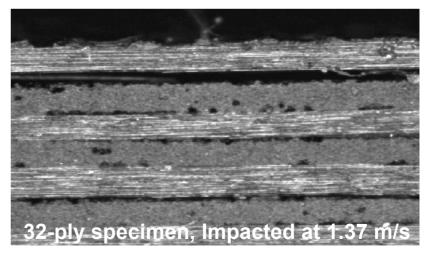
Photomicrograph of Delamination

- □ Surface motion is stronger for sub-surface delamination
- □ The theoretical calculations somewhat conform the experimental results. The photomicrograph showed the presence of major sub-surface delamination
- □ The depth of the delamination source can be identified with some confidence

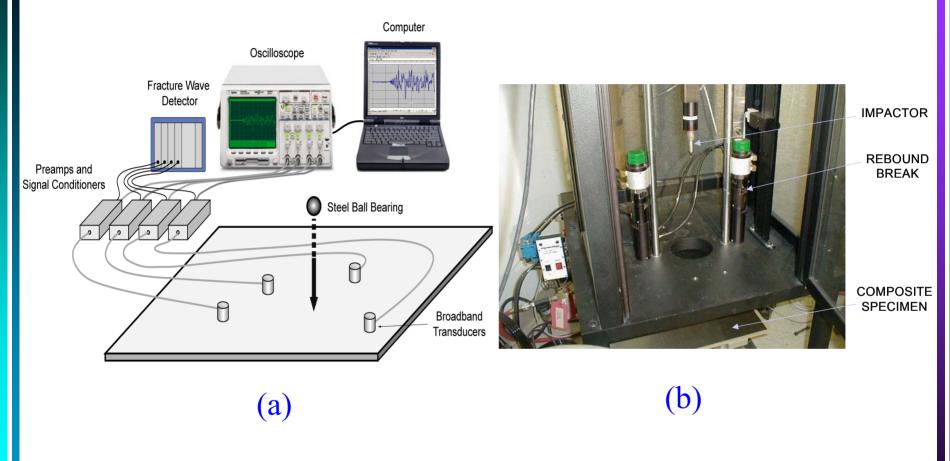
Non damaging and damaging impact tests: (a) Main data acquisition system (b) Close-up of the Instron/Dynatup impact machine

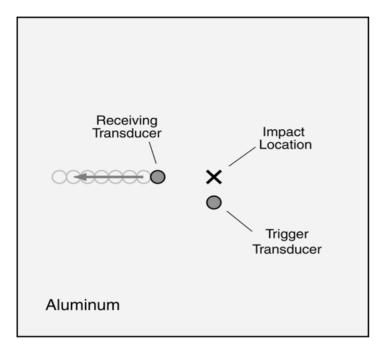
- □ Thickness: 1/16" (1.6 mm)
- □ 2.1 m/s impact velocity using a steel ball
- Constant trigger source for the experimental results

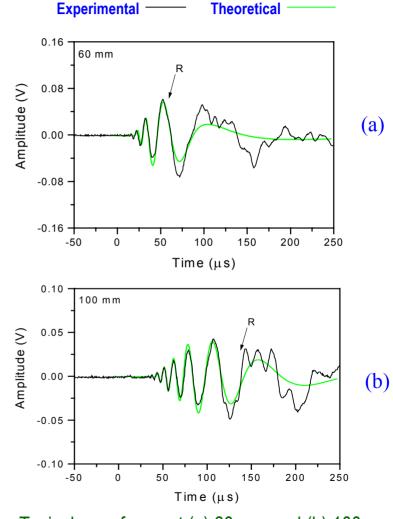
Typical waveforms at (a) 60 mm and (b) 100 mm away from impact location

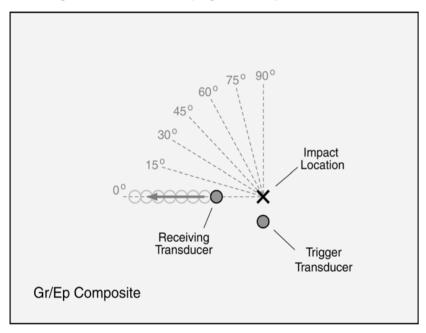
- □ Thickness: 4.3 mm
- □ 15 degree interval, 10 mm increments
- Same experimental condition as that of aluminum impact tests

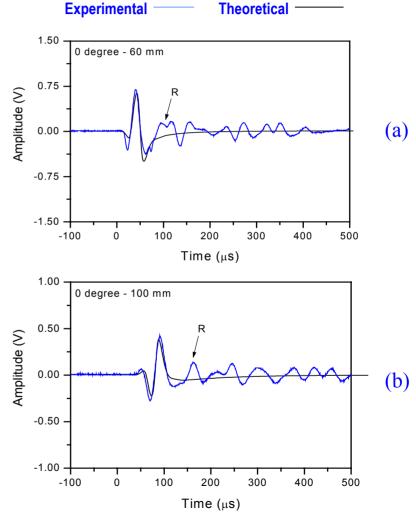
Typical waveforms at (a) 60 mm and (b) 100 mm away from impact location

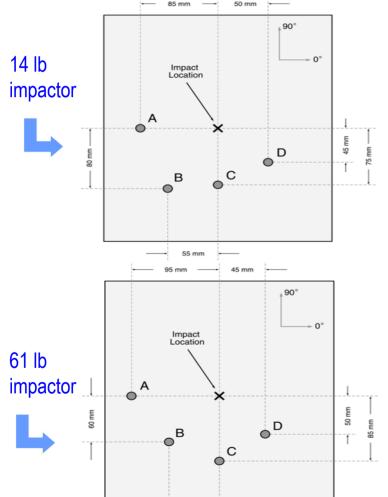
Sensor locations on the 32 layered cross-ply plate

External appearance

(No major internal damage)

Immersion ultrasonic C-scan

(Internal delamination)

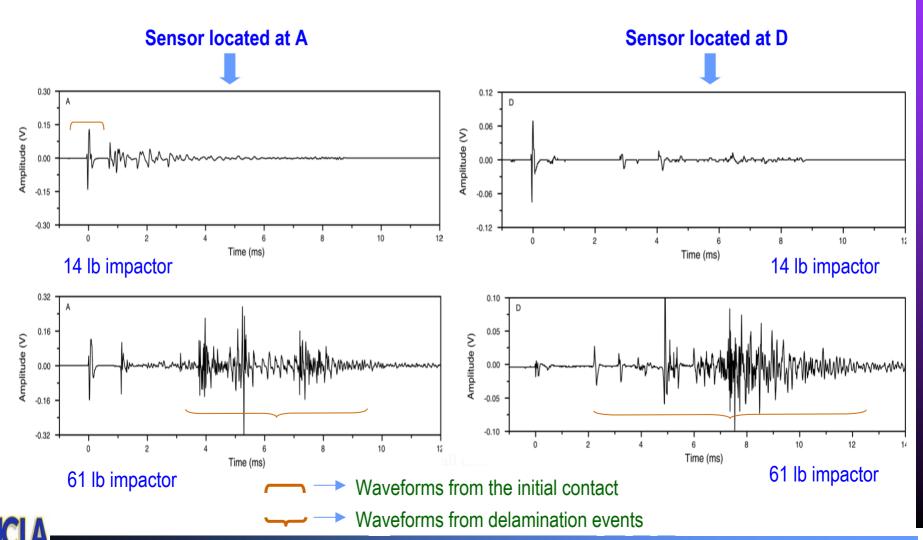
## Typical recorded acoustic emission waveforms

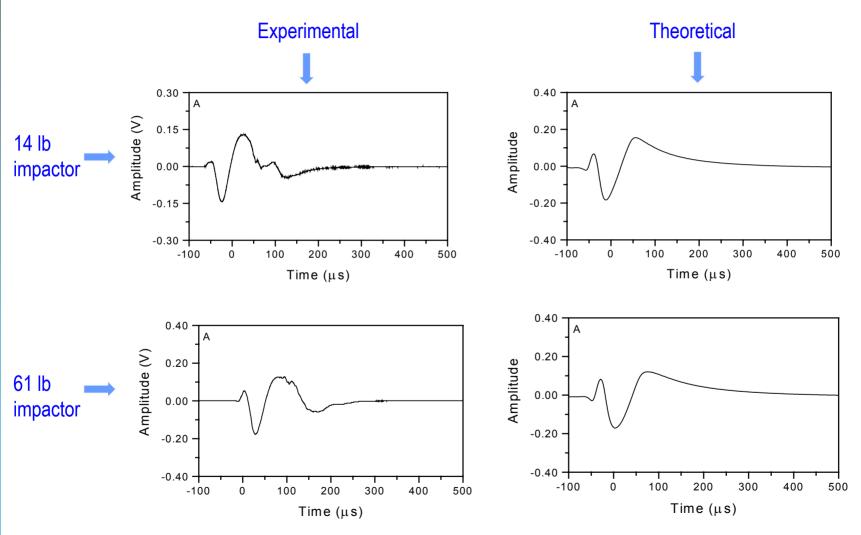
## Waveforms from Initial Contact Load

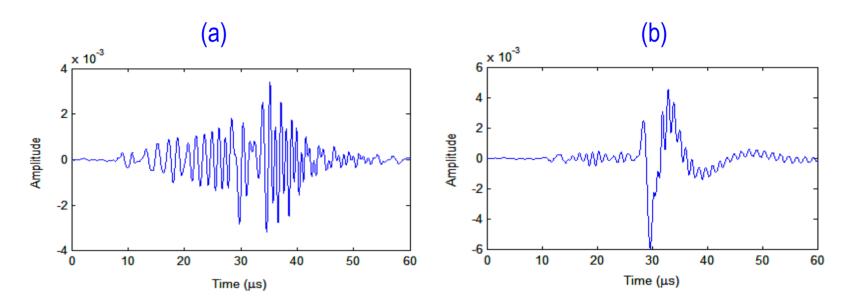
Theoretical signals from initiation of shear delamination at interfaces between (a) layers 4-5 (b) layers 16-17

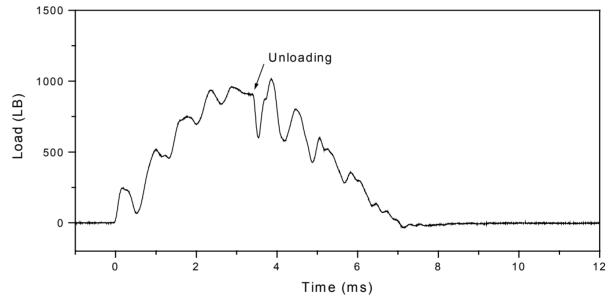
Unloading occurs during delamination damage

#### **Sensor location A**

Force-time history

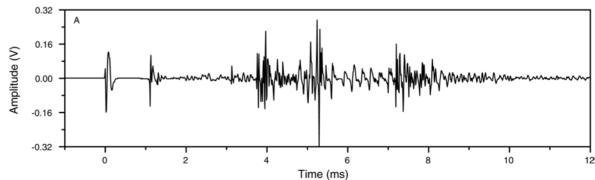
Recorded signal
